DAMAGE TO NON-STRUCTURAL COMPONENTS IN LARGE ROOMS BY THE JAPAN EARTHQUAKE, MARCH 11TH, 2011

Ken'ichi KAWAGUCHI¹

ABSTRACT: The author has kept warning the danger of the failure of non-structural components in large rooms since Kobe earthquake in 1995. The Japan earthquake in 2011 has brought about the damage to the non-structural components, especially to the suspended ceilings in large rooms, in a very wide scale. The examples of failure are reported and discussed.

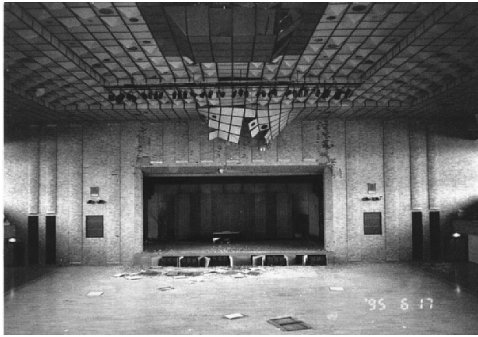
(a) Conventional type ceiling

Figure 1. Suspended ceilings failed in the Kobe earthquake, 1995

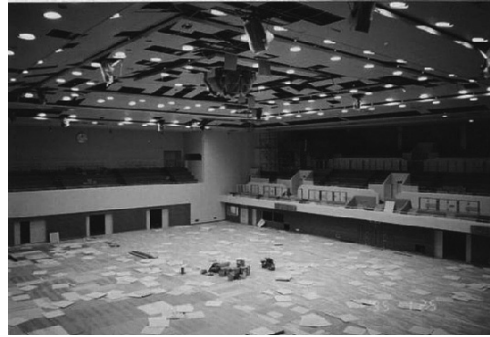
(b) Grid type ceiling

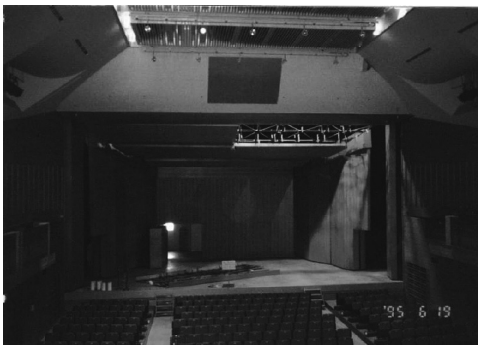
(a) Collapse of an acoustic panel

Figure 2. Suspended facilities failed in the Kobe earthquake, 1995

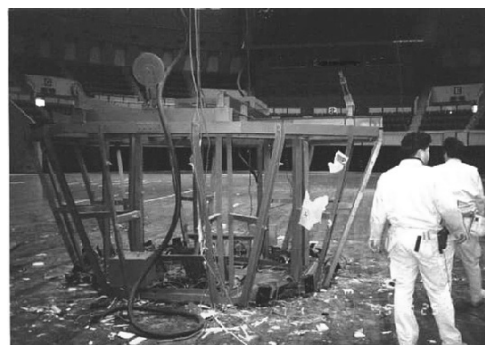
(b) A huge speaker cluster frame

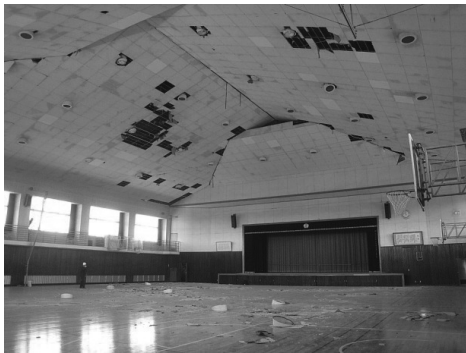
Most of the ceiling systems are developed and prepared for horizontal use. However in many cases in large rooms the ceilings are designed to be inclined or curved for many reasons. The gymnasium of a junior high school in Tochigi prefecture had inclined suspended ceilings finished with gypsum acoustic boards. Many of the ceiling boards fell by the failure at the heads of the nails, which fixed the board to the furring strips (**Figure 4**). Many covers of lightings also dislocated and fell. These failure injured many students who used the gymnasium at the moment when the main shock of the earthquake hit the area.

(a) Interior view of the gymnasium

Figure 4. Damage to the ceilings in a school gymnasium in Tochigi prefecture

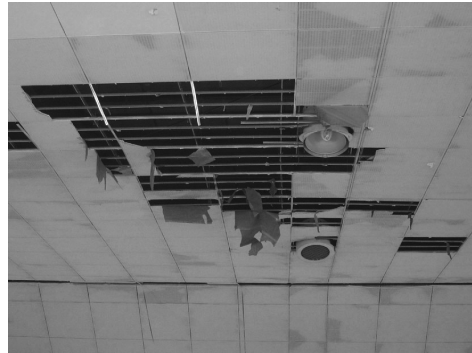
(b) Gypsum boards failed at the nails' heads

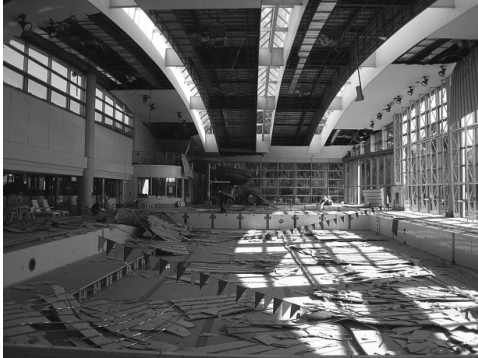
The large part of the curved ceiling of a swimming pool in Tochigi prefecture collapsed mainly because of the failure at the joints so-called “clips” (**Figure 5**). Clips have been developed for quick and easy construction and very commonly used for the conventional ceiling systems in Japan. However recently they became to be regarded as one of the most problematic parts, in the respect of earthquake resistance, in the ceiling systems. The steel frame of the building looked very sparse to allow lots of light from outside. The frame response was probably so strong that the clips could not

keep their firmness.

(a) Interior view of the pool

Figure 5. Damage to the curved ceilings of a swimming pool in Tochigi prefecture

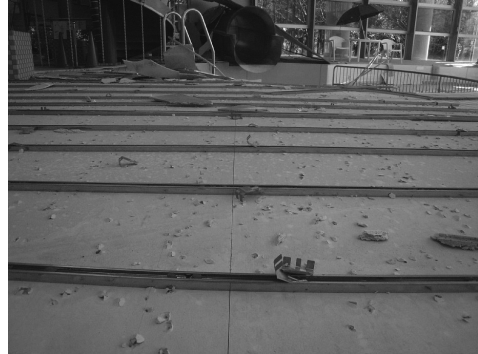
(b) Failed furring strips and clips

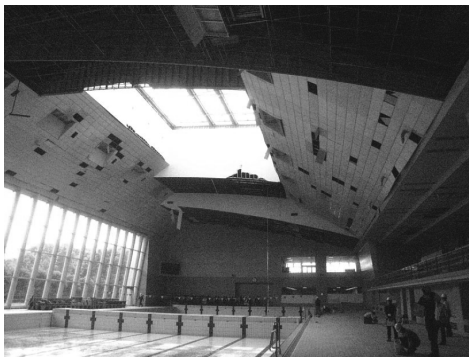
Another swimming pool in Ibaragi prefecture was also suffered from collapse of suspended ceilings (**Figure 6**). Dislocation of the ceiling panels from “T-bar” type furring strips, failure at hanger-joints and clips can be observed.

(a) Interior view of the pool

Figure 6. Damage to the curved ceilings of a swimming pool in Ibaragi prefecture

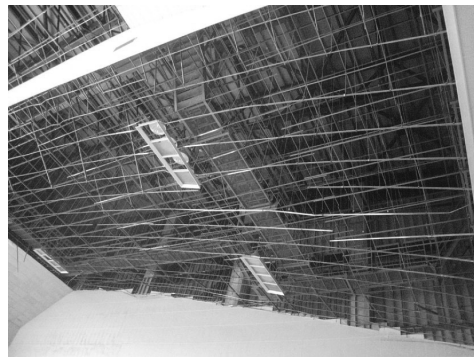
(b) Collapsed curved ceilings

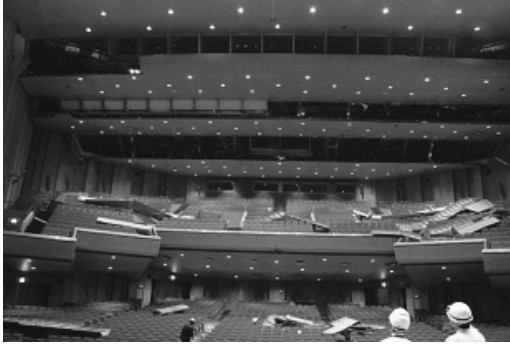
Auditoriums usually have ceilings of complexly curved surfaces for their functions and acoustic performance (**Figure 7**). Auditoriums often have very large space above the ceiling in order to form the curved ceilings and to house function rooms. Very long suspension length of the ceiling makes the ceiling system rather unstable and often causes the failure of the ceilings. Very heavy panels are usually used for the ceilings for their acoustics. These heavy ceilings also cause easy collapse of the ceiling systems.

(a) An auditorium in Fukushima

Figure 7. Damage to the acoustic curved ceilings of auditoriums

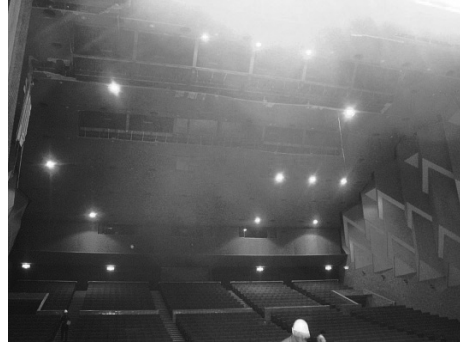
(b) An auditorium in Miyagi

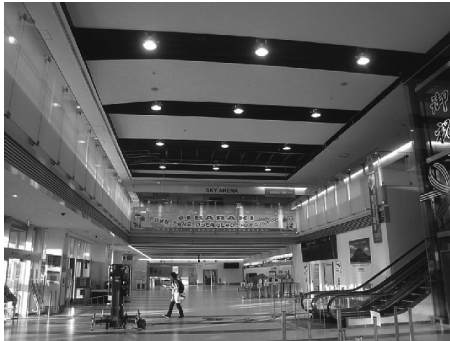
The ceilings at the entrance hall of an airport building, completed just a year ago, failed during the earthquake (**Figure 8**). There was no damage to the building structures. The height of the ceilings was so high but, luckily, nobody was injured. The important role of an airport in the emergency must not have allowed such easy collapse of non-structural components. The architectural design should have done more carefully. The instance of collapse of the ceiling was recorded by TV clue, which were there just by chance, and repetitively reported the failure with the video in the news program. The airport was reopened in a month by removing the remained ceilings of the entrance hall. The estimated impact load according to the results of dummy head experiment has been reported by the author's group in a report in Japanese.

(a) View of the entrance hall

Figure 8. Damage to the ceilings of entrance hall of an airport

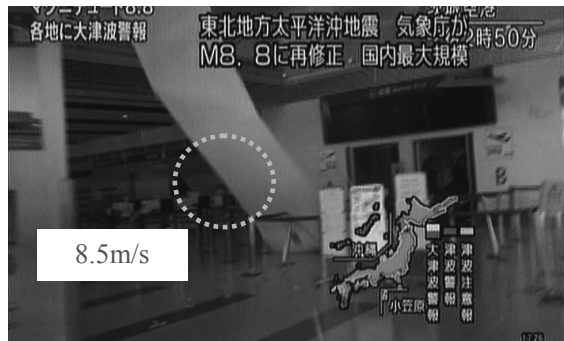
(b) Estimated velocity of the ceiling during fall

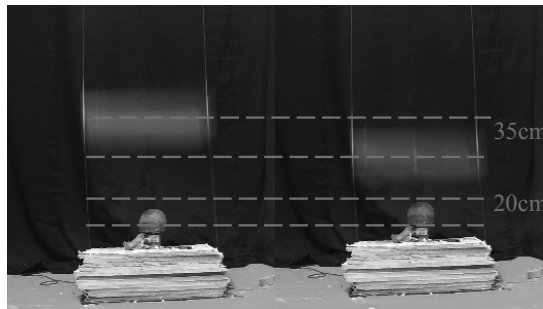
(c) Estimation of the impact load in comparison to the dummy head experiment

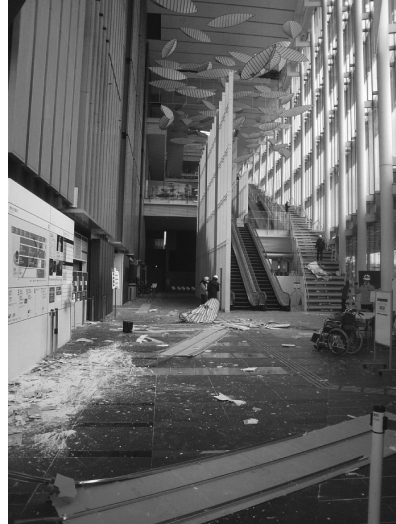
The National Museum of Emerging Science and Innovation is standing at an artificial island in Tokyo (**Figure 9**). The ceilings of the entrance hall of the museum were failed during the main shock and the after shock. The evacuation guidance by the museum staff was so well organized that nobody was injured. The director of the museum considered the accident seriously and decided not to recover the ceilings in the same style as they were. He asked the author to supervise the recovery plan. The author recommended using the lightest and most flexible material, membrane, for the new ceiling. The director removed all the remained conventional ceilings of the entrance hall and renewed it with the membrane ceiling, which hardly fails again and never injure people.

(b) The damage in the entrance hall

Figure 9. The National Museum of Emerging Science and Innovation

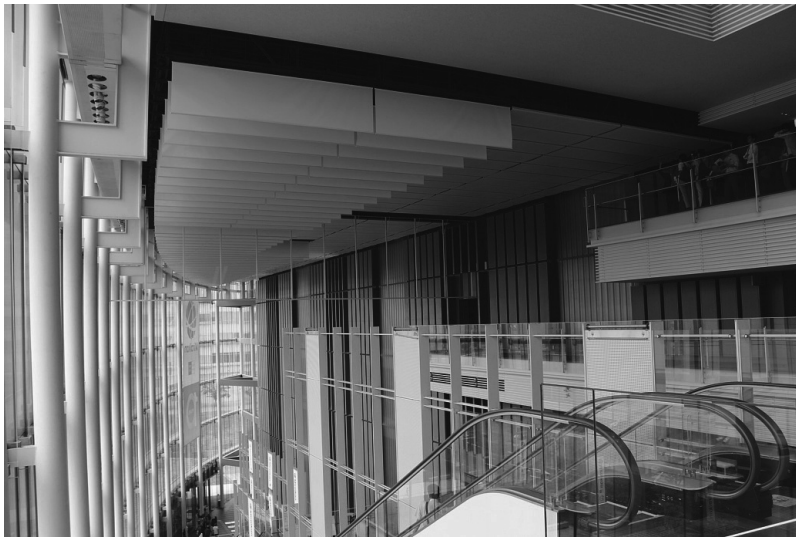
(c) New membrane ceilings

The recovery work was quickly completed and the museum reopened on 11th June, 2011.

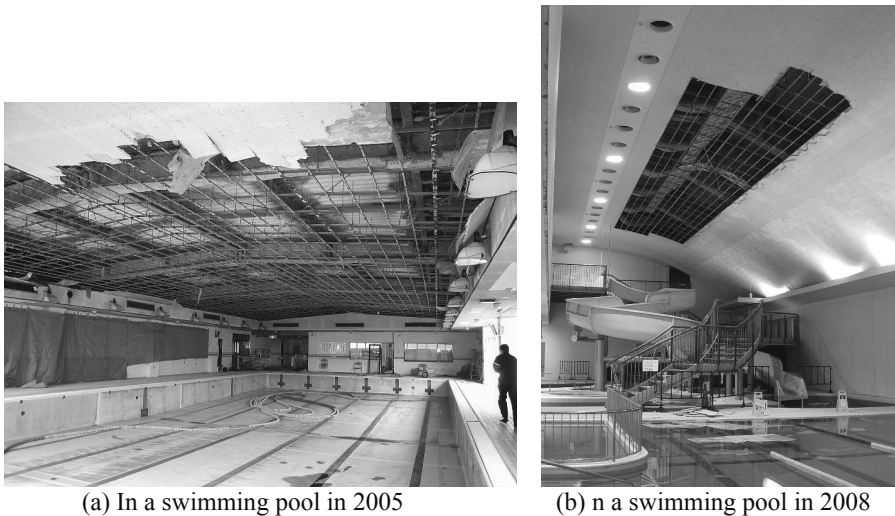
Non-structural components, especially suspended ceilings in the large rooms can fail easily, and not only by earthquakes (**Figure 10**). The earthquake is just one of the causes that bring about the failure simultaneously in many places. Failure of non-structural components becomes extremely dangerous when they are put at the locations that satisfy the following three conditions.

Figure 10. Example of failure of suspended ceilings without any earthquake
