# SINKHOLE DAMAGE IN ARMALA AREA IN POKHARA, NEPAL: A PRELIMINARY SURVEY REPORT

**ABSTRACT:** Nepal is a seismic prone country. There is a very high potential that an upcoming strong earthquake may have catastrophic consequences in Armala area, Pokhara Valley, where the unexpected formation of a substantial number of sinkholes is already in place since November 2013. In order to provide measures aimed at reducing sinkhole risk, new insights into the sinkhole cause and features is crucial. This paper reports on two damage surveys conducted in June and November 2014 by the Authors in Armala area, to investigate the cause of such sinkholes. Comparison of photos, taken in the two surveys, clearly indicates not only the formation of new sinkholes, but also the re-activation of sinkholes that were previously backfilled. By means of S-wave explorations and dynamic cone penetration tests, qualitative characterization of soil profile was attained and shallow weak soil layers, which are believed to be the location for future sinkholes, could be identified. Sinkhole cause are described and feasible countermeasures are proposed to mitigate sinkhole risk in Armala area.

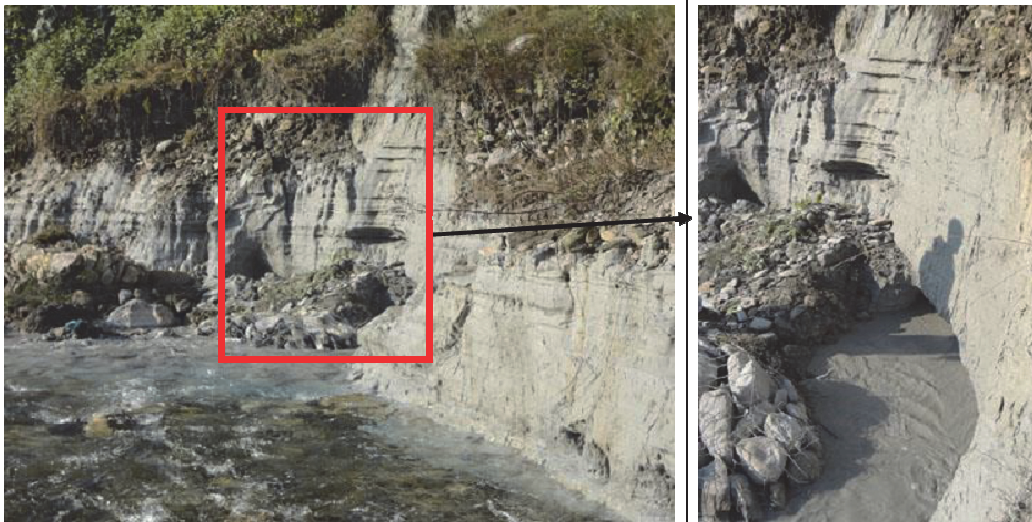
The muddy silty water outlet (Figure 3) at the Kali Khola (Small River) riverbank (at point B red square in Figure 4) is the evidence that there are in act of erosion and cave-in processes within the subsurface of the damaged area. The local residence observed this muddy water outlet about one week before the first sinkhole appeared in November 2013.

**Figure 3** A muddy silty water outlet at bank of Kali River (Technical research report, 2014)

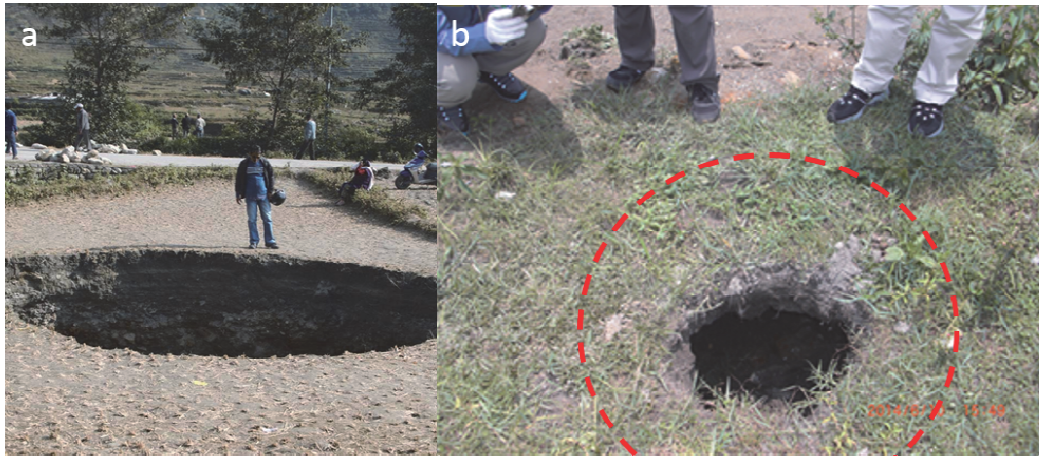
According to local residence the first sinkhole appeared in November 2013 at point 3 (Figure 5). Since then, more than 150 sinkholes developed in this area. A typical circular-shape sinkhole appeared in Nov. 2013 is shown in Figure 6(a) (mysansar.com).

Figure 6(b) shows a small sinkhole appeared at point 2 (Figure 5), just one day before the survey team visited this area in June 2014. Note that, although the sinkhole in Figure 6(b) has a small diameter at the surface, its diameter is much larger in the subsurface (red dotted line). Such spherical

shape is due to the fact that the soil in the upper part of the sinkhole was retained by the root system of the grass binding the surface soil.

**Figure 6** (a) a typical sinkhole formed on Nov. 2013 (source: mysansar.com); and (b) a sinkhole formed in June 2014

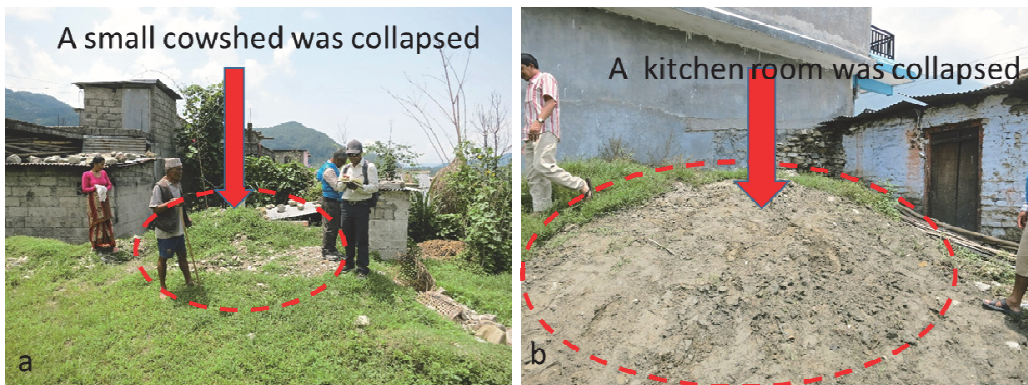
The sinkholes affected not only the agricultural farmland. It also caused the collapse of cowshed [Figure 7\(a\)](#) at point 11 ([Figure 5](#)), and kitchen of the local residents [Figure 7\(b\)](#) at point 25 ([Figure 5](#)). Homeowner said that about 60 m<sup>3</sup> of filling material were used to fill the sinkhole shown in [Figure 7 \(a\)](#).

**Figure 7** Typical effects of sinkhole on residential properties: (a) collapsed cowshed and (b) collapsed kitchen

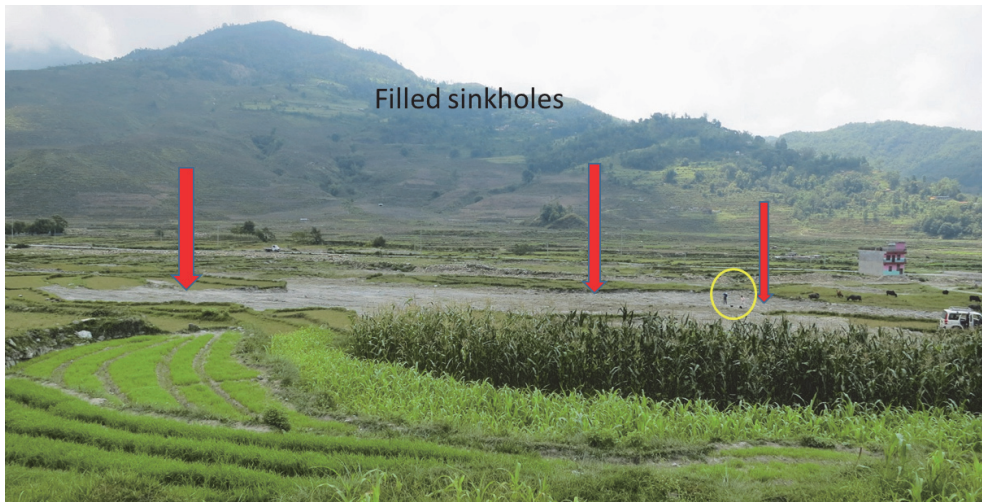
Immediately after the occurrence of sinkholes, a wide area affected by the cave-in was backfilled ([Figure 8](#)) by using gravelly soil retrieved from nearby quarries, which is identified by a yellow color filled area in [Figure 5](#). At the time of the first damage survey in June 2014, most of those sinkholes gave the impression to be essentially fully backfilled [Figure 8](#). However, photos taken in November 2014 clearly show that the backfilling was not an adequate solution as most of former sinkholes re-activated [Figure 9](#) likely in August 2014 during the peak rainy season in Pokhara valley.

**Figure 8** Photo of the sinkholes backfilled area taken in June 2014 (red arrows show backfilled area; yellow circle indicates the location of Dynamic Cone Penetration Test No.3)

From the third DCPT, it is concluded that the used filling material is also gravelly soil. However, the compaction at the surface is not good enough because the N-value measure is very low.

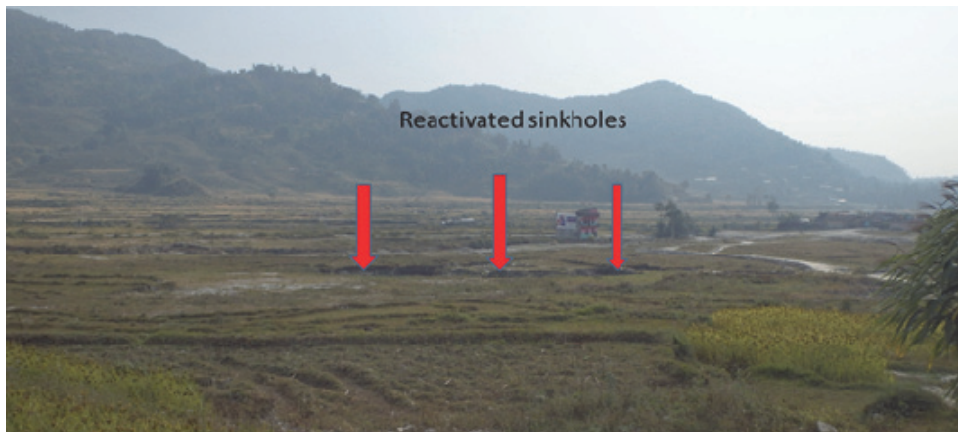
**Figure 9** Re-activated sinkholes area observed in November 2014 (c.f. Figure 8)

Note that due to loose conditions of backfilled material, it is expected that the development of a reactivated sinkhole is much quicker than that of an original sinkhole where natural compacted soils was gradually eroded by water.

As explained before, as a possible countermeasure, the government agency backfilled a number of sinkhole. However, it was clearly a temporary and not satisfactory solution since the majority of the sinkholes re-activated during the rainy season.

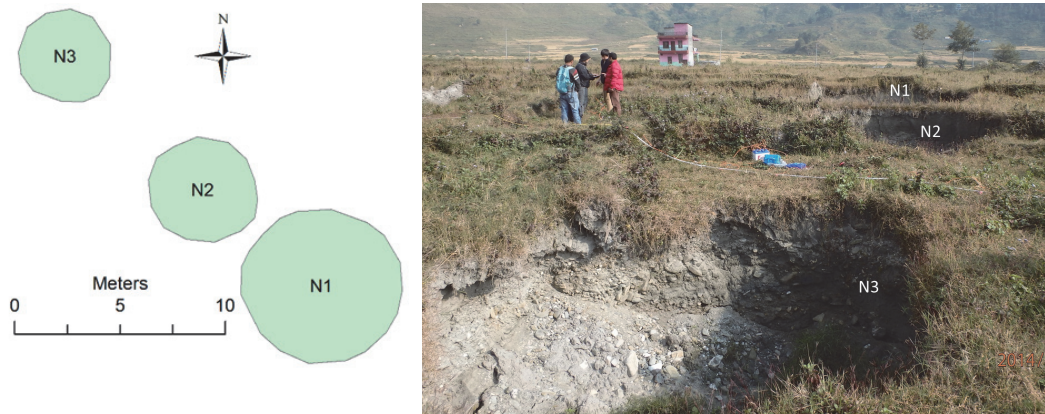
Among many, sinkholes N1, N2 and N3 in the area A in [Figure 5](#) were found of particular interests. They were developed in a delimited area of approximately 10×20 m, as shown in the schematic map reported in [Figure 10](#). They have a circular pattern and a diameter ranging from 4.6 m (N3) up to 6.8 m (N1). Their depth measured at the top of collapsed soil varied from 2.2 m (N1, N3) to a maximum of 3.5 m (N2). According to local residents, N1 was the first sinkhole to be formed. Few days later, N2 was caved-in and finally N3 was developed.

This progressive formation of several sinkholes along a straight line (moving along upstream direction from N1 to N3) may suggest that the collapse of N1 caused the complete disruption of underground water flow. Consequently, water started to erode the soil just adjacent N1 until a new cave-in (N2) was formed. In similar way, N3 was later developed. According to local residents, same pattern of the sinkholes also appeared in November 2013.

**Figure 10** Series of sinkholes appeared in the area A reported in Figure 5

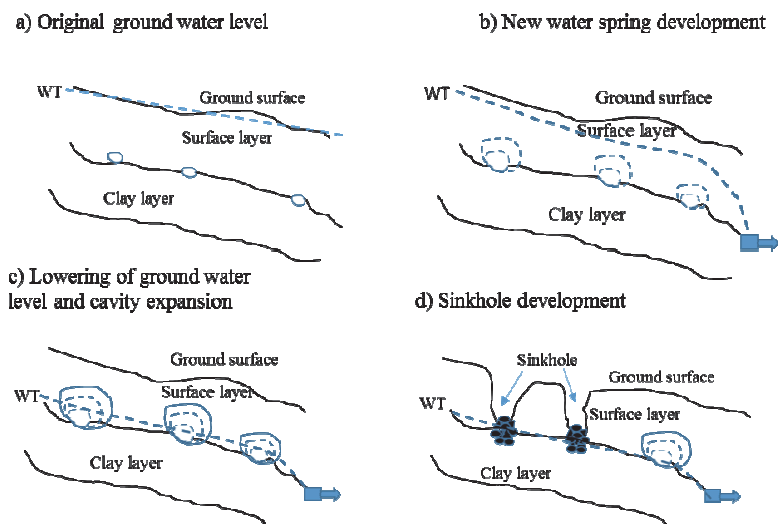
**Figure 11** Probable mechanisms of sinkhole observed in Armala area

Nevertheless, in November 2013, suddenly, a water spring was observed for the first time by local resident (Figure 3). It was rapidly followed by formation of a number of sinkholes as already described earlier. Authors believed that the formation of water spring induced a change in the groundwater level, i.e. water table decline (Figure 11 (b)).

The drastic fall in groundwater level and its fluctuation during rainy season, accelerated the erosion process (as evidenced by mud water observed at the water spring outlet) and cavities enlargement (Figure 11 (c)). As the process continued, the loose, unconsolidated soil and sand above was gradually washed into the cracks and voids. Depending on how thick and strong the top layer was and how close to the surface the void beneath was, the ground was not able to sustain its own weight. Thus, cavities that before were stable, suddenly become instable and collapsed (Figure 11(d)).

- Preventing water withdrawal and controlling irrigation;
- Prevent the fluctuation of water table;
- Using effective drainage system and diverting surface runoff.

Improving the ground by compaction or ground injection to increase the strength and bearing capacity of the soils.

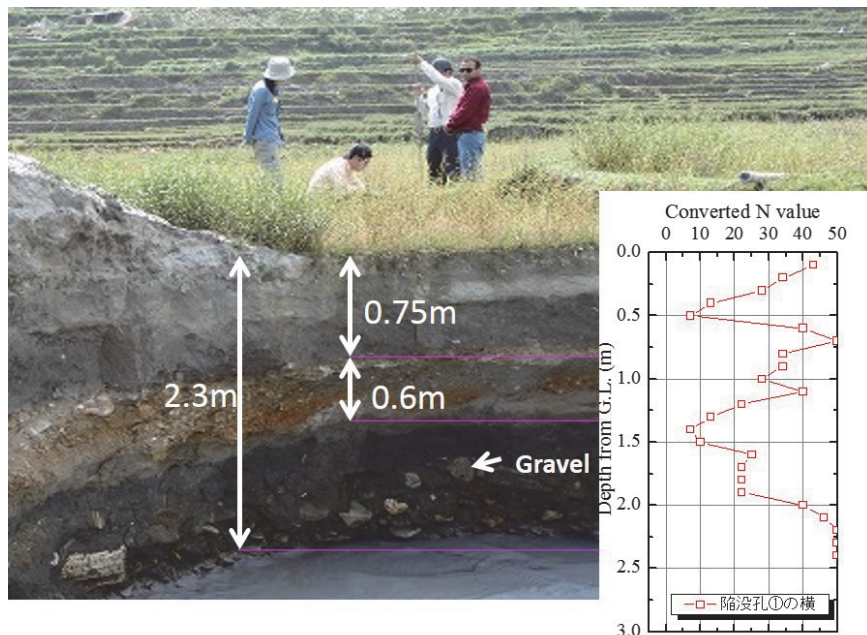
**Figure 12** Soil profile and DCPT result in the location 2 observed in Sinkhole on June 2014

In the case of DCPT No. 2, the converted DCPT-N values are plotted in Figure 12. The upper layers of surface soil could be penetrated until reaching the gravel layer, where even by hitting more than 150 times the penetration process stopped.

From these test results, it is assumed that likely the cave-in started just below the gravelly layer. Then progressively the cavity size increased and finally the loose upper layer collapsed.

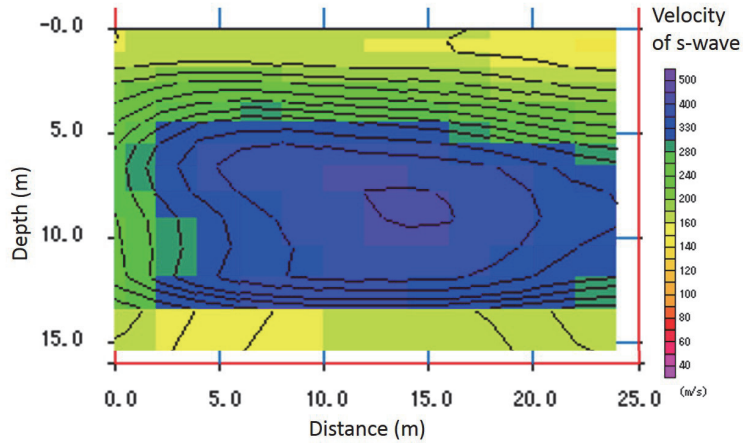
Typical results of surface wave exploration for a section of 25 mm are shown in Figure 14. One can see that the shear wave velocity for the surface layer is in the range of 150-180 m/s, confirming the presence of a very loose sand layer of thickness 1.5 m. The underneath gravel has a higher velocity, than surface layer, of about 240 m/s. Moreover, the stiff soil below 4 m depth has a shear wave velocity greater than 350 m/s. It should be noted that, the results obtained for a depth from ground surface below 15 m were considered not reliable because technical limitation of the surface wave measurement method used.

**Figure 14** A typical profile of surface wave exploration

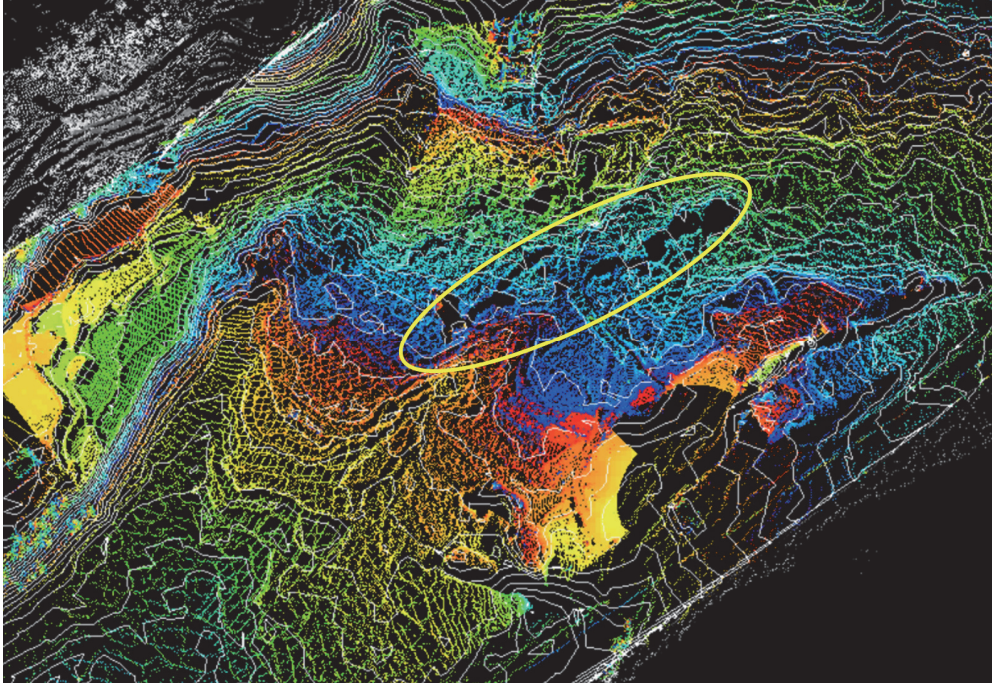
In November 2014, to acquire the entire 3-D image of the sinkhole damage area, a survey was conducted by using the Light Detection And Ranging (LiDAR) shown in Figure 15. The area was scanned from three locations as shown in Figure 5. The individual 3D digital surface models were then combined to create the entire terrain model of the study area. Figure 16 shows a bird-eye view of the sinkhole affected area. The black part at the lower right corner of the image is the hidden part behind the cliffs. The black spots highlighted by yellow circle are recent and reactivated sinkholes.

**Figure 16** Birds eye view of the sinkhole effected area
