# REPORT ON SOME LARGE SPAN STRUCTURES DAMAGED DURING THE “2016 KUMAMOTO EARTHQUAKE”

**ABSTRACT:** The 2016 Kumamoto earthquake, that measured a maximum of seven on the JMA seismic intensity scale, occurred in Kyushu, Japan, in April, 2016. One of the two investigated buildings has a large membrane roof structure that normally has high earthquake resistance. It encloses a large space; nevertheless, it was not used as an evacuation center owing to the damage, not to the structural members, but to the non-structural components. Another building is a public hall that has a heavy ceiling for better acoustic performance. In this paper, the damage investigation of these two large-span structures in Kumamoto city is reported.

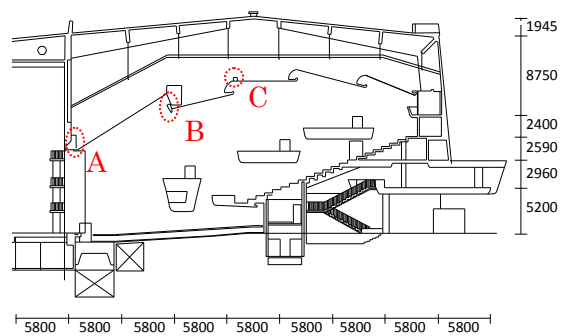
**Figure 5.** Section of the hall

The internal view is shown in **Figure 3**. **Figure 4** and **Figure 5** show the plan and section of the hall, respectively; the location where the ceiling fell from a height of 10 – 16 m is also shown in **Figure 5**. The observation was conducted from the floor in the hall without entering the space above the ceiling, owing to the danger of aftershocks. Therefore, the ceiling details were unfortunately unclear at this time. The suspended ceiling, mortar finish on 30 – 50 mm thick metal lath, installed on both sides of the stage and the 9.5 mm thick vertical gypsum boards installed in the center above the proscenium arch fell down. On both sides above the proscenium arch, shown at location A in **Figure 5**, the impact marks of the collision of the ceiling and the walls were observed. With regard to the vertical gypsum panels, the lighting equipment hanging in the front partially prevented the ceiling from falling. The ceiling installed directly under the ceiling room hung at location B in **Figure 5**, and the 6-mm thick calcium silicate ceiling fell down at location C in **Figure 5**. As mentioned, the ceiling materials differed according to location. The magnitude of the impact force caused by the fall of the ceiling is clear from **Figure 6**, especially in the case of the mortar finish on the metal lath. As shown in **Figure 7**, there was the danger of falling owing to aftershocks. Regarding further damage, the fall of the lighting covers (**Figure 8**) and the cracking of the floor above the duct space in the basement (**Figure 9**) were observed. It is considered that the crack occurred at the point of the floor overhanging the orchestra pit and the duct space, because of the vertical motion of the floor as a cantilever.

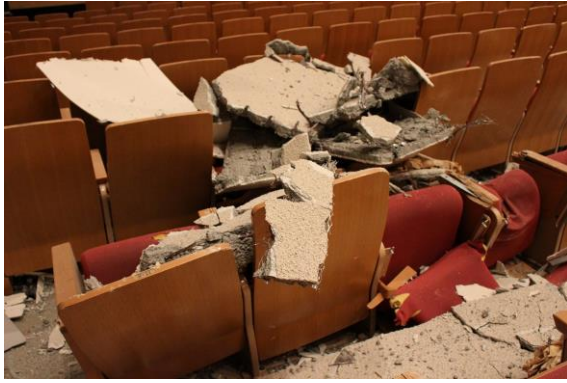
**Figure 6.** Damage to the audience seats

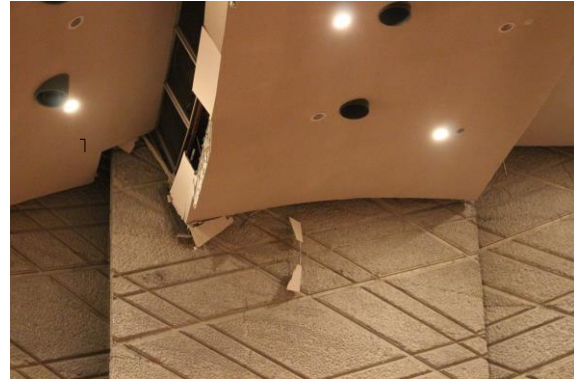
**Figure 7.** Failure of the ceiling

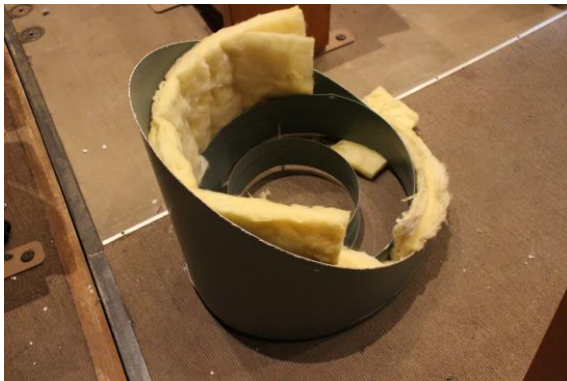
**Figure 8.** Fallen lighting cover

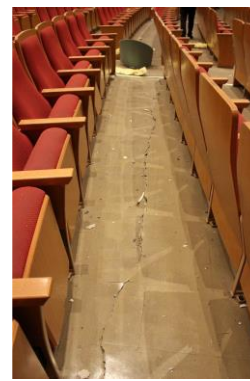
**Figure 9.** Floor damage

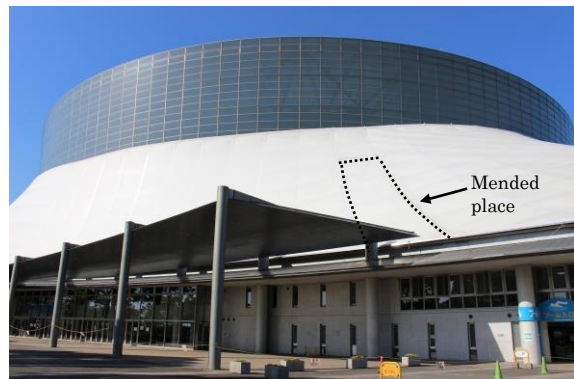
**Figure 13.** After repair of the membrane

**Figure 12** shows the plan of the facility. The damage in each area is summarized in the following section. According to the staff, although the welds of the membrane in the amorphous area fell off during the earthquake, the area was mended prior to the investigation (**Figure 13**). In addition, the connection of the canopy and the columns along the circumference of the amorphous area was damaged. In the multi-purpose ground, numerous glass wool panels of 50-mm thickness, which were installed at the ring truss for acoustic performance, fell off. Cracks and exfoliation of the concrete were observed in the bearing of the truss frame. The strings of the membrane under the truss frame in the amorphous area were frayed. The damage to the membrane caused rain to leak in on multi-purpose room 1, the meeting room etc. In the meeting room, the cracks in the walls occurred as a result of the leaking rain. Multi-purpose room 1 was used as the training room; however, all training machines were moved to other rooms because of the rain leaking in from the torn movable membrane ceiling. In multi-purpose room 2, glass wool boards were placed on the heavy ceiling made of expanded metal.

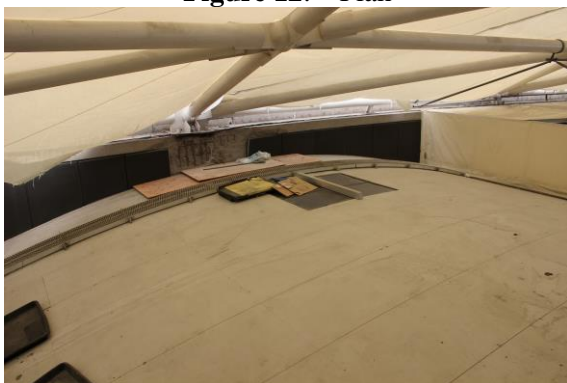
**Figure 14.** Damage to the bearing of the truss frame

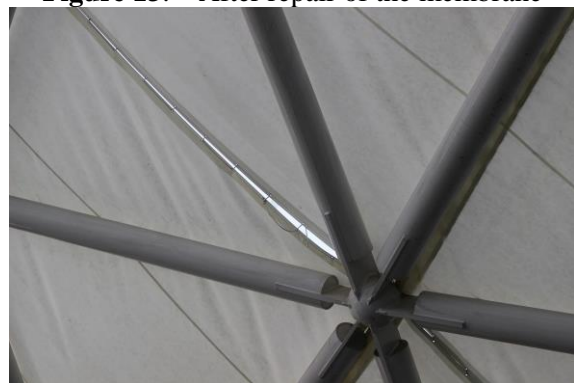
**Figure 15.** Frayed strings of the membrane

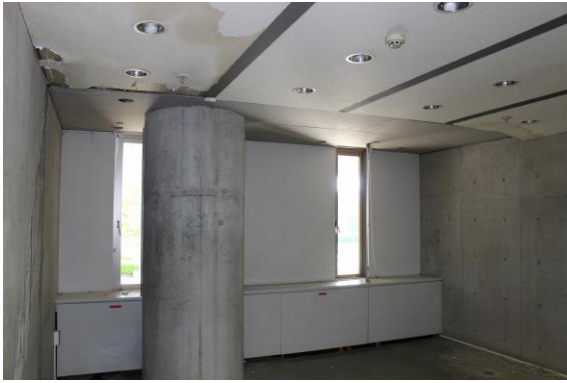
**Figure 16.** Damage to the ceiling

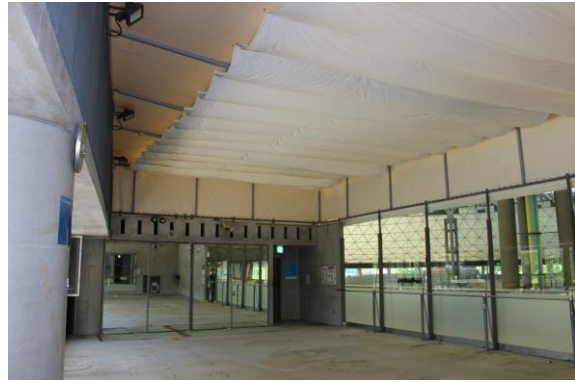
**Figure 17.** Damage to the movable membrane ceiling

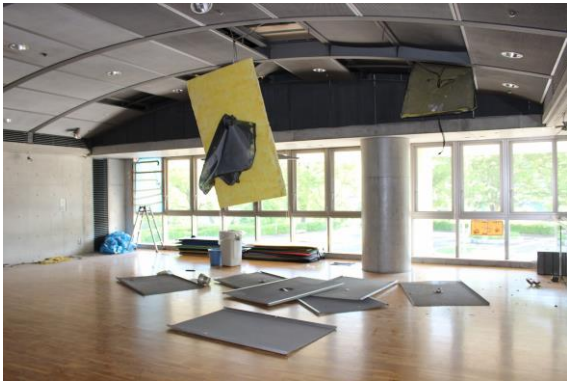
**Figure 18.** Ceiling failure

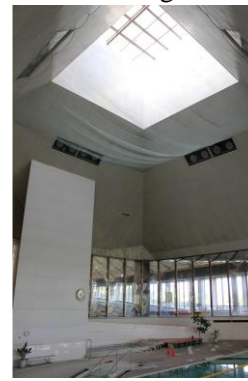
**Figure 19.** Safety net for ceiling collapse
