MARCH 16, 2022 M7.3 FUKUSHIMA EARTHQUAKE GEOTECHNICAL DAMAGE SURVEY

Kwok-Kwan LAU¹, Pei-chen HSIEH¹, Masataka SHIGA² and Takashi KIYOTA³

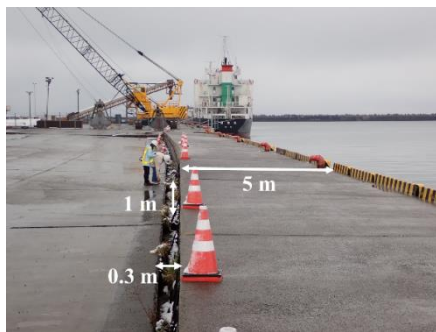
At Soma Port, ground settlement of approximately 0.5 m to 1 m was recorded at Quay No. 2 as shown in Figure 3a and 3c. The 5m-thick quay wall concrete block has moved towards the sea by about 20 cm to 30 cm. A small amount of boiled sand, as can be appreciated in Figure 2c, was observed in the gap between the quay wall and the settled ground in the southeastern corner, at which liquefaction also happened in the 2021 Fukushima Earthquake. Extensive cracks developed parallelly to the shore at about 14 m away from the quay wall, with a length of 85 m to 100 m and an opening size of about 30 cm. The resulting damage was similar to that caused by the 2021 Fukushima Earthquake (Inoue et al., 2021).

(a) Deformation at Quay No. 2

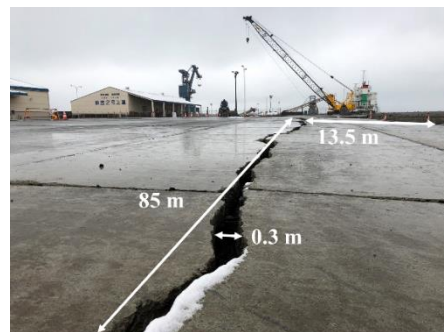
(b) Crack on the ground at Quay No. 2

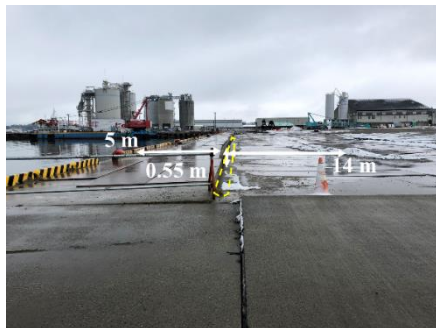
(c) Liquefaction at Quay No.2

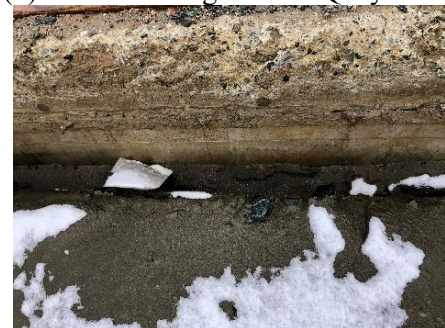
(d) Close up of the crack in (c)

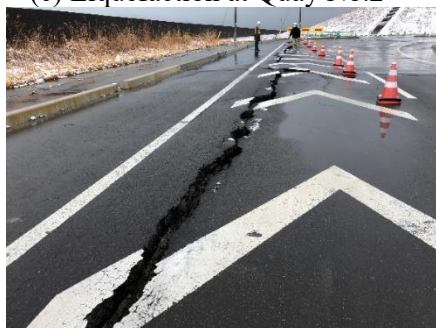
At Quay No. 5, a 130m-long crack was recorded on the carriageway (See Figure 3e). There were small steps on the cracked road due to settlement. Slight displacement between seawall panels was also identified. Another implication of the earthquake was the destruction to two of the four coal unloading machines installed at Quay No. 5 as shown in Figure 3f. This has halted the operation of the Shinchi Thermal Power Station, severely affecting the electricity supply in the service area of Tokyo Electric Power Company (TEPCO) on March 22, 2022.

(e) Crack in the road at Quay No. 5

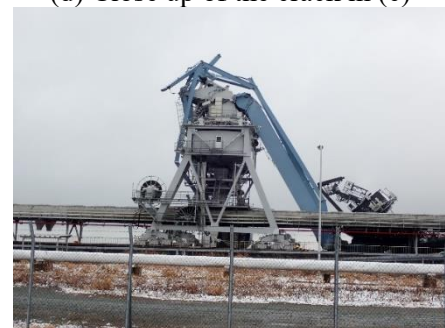
(f) Damaged coal unloading machine

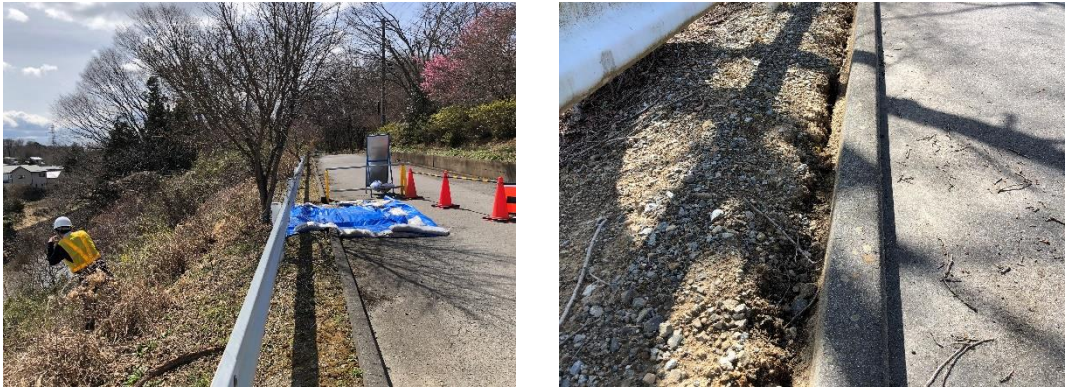
Figure 4. Ground settlement in Minamimachi

The ground settlement in Minamimachi of Yabuki Town was inspected. The damage occurred at the shoulder of a local road next to a hotel facility, which stands over the Kumato River. The subsided area was about 1.5 m perpendicular to the slope crest and 2 m long along the road as shown in Figure 4. Upslope of the ground settlement, there were traces of repaired works in the carpark pavement of the hotel. Fresh soil could be seen in a hollow area in the downslope side. These suggest that cavity may be present in the ground. At the northern end of the road, cracks of 10 cm wide were found at the slope crest and on the road. At this location, the ground had settled and displaced towards the river under the ground shaking. Nevertheless, no major deformation was identified in the embankment from the drone survey.

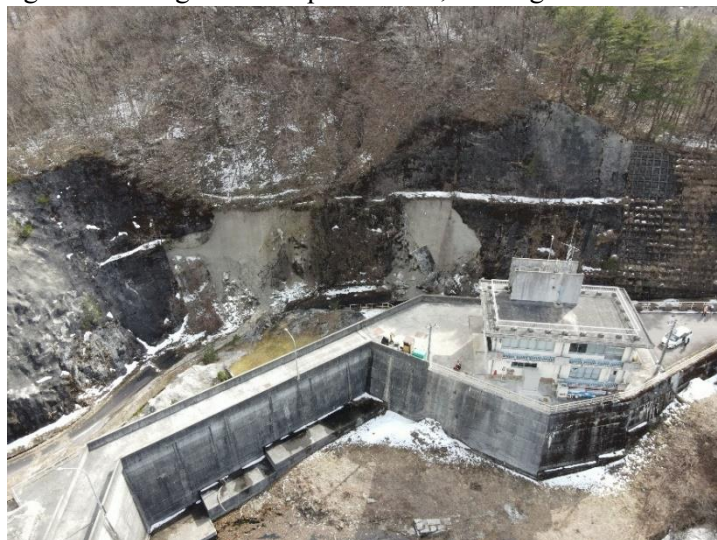
Figure 5. Landslide next to Dake Dam

A small-scale slope failure occurred on the steep slope along Dake Walking Trail on the southern part of Dake Dam. The slope angle was about 60 degrees. The shotcrete facing of the slope fell onto the path exposing the mudstone behind. It is possible that the shear resistance of the weathered mudstone was exceeded by the sliding force during the earthquake event, causing shallow failure on the slope.

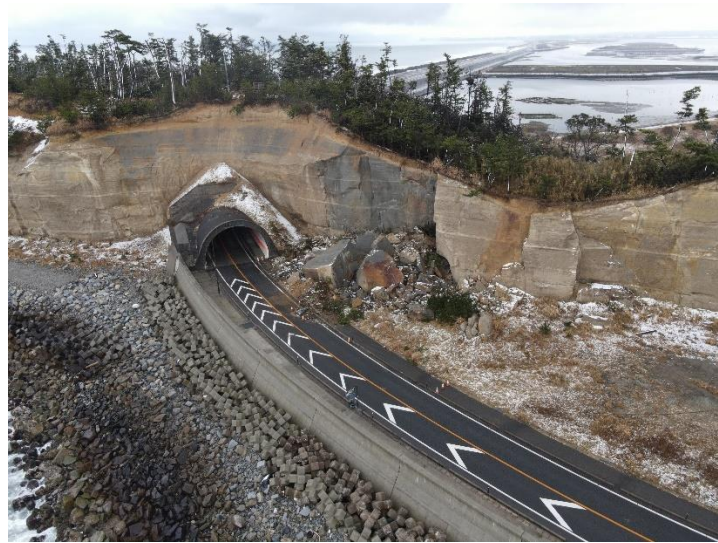
(a) Overview

Rock slope failure was triggered by this Fukushima earthquake at the northern side of the tunnel portal of Unoomisaki Tunnel along the 2-lane carriageway of Matsukawa-ura Bridge as demonstrated in Figure 6a. From the 1:50,000 Geological Map of the Soma-Nakamura District, this region is composed of greenish gray mudstone (D2) of Pliocene Dainenji Formation (Geological Survey of Japan, AIST, 1996). With some layers of sandstone, this formation displays horizontal beddings, and the ground is prone to slope failure as can be observed from the presence of multiple joint sets. Rockfalls could be seen to have taken place following the vertical joints which are orange-brown and shows significant signs of chemical weathering brought by seepage. The rock boulders were as large as 5 m wide. Debris of damaged electricity poles, rock, surface soil and pine trees which were on top of the cliff blocked a small part of the carriageway (see Figure 6b). The extent of the rockfall was estimated to be about 15 m in breadth.

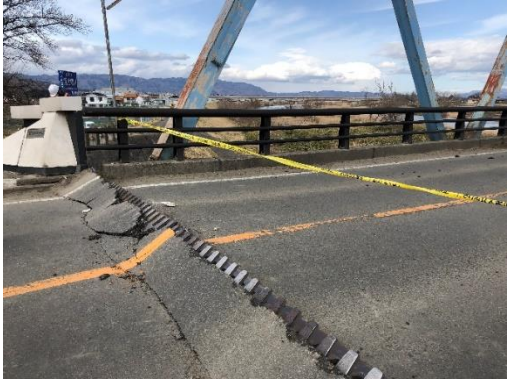
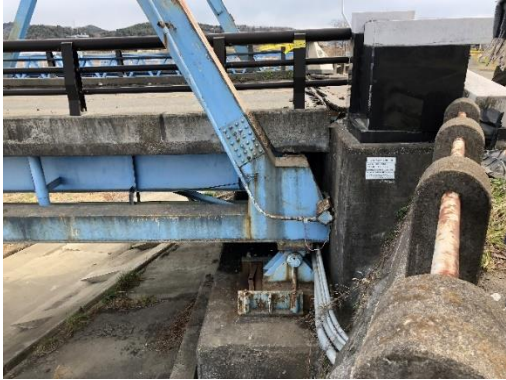
(a) West abutment

The 2022 Fukushima Earthquake caused large damage to the 4-span continuous truss Date Bridge. The bridge displacement was approximately 25 cm towards to the west. During the ground shaking, the deck was compressed at the western abutment, and it was detached from the east abutment as shown in Figure

7a and 7b. Some water pipes and electricity cables below the bridge girder were deformed. Dislocation could be observed in the support connections in the piers (Figure 7c). Traffic has been blocked since the earthquake event.

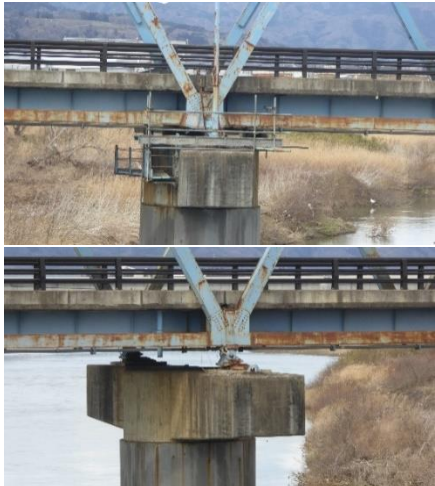
(c) Displacement in pier supports

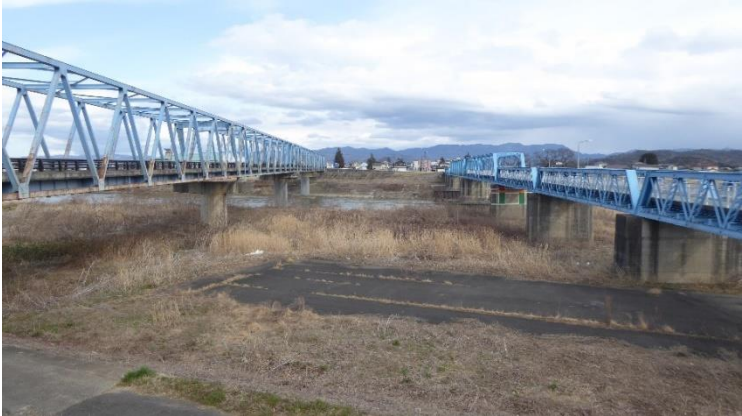
On the other hand, the old, pedestrian Date Bridge, which is of simple truss structure survived the earthquake, showing minor damages only. Small relative displacements could be found between the individual trusses. At different locations, the barriers have showed some degree of deformations which give signs of compression or extension.

(d) Date Bridge on the right and the old bridge on the left

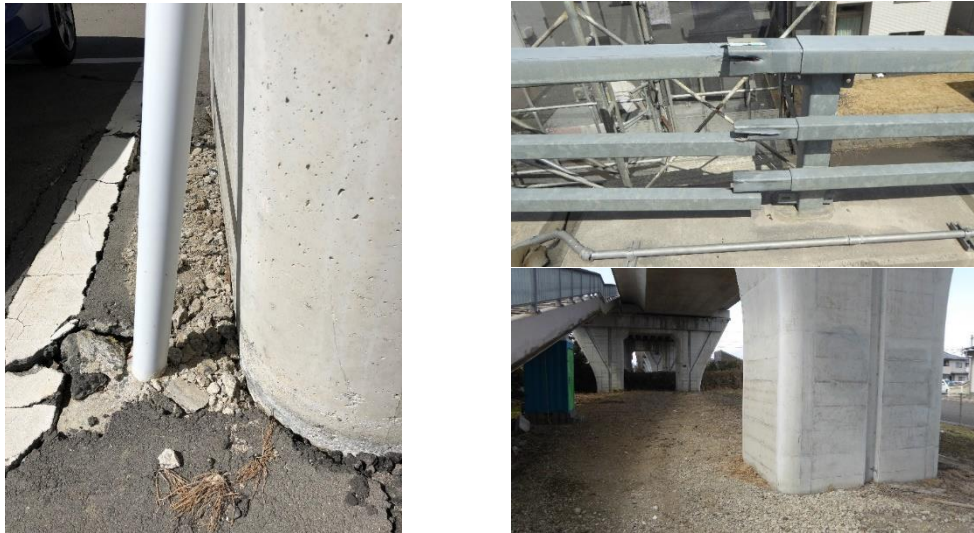
Figure 8. Damages in the Kasaishi Tohoku Line Overpass

Various forms of damage could be identified in the Kasaishi Tohoku Line Overpass. Fault movement could have caused the steps that were seen in the connection joints between the retaining walls. There were also deformations in the hand railing and barrier. No significant crack was observed on the road pavement in the meanwhile. The Overpass Bridge suffered damages from the previous 2021 earthquake (Abukumajiho, 2021), with cracks appearing in the embankment of Pier P6 and P7. Although several rubber joints were seen popping out, no new damage to the embankment section was visible after the 2022 earthquake.

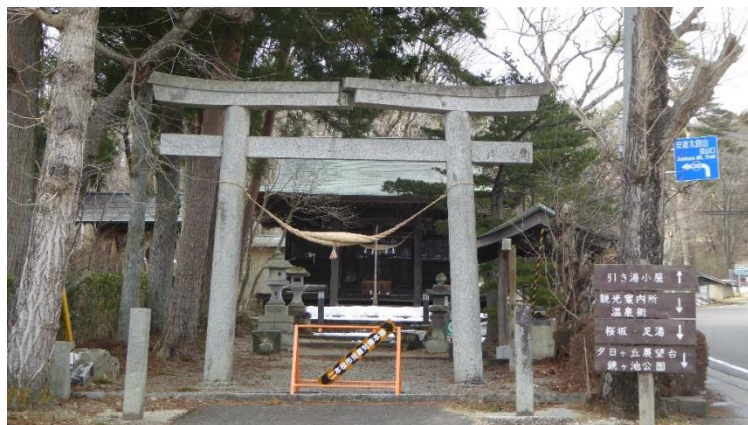
Figure 9. Dake Onsen Shrine

While there was traffic control imposed to the Dake Onsen Line, probably in consideration of the ongoing slope works, no slope failure was spotted in this area of Route 459. Leaving the Dake Onsen Line, the investigation team stopped at the Dake Onsen Shrine. As can be seen from Figure 9, dislocation of the connecting part of the beam of the Torii gate was noted. There were stone lanterns fallen as well.

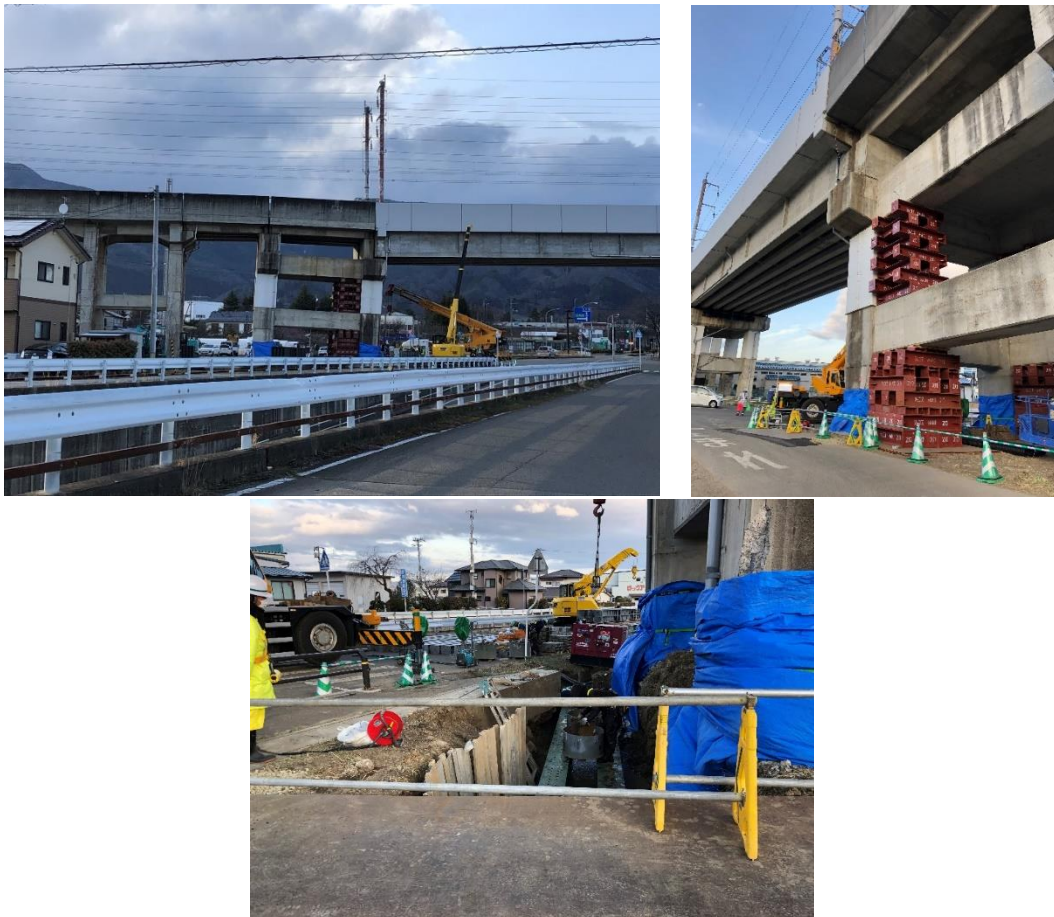
Figure 10. Damaged pier of the Tohoku Shinkansen viaduct

South of the Shiroishizao Station, one Tohoku Shinkansen viaduct pier suffered from tilting after the earthquake. The pier inclined towards the direction of the Shiroishizao Station. Based on the landform information from the Geospatial Information Authority of Japan (GSI), the damaged pier locates on the alluvium plain of Takigawa River, neighboring a terrain plain in the southwest. There could be old river channel underneath in this area, where soft deposit may be present. Based on the immediate inspection report of the East Japan Railway Company (JR East, 2022), no land subsidence was observed around the pier. Shear failure at the base of the pier could have triggered the tilting. As shown in Figure 10, restoration works has been in progress as to realign the harmed pier.

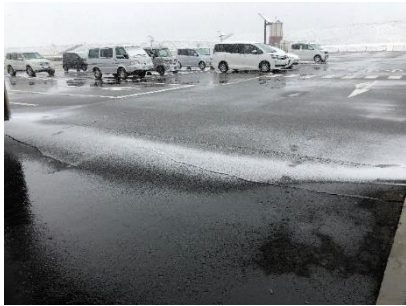
Figure 11. Cracks in Watari Town

Slight ground surface damages (Figure 11) were observed in the vicinity of Arahama Port. For example, a crack was found at the bottom of electric pole near a hotel. As can be observed in Figure 13a, cracks with opening up to 15 cm stretched in the Torinoumi Park close to the sea wall. From a previous report (Wakamatsu, 2021), multiple sand ejecta were found from the 2021 earthquake at the same location, and some ejecta have been identified at similar locations by a local resident as shown in Figure 13b and 13c.

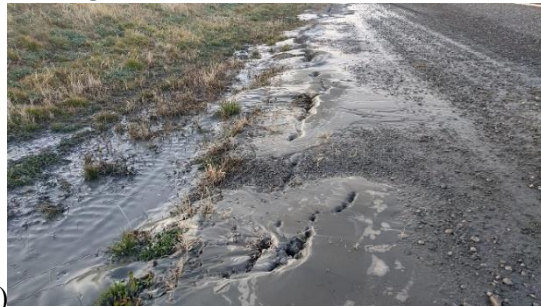
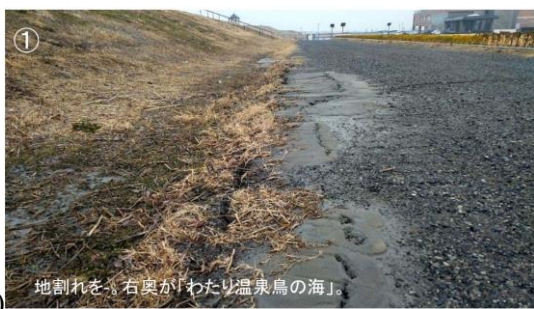
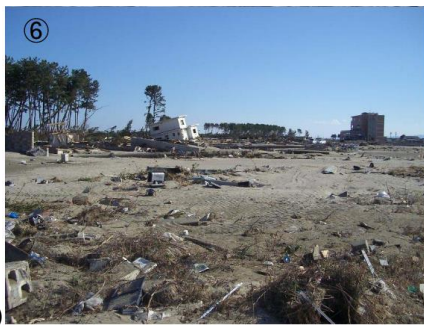
Figure 12. Re-liquefaction in the Arahama Port: (a) Liquefaction in 2022 (Photo credit to Saito K., and provided by Wakamatsu K.), (b) Liquefaction at the same spot as (a) in 2021 and (c) Liquefaction in 2011 (photos b and c are extracted from Wakamatsu, 2021)

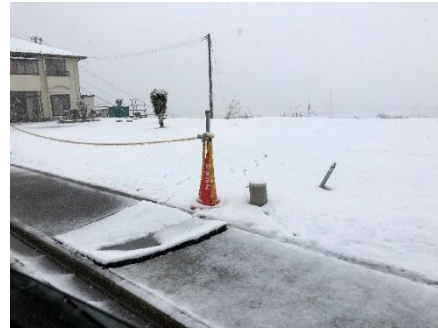
The damage conditions in the residential embankment area of Taiyo New Town in Yamamoto Town were examined as significant ground deformation was resulted in the 2011 Tohoku Earthquake. While cracks of 10 cm to 20 cm could be identified in the road connecting to the National Route 6 (Figure 13a, no key geotechnical damage was brought by the earthquake, so as the situation after the 2021 earthquake (Figure 13).

(a) Some deformation occurred on the road

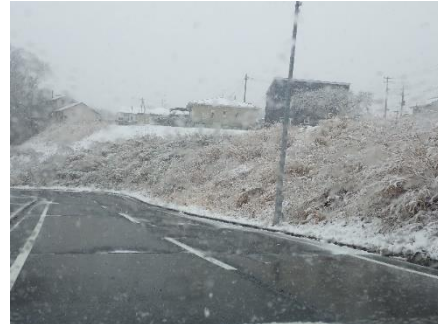
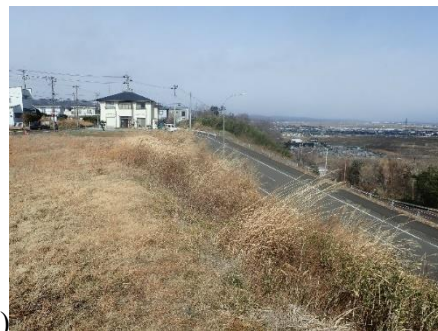
Figure 13. Embankment of the Taiyo Newtown: after earthquakes of (a) March 16, 2022, (b) February 13, 2021 and (c) March 11, 2011

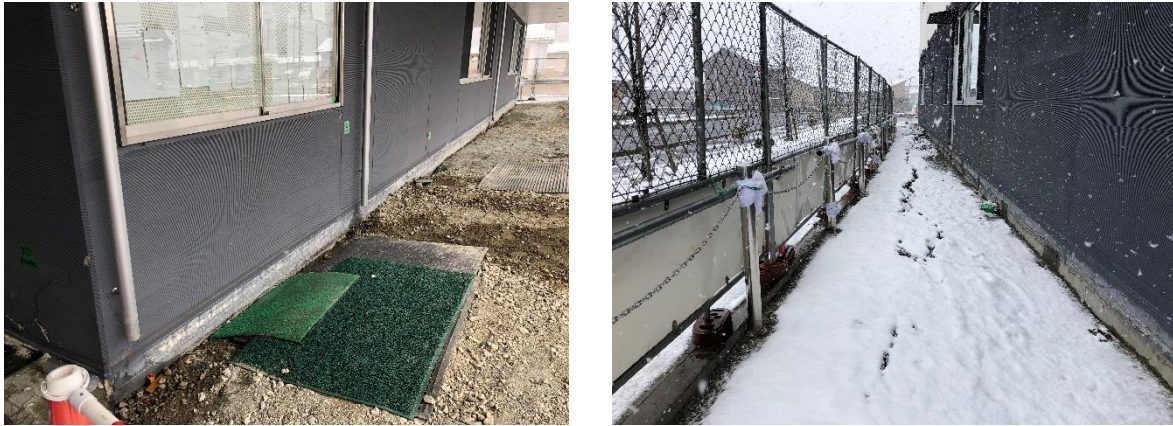
(a) Disaster Prevention and Communication Center of Yamamoto Town

Following the damage survey of the 2021 Fukushima Earthquake (Inoue et al., 2021), inspection was made around the Disaster Prevention and Communication Center of Yamamoto Town ($37^{\circ}55'20.0''\text{N}$, $140^{\circ}53'52.0''\text{E}$). Cracks and ground settlement could be observed in the surrounding ground of the Center (Figure 14a). On the National Route 6 in Sakamoto of Yamamoto Town ($37^{\circ}55'35.2''\text{N}$, $140^{\circ}53'54.4''\text{E}$), the ground settled mildly and a crack of about 30 m long was being repaired; in a nearby petrol station, there seems to be uplift in the surface drainage channel (Figure 14b).

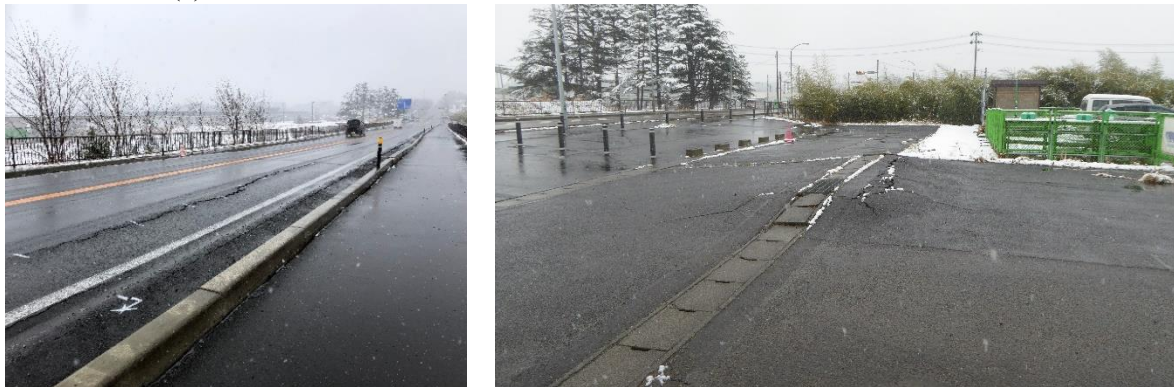
(b) Crack in Route 6 and uplift in a nearby petrol station

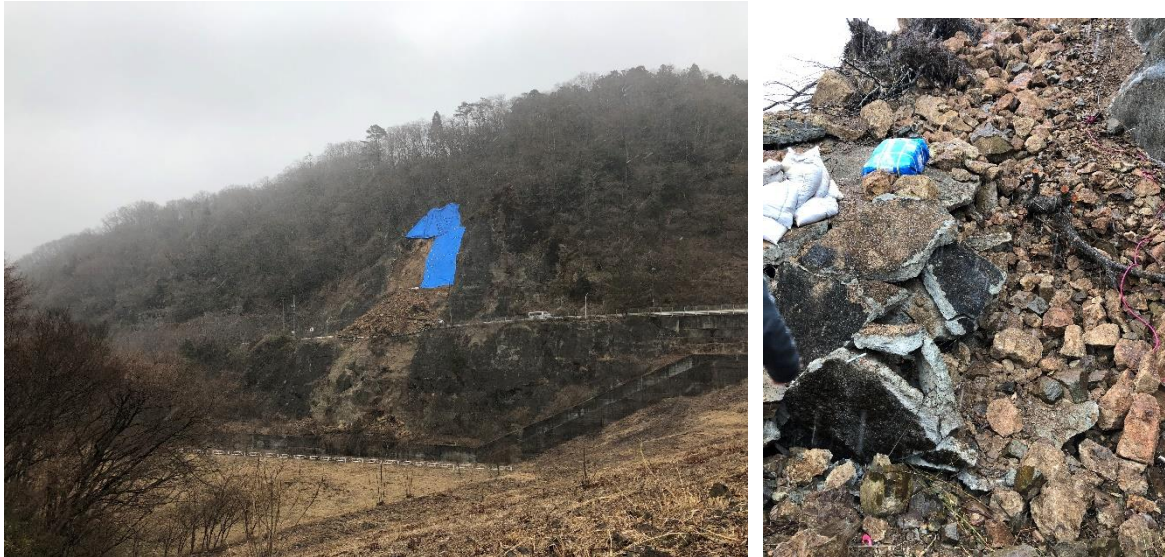
Figure 15. Landslide at Tarumizu Dam

Massive landslide was inspected along the road leading from the top-left water dam and the dam office (Figure 15). The 4m-wide road was fully blocked by the landslide debris which was made up of the shotcrete, rock, mud, and trees. The debris mass continued to run out downslope to the top part of the spillway structure overlooking the Masuda River. The average slope inclination was between 50 degrees and 60 degrees at this site. The crest of scarp area was about 15 m high from the road level. The width and depth of the landslide were about 10 m and 1 m respectively. The failed section was of the largest slope height compared to the adjacent slope also reinforced by shotcrete. The influence of seismic motion could thus add to the driving force and reduce the factor of safety. Possible failure mechanisms should be investigated in the future.

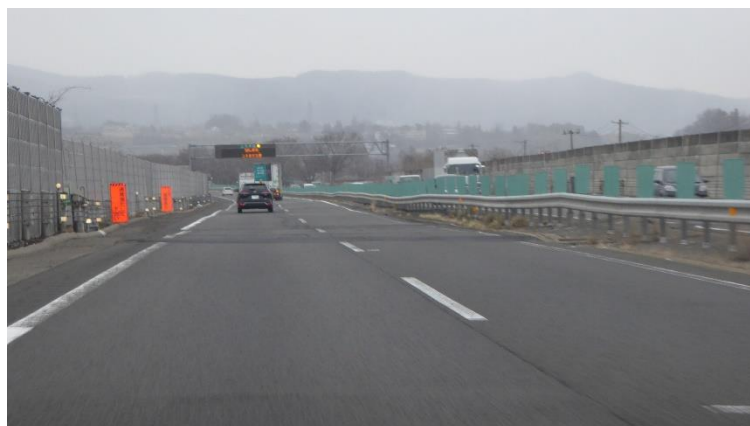
The Tohoku Expressway was affected by moderate ground cracking and settlement associated with the 2022 Fukushima Earthquake (Figure 16). Bumps in the road were frequently encountered. A length of approximately 50 m retaining wall seems to have been damaged as it was under immediate recovery works.

Figure 16. Road section near Box Culvert Kunimi 71, at 293.73 KP (37°59'39.5"N, 140°36'26.3"E): repaired crack

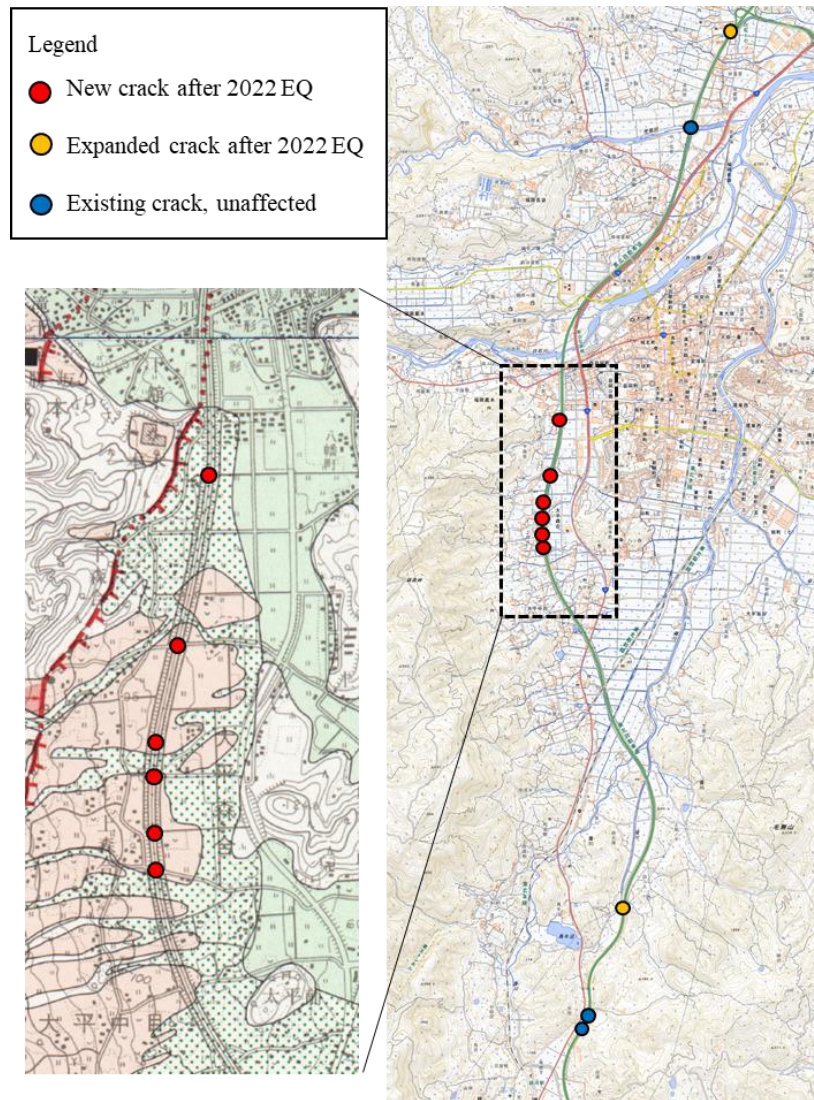
Figure 17. Distribution of ground cracking, created based on map information of the Geospatial Information Authority of Japan (GSI, 2022)

By comparing the observations from the reconnaissance survey against Google Street View as of August 2021, a preliminary analysis of the distribution of ground cracking was carried out. As presented in Figure 17, cracks induced by this 2022 earthquake were identified at localities marked by red dots. Yellow dots indicate locations with cracking which propagated after the ground shaking while blue dots are locations with existing cracks. The new cracks occurred mainly in the vicinity of the boundary between box culvert and embankment regions. They are also concentrated in the western side of Shiroishi City, for instance, near Box Culvert Kunimi 65, 66, 67, 69, 71 and 75.
