PROVISIONAL REPORT OF THE DAMAGE CAUSED BY THE JUNE 14th 2008, IWATE-MIYAGI EARTHQUAKE

Key Words: Iwate-Miyagi Earthquake, geotechnical issues, rehabilitations

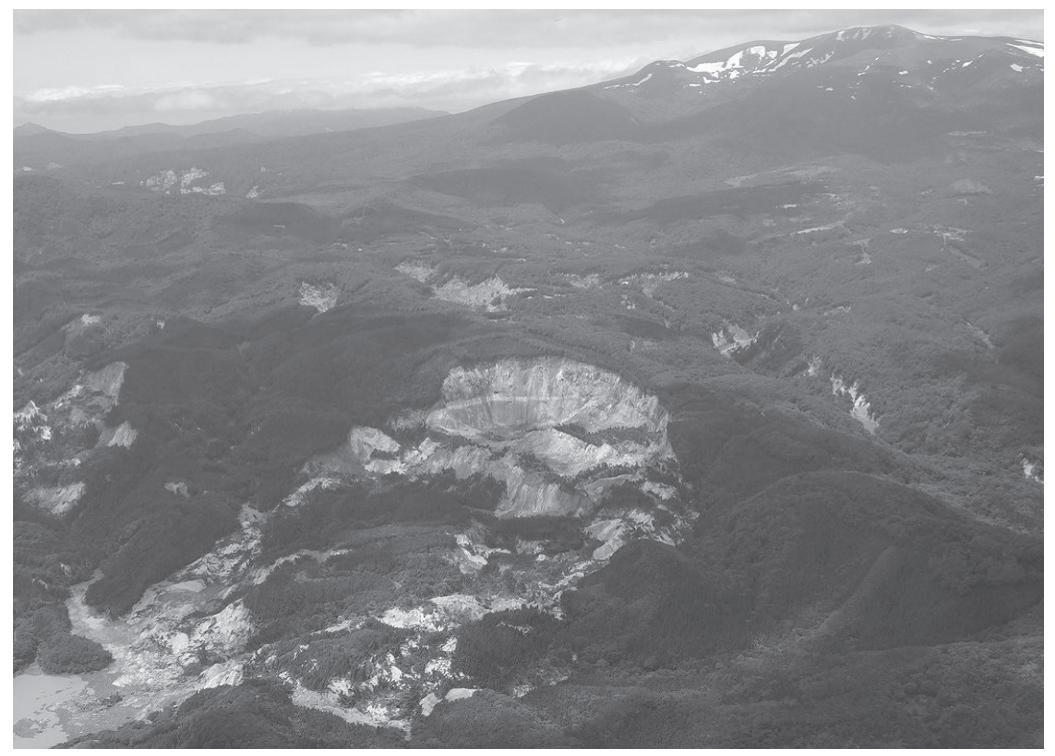
Fig. 1 shows the bird's eyes view of a largest landslide at Aratosawa with Kurikoma Volcano rising behind. The terrain here is suggestive that similar landslides have been reactivated. A wide-spread and almost horizontal laminar structure of lose volcanic sand and ashes is exposed on the escarpment. When wet, some pieces of light-gray rock fragments taken from the toe of the landslide mass smelled strong hydrogen sulfide (see Fig. 3)

Fig. 1. Landslide at Aratosawa dam: (Photo by K. Konagai, June 15, 2008)

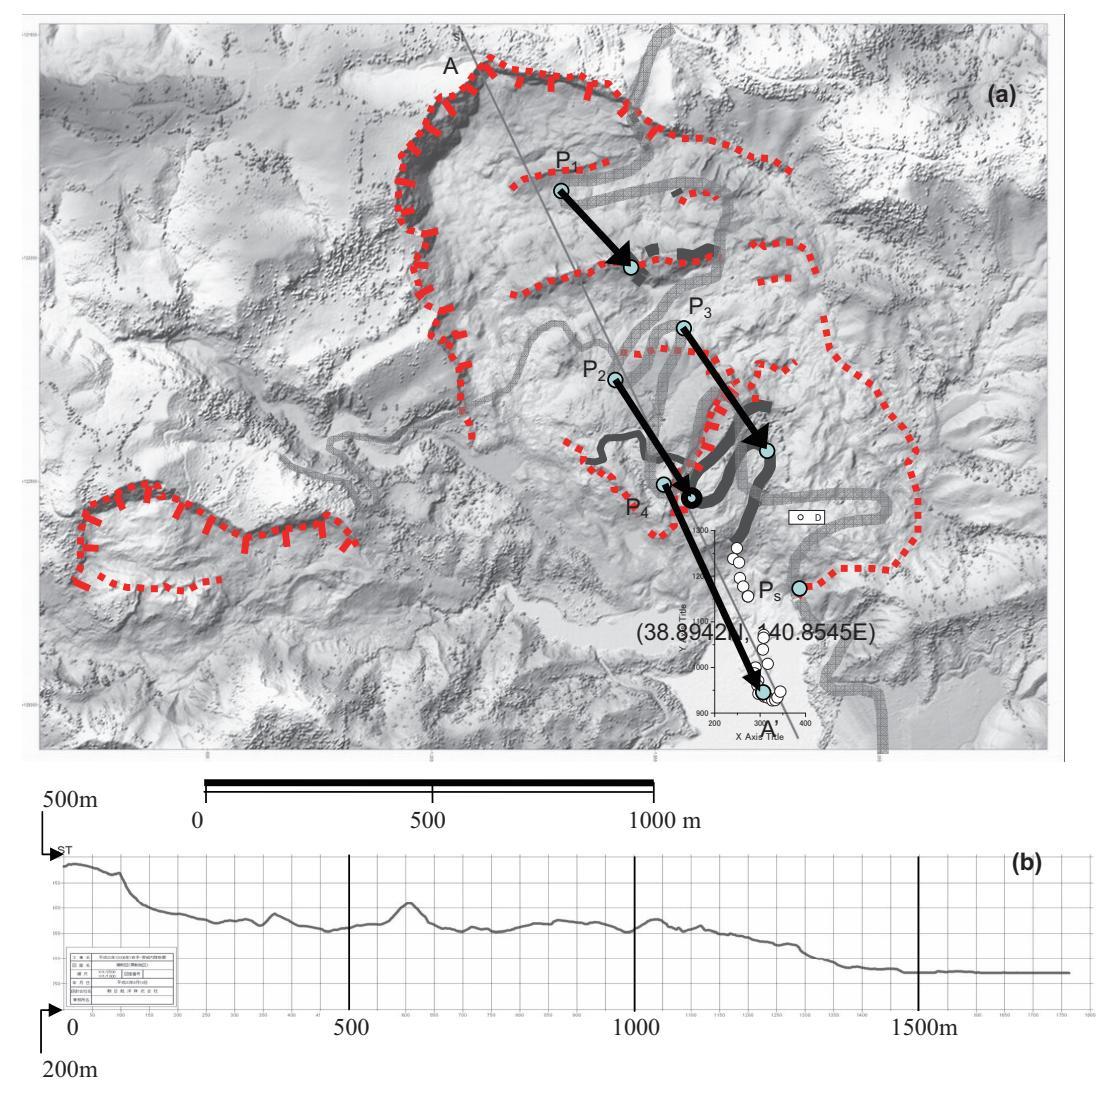
Fig. 2 shows a digital elevation model (DEM hereafter) of the landslide at Aratosawa. The road locations before (gray) and after the earthquake were drawn upon the DEM by using images from helicopter survey, photos (black lines), and field GPS survey (open circles) etc. The arrows show that Points P_1 , P_2 , P_3 and P_4 have respectively moved about 200m, 300m, 300m and 500m SSE towards the dam lake. The slide blocks are lined up in a succession. The cross-section A-A' (Figure 2b) shows a gradient of about 3-4 degrees. Even though the base slope was very gentle the soil masses have moved some 200 to 500 meters.

Fig. 2. Landslide behind Aratosawa dam: (Aero Asahi Co. provided the digital elevation model).

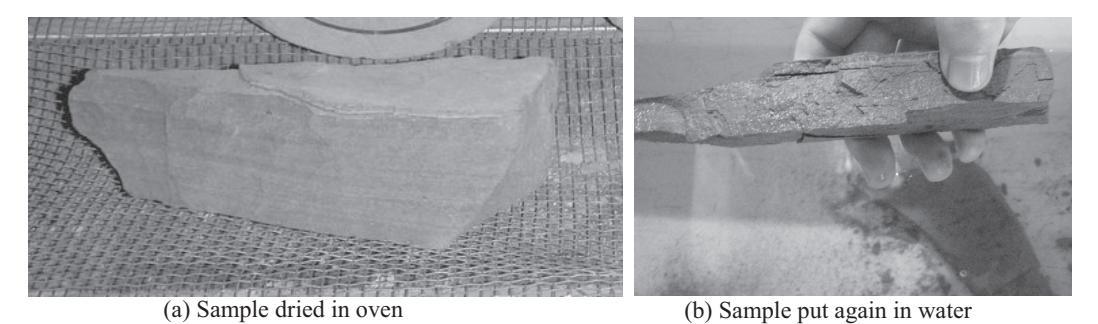
A rock piece from the landslide mass was taken at 38.8942°N, 140.8545°E, to determine specific gravities under different conditions (Fig. 3).

Specific gravity immediately after the sample was taken (18:00JST, June 16, 2008)	$= 1.78 \text{ g/cm}^3$
Specific gravity after the sample was dried for 24 hours at 105° C in oven	$= 1.18 \text{ g/cm}^{3}$
Specific gravity after the sample was again soaked up in water for three hours	$= 1.69 \text{ g/cm}^3$

When soaked in water, the sample smelled hydrogen sulfide which is evidence that the materials were from volcanoes. It is remarkable that the specific gravity of the dried sample is quite small, indicating large volume of voids.

Fig. 3. Rock sample taken for testing specific gravities under different conditions.

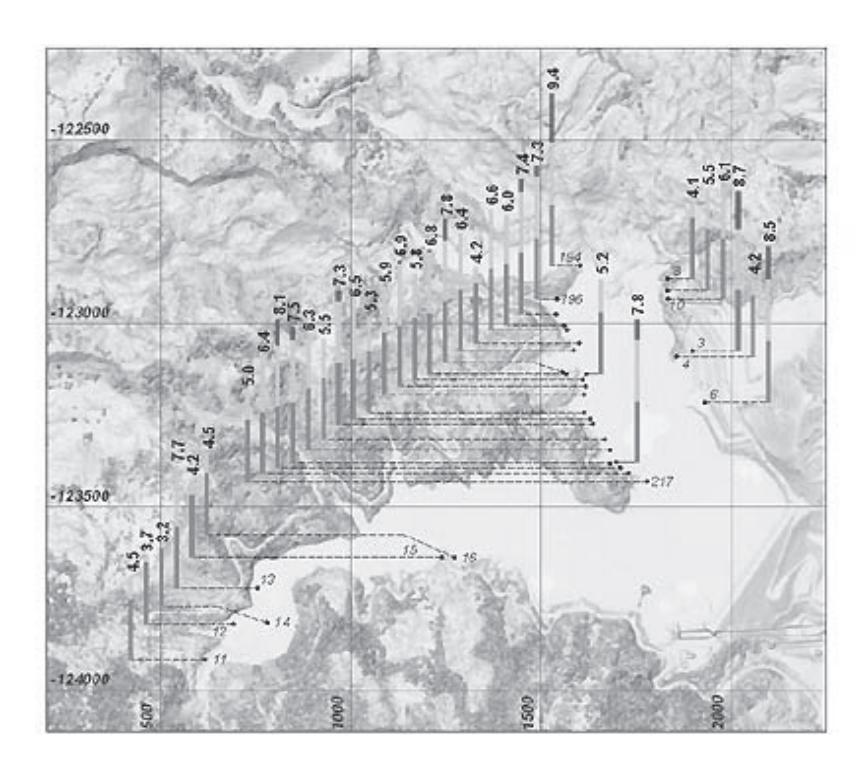
The Aratosawa landslide mass also caused some remarkable seiche in the lake behind the Aratosawa dam. As shown in Table 1, the lake elevation increased from 268.5 m before the earthquake to 270.9 m after the earthquake. This increase in lake elevation is due to the plunge of the landslide mass and possibly also due to some tectonic deformation.

Fig. 4: Seiche hight water marks above the lake elevation of 259.7m on July 12 and 13

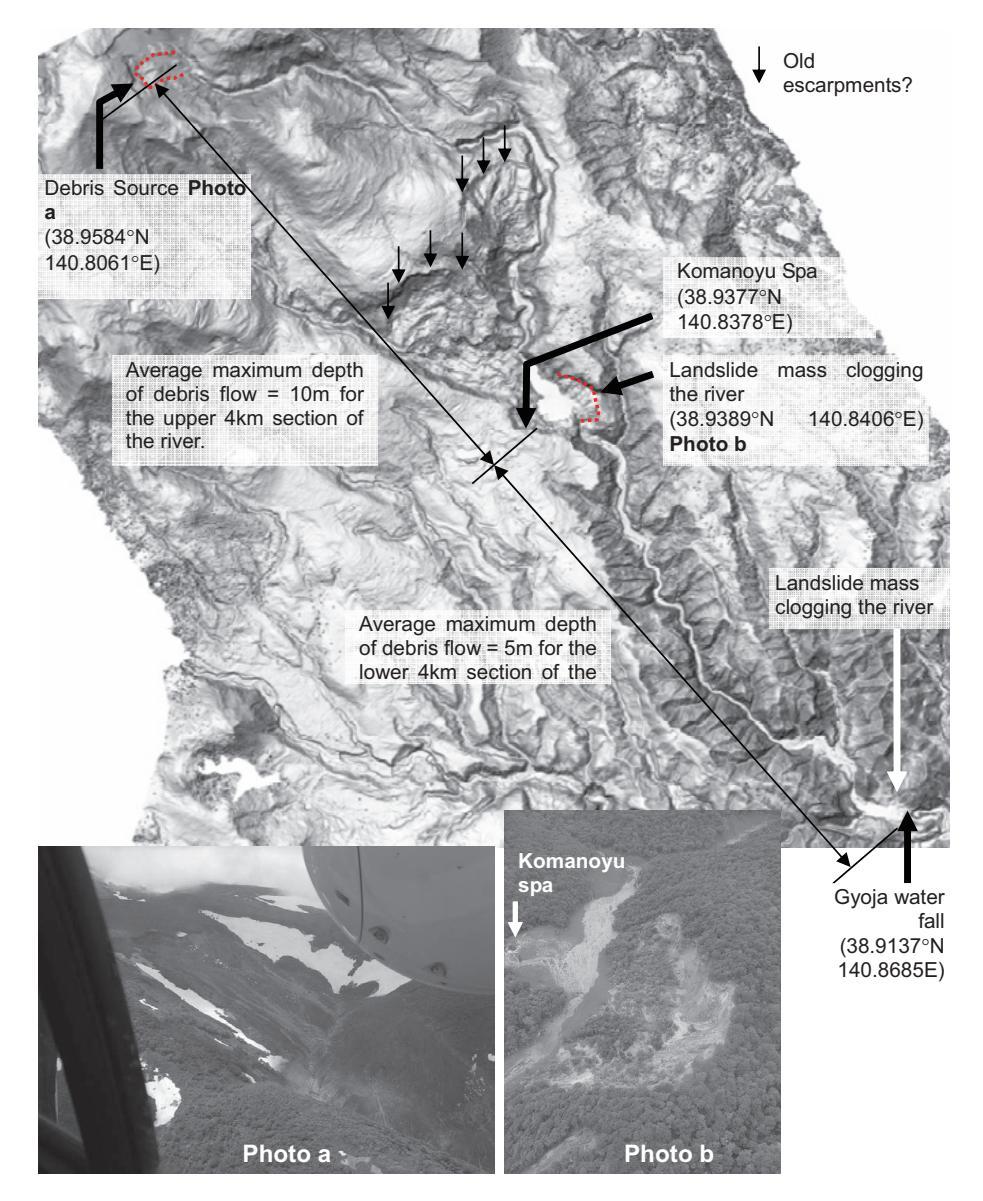
Wet debris masses flowed along Dozo and Ura Rivers. A deep scar was created immediately beneath the snow remaining near the eastern peak of Mt. Komagatake (**Photo a**, 38.9584°N 140.8061°E). The debris flow from this source swept into Dozo River, and scoured sediment and vegetation from the channel.

Fig. 5. Debris flow along Dozo and Ura Rivers: (DEM provided by Aero Asahi Co.)

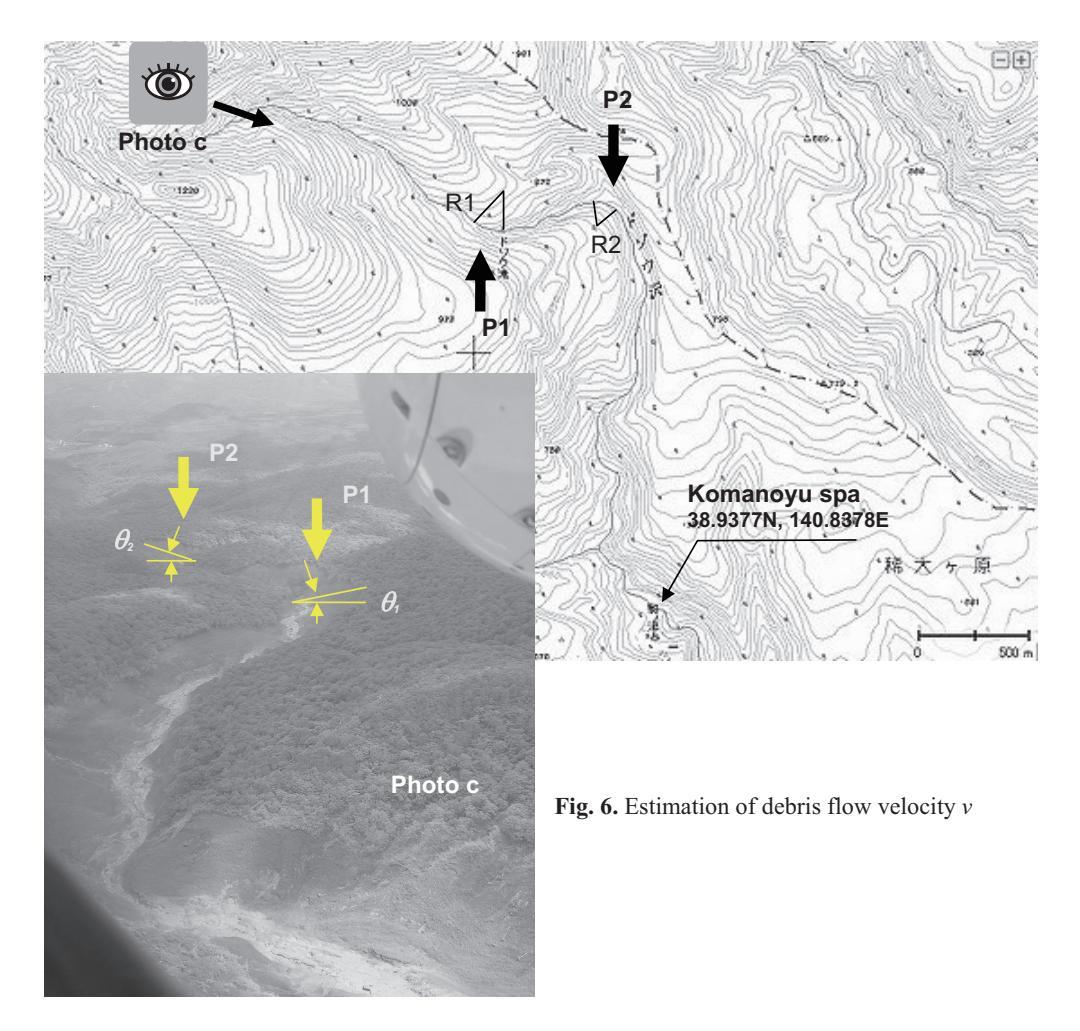
The mud flow, with its channel clogged with another landslide mass (**Photo b**, 38.9389°N 140.8406°E, surged up to a hot spa resort "Komano-Yu" (**Photo b**, 38.9377°N 140.8378°E), where seven people were trapped in soil and rubble. The average maximum debris flow depth for the 4 km-long upper stream reach of Komanoyu spa was visually estimated to be about 10 m, while it was about half for the lower stream reach probably loosing its momentum. The flow was stopped at Gyoja waterfall (38.9137°N 140.8685°E). (DEM provided by Aero Asahi Co.)

This wet flow along a curved channel had enough momentum to surge up along its outer wall (**Photo c**). Assuming that walls of the channel covered with mud show the inclined mud flow surface, the following equation is obtained.

Necessary parameters for Eq. (2) at Points #1 and #2 are roughly made out from the photo (left) and the topographical map (below) as:

$$v \cong \sqrt{Rg\theta} = 15 \sim 19 \text{m/s} \tag{3}$$

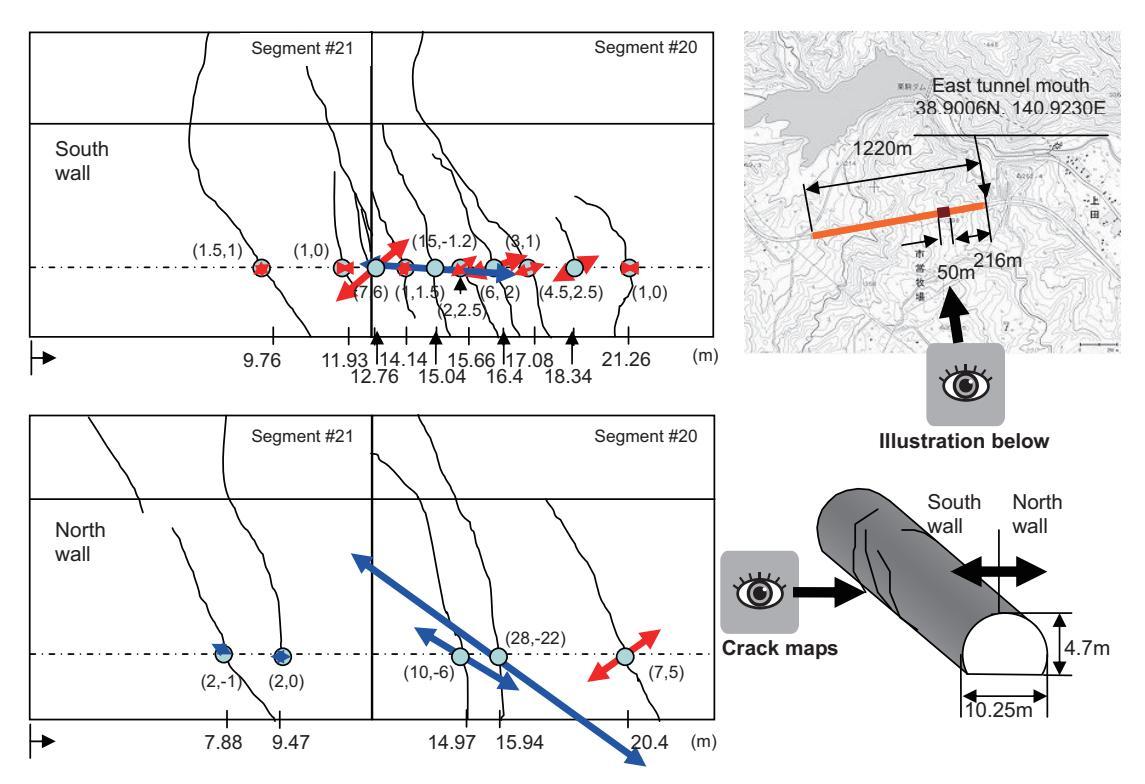
Fig. 7. Cracks in Shin-Tamayama Tunnel:

A 36m-long segment at 216m inside the eastern end (38.9006°N, 140.9230°E) of the 1220-m-long tunnel was diagonally cracked. Fig. 7 shows projections of the cracked south and north walls on a virtual screen. These cracks were all opened. Black arrows show that the eastern segment moved down with respect to the western segment, while gray ones show the opposite. Numbers in parentheses show these relative displacements in millimeters. If a deep-seated landslide was the cause, long-term monitoring will be a must for rational repairs.
