RECENT RESEARCH ON SEISMIC BEHAVIORS OF  
BURIED PIPELINES IN CHINA

Wei LIAN<sup>I)</sup>  
and Tsuneo KATAYAMA<sup>II)</sup>

DAMAGE TO PIPELINES DURING HAICHENG AND TANGSHAN EARTHQUAKES

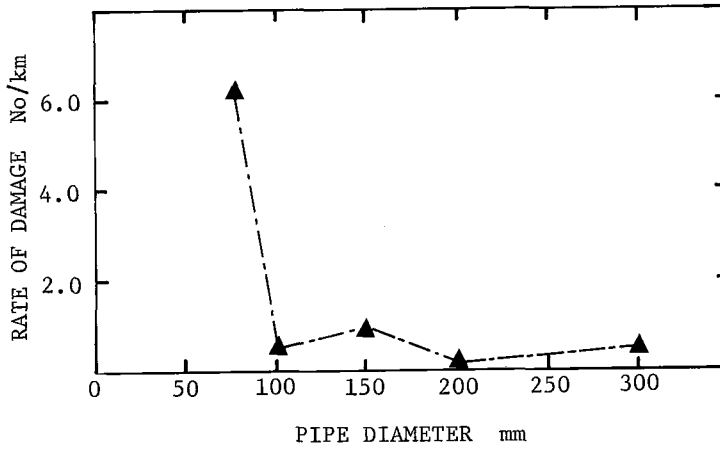
Fig.1-1. Damage Rate Versus Pipe Size  
(Cast Iron Pipe, Yingkou)

Fig.1-2. Damage Rate Versus Pipe Size  
(Cast Iron Pipe, Dashichao)

Fig.1-3. Damage Rate Versus Pipe Size  
(Cast Iron Pipe, Tianjin)

Fig.1-4. Damage Rate Versus Pipe Size  
(Cast Iron Pipe, Tanggu)

4) EFFECTS OF PIPE SIZE: Damage data from both Haicheng and Tangshan earthquakes revealed a trend that the damage rate varied inversely with the pipe size. That is, as the pipe size increases, the rate of damage decreases. Fig. 1-1 to Fig. 1-4 are damage rate versus pipe size relationships obtained from collected pipeline damage data. Since the actual situation was very much complicated, these data are only of qualitative sense.

*COMMENTS ON THE PRESENT CHINESE FORMULAE:* The form of transfer coefficient  $\zeta$  given by Eq. (20) was assumed because of the apparent effect of pipe size observed during past experiences (see Figs. 1-1 through 1-5). However, if a buried pipeline is assumed as being supported by elastic axial foundation with a spring constant  $K_1$  (kg/cm/cm) per unit length of pipe, the transfer coefficient should take the following form

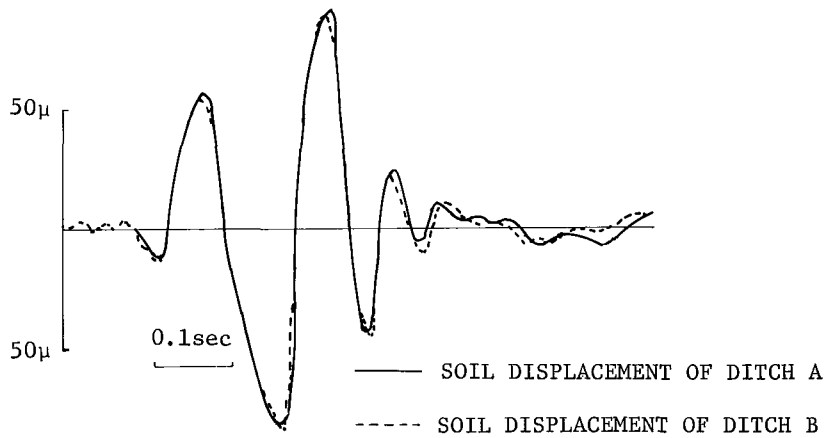
Fig.2-2. Comparison of Soil Displacements  
(Backfill of Ditch A Being Shallow Loose Soil)

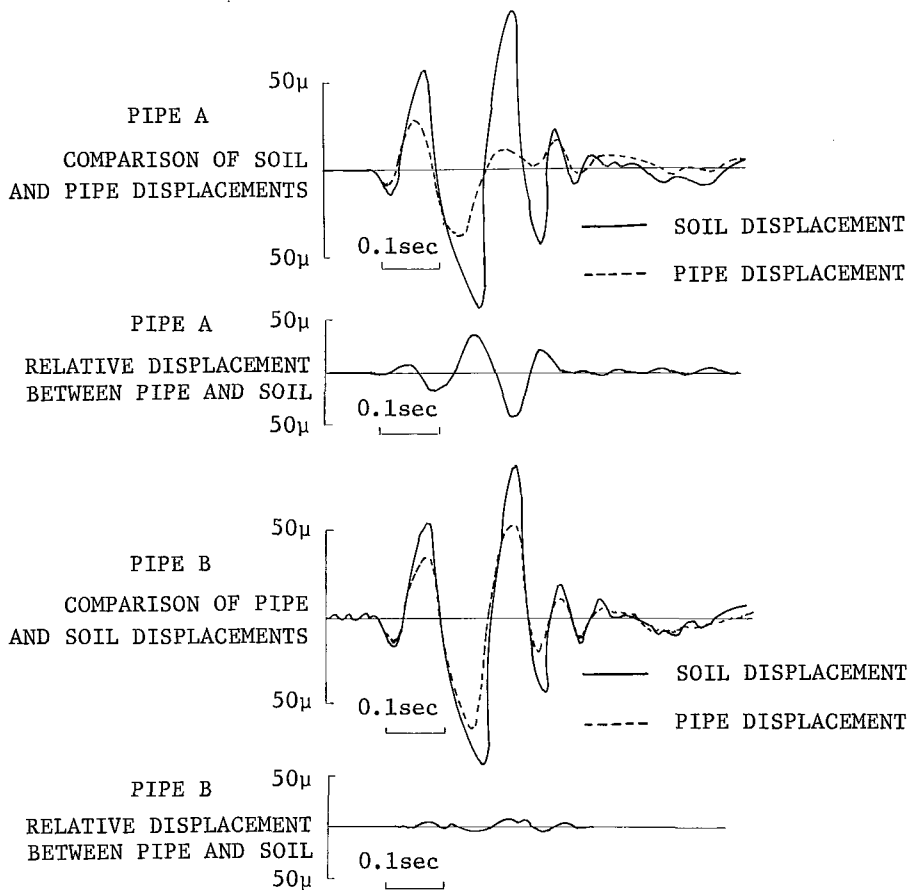
Fig.2-3. Pipe and Soil Displacement Records  
(Backfill of Ditch A Being Shallow Loose Soil)

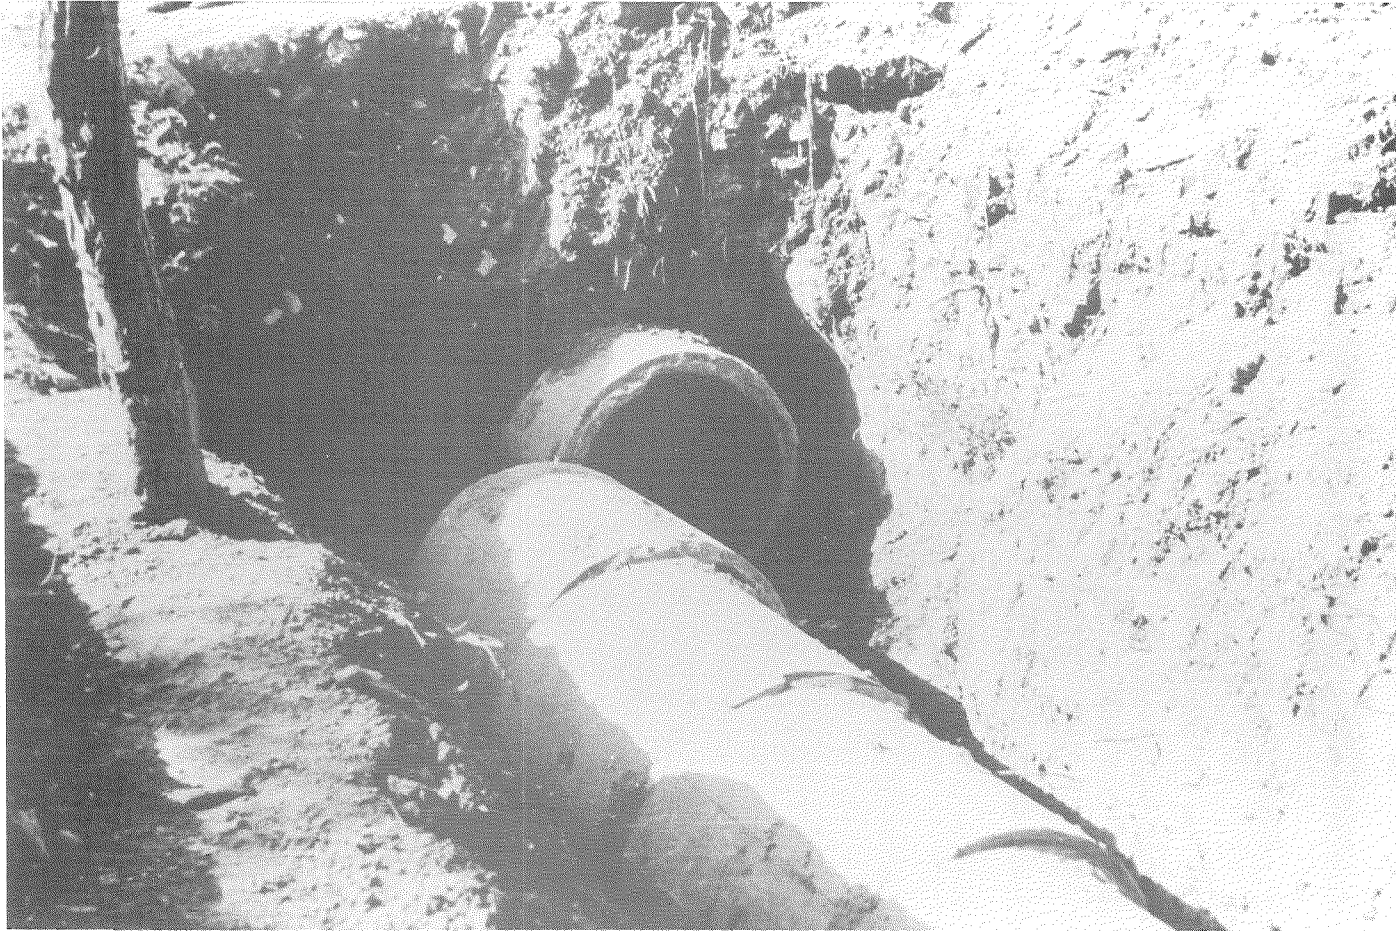
Photo 1 shows a  $\phi 1000$  R/C buried pipeline undergoing a horizontal stagger as great as about 80cm and a pulling out of 20cm or so at the pipe connection. Photo 2 is showing a  $\phi 200$  castiron pipeline located in the East Water Supply Plant suffering from a 22cm vertical stagger and a 3cm pulling apart at the joint. Photo 3 is an example of a R/C buried pipeline severely cracked. Photos 4-6 indicate several castiron pipelines having the same 300mm diameter experiencing serious damages of changeable failure modes including staggering, crushing, fracture, circumferential crack, joint pulled out, and even bending and twisting.

1.  $\phi$  1000 R/C Pipe Undergoing Horizontal Stagger in Fault Rupture Zone in Tangshan

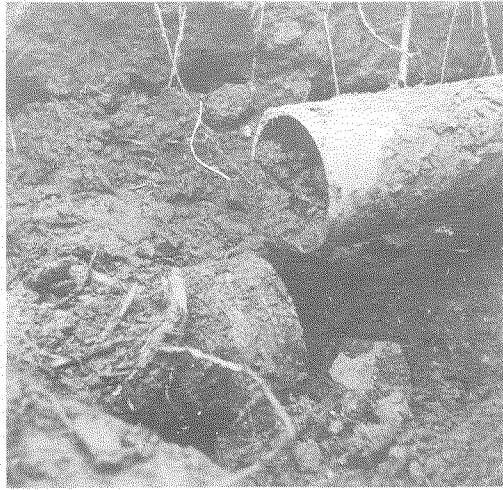
2.  $\phi$  200 Pulled-out Castiron Pipe Showing Stagger in Tangshan

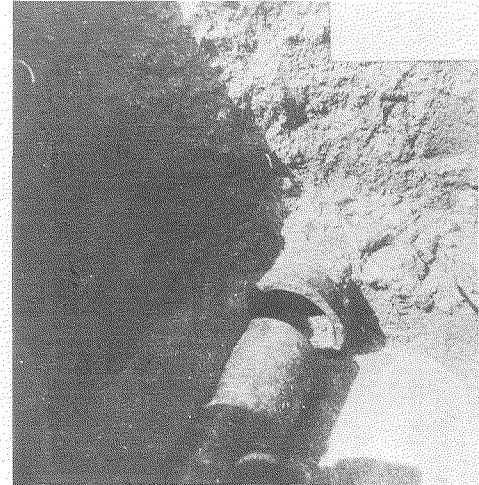
4.  $\phi$  300 Castiron Pipe Damaged in Tangshan (1)

5.  $\phi$  300 Castiron Pipe Damaged in Tangshan (2)

6.  $\phi$  300 Castiron Pipe Damaged in Tangshan (3)

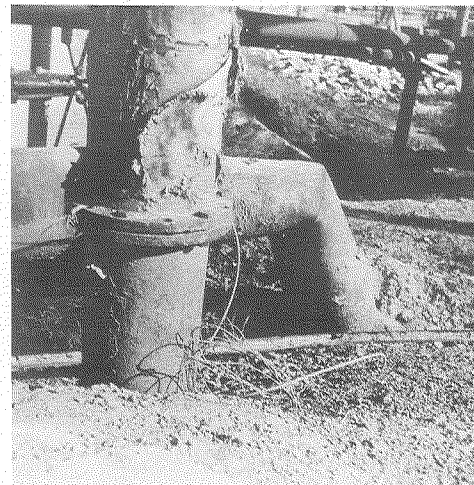
During the Tangshan earthquake, two steel pipelines crossing the Hai River in Tianjin area (intensity 7-8) were damaged at the castiron connections at or near the river side. Photo 10 shows the bent parts of a steel pipeline squeezed flat in the Tanggu Alkali Factory near a river bank and within the area of intensity 8. A  $\phi 500$  steel pipeline of a chemical factory in Hangu suffered similar damage as shown in Photo 11 owing to the same reason.

11.  $\phi$  500 Steel Pipe in Hangu Showing Similar Damage as in Photo 10

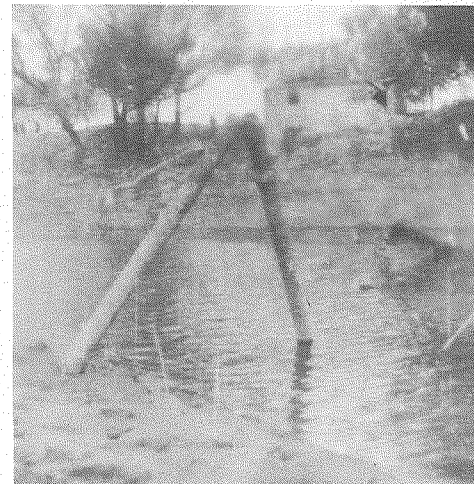
In Tangshan City, there were six steel pipelines crossing the Dou River at different places. All of them were unexceptionally damaged, displaying varying sorts of failure. Photo 12 shows one of those severe damage. Photo 13 is another representative damaged example which had buckled as a result of the face to face inward soil movements of banks of the Dou River, the middle point of the pipeline tilting up as high as 2.5m.

13. Buckled Steel Pipe due to Shortening Caused by Inward Bank Slides in Tangshan

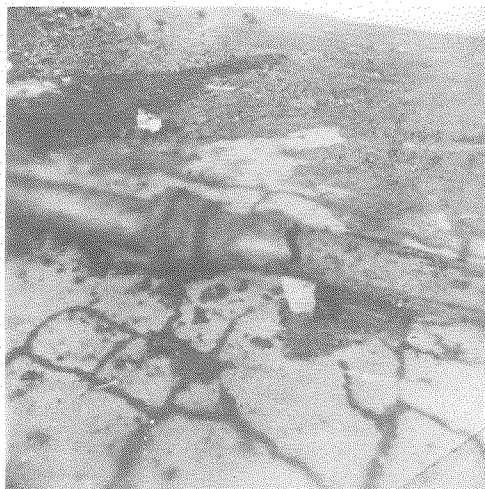
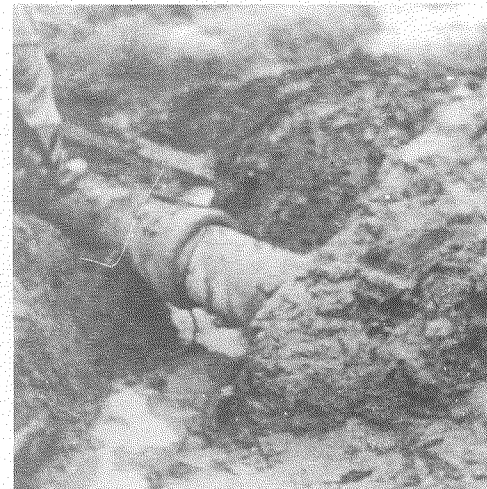
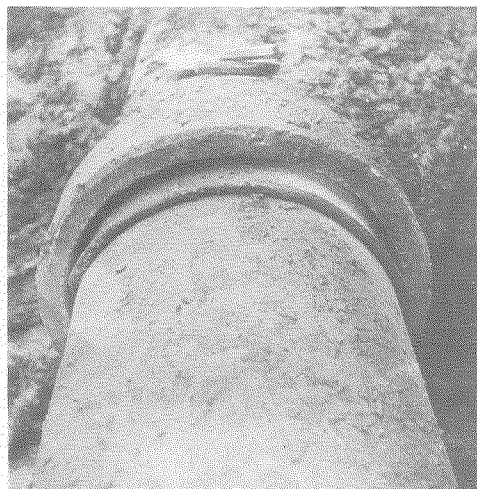
During both Haicheng and Tangshan earthquakes, it was found that evidences there and here rose again in supporting this point of view. Photos 18-20 provide some convincing sights telling buried pipelines cracked, pulled loose or apart near or right at the pipeline joints by imposed axial strain.

18. Pipe Damage Possibly Caused by Imposed Axial Strain (1)

19. Pipe Damage Possibly Caused by Imposed Axial Strain (2)

20. Pipe Damage Possibly Caused by Imposed Axial Strain (3)

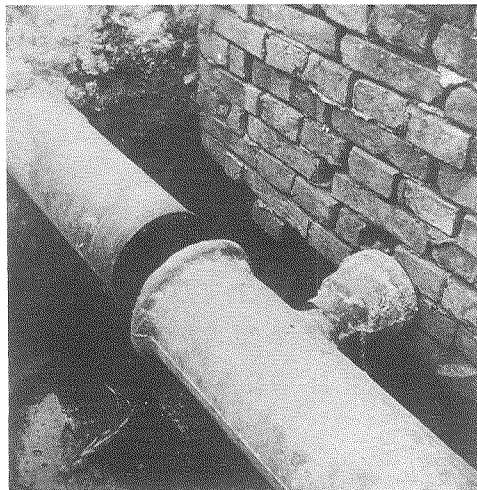
(a) One representative example is the pipeline crossing and rigidly fixed at wall. Deformation of pipelines coming out of the ground and passing through the rather rigid walls of buildings would be forcibly restricted at the connection point, hence stimulating considerably large stresses and ending up with occurring damages of changeable modes during an earthquake shock. Photos 21 and 22 are two such severely damaged examples, the former being steel pipeline, the latter castiron.

21. Damage of Steel Pipe at Wall Crossing

22. Damage of Castiron Pipe at Wall Crossing

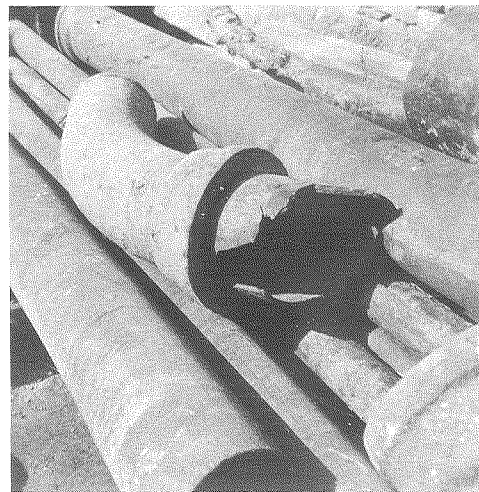
(b) Accessories and fittings of pipeline system such as elbows, tees, and crosses at pipeline junctions were liable to break owing to the stress concentration aroused during a strong shock. It is obvious that individual branches of pipelines in different runs converging in to the same junction would have their deformations severely restricted with each other there, thus forming a vulnerable part of the pipeline system. Photos 23-24 show a number of elbows and other pipeline fittings damaged in varying patterns during both Haicheng and Tangshan earthquakes.

23. Damage to Pipe Fittings (1)

天津化工厂(汉沽)转  
车间 $\phi 125$ 、 $\phi 150$   
三通,弯头震坏36个

24. Damage to Pipe Fittings (2)

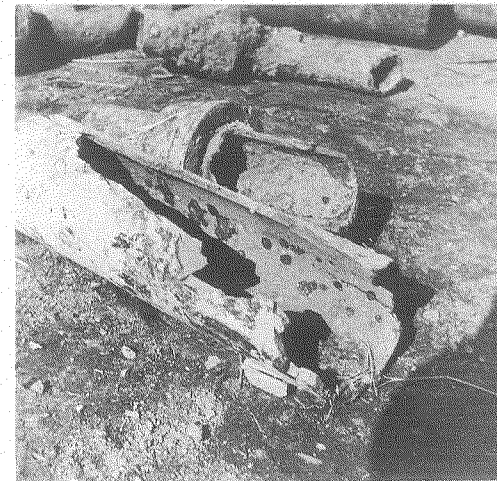
Another example to be cited was in Yingkou City, where a large number of corroded castiron pipelines were seriously damaged at various localities of the pipelines with different damage modes as shown in Photos 26-28.

26. Damage to Corroded Castiron Pipes in Yingkou (1)

27. Damage to Corroded Castiron Pipes in Yingkou (2)

28. Damage to Corroded Castiron Pipes in Yingkou (3)
