# Performance of Soil Retaining Walls during the Great Hanshin-Awaji Earthquake

During the Great Hanshin-Awaji Earthquake of January 17, 1995, many conventional masonry and unreinforced concrete gravity-type retaining walls totally collapsed, while many modern cantilever reinforced concrete retaining walls also were seriously damaged. Geogrid-reinforced soil retaining walls having a full-height concrete facing with a total length about 2km performed very well, and it is of particular importance that a wall located in one of the most severely shaken areas deformed only slightly.

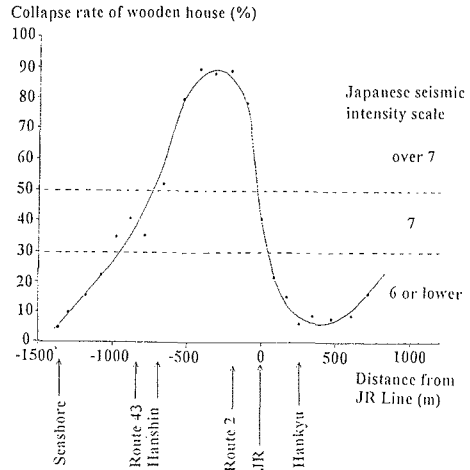
Fig. 4 Collapse rate of wooden houses along Line 12 shown in Fig. 2

As seen from Figs. 2a and 2b, the foundation ground of the areas where the collapse rate of wooden houses was highest is mainly 1) later Pleistocene terrace deposits (Ts) located between Holocene sandy and gravelly alluvial fans at relatively higher elevations, and 2) Holocene clayey deposits at the lowest elevations, located south of the fan and terrace deposits. Note, however, that the highest damage rate was not observed in the southern areas along the present seashore, where the Holocene clay deposit is relatively thick. Along a particular line (Line 12, Fig. 2), the maximum damage rate was observed immediately south of the JR Tohkaido Line, where the surface soil is alluvial fan deposits consisting of mainly gravel and sand (Fig. 4).

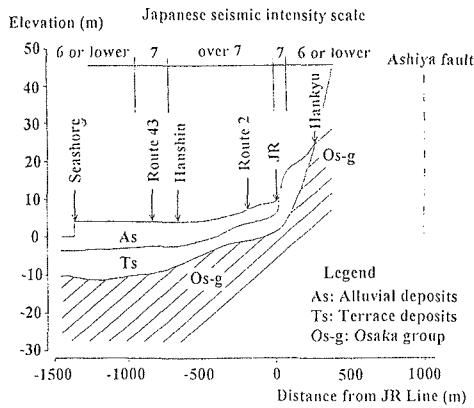
Fig. 3 Geological cross-section in the NS direction, Line 12 shown in Fig. 2

Fig. 2b shows geographical and geological classification of the area corresponding to Fig. 2a, and Fig. 3 shows a typical geological cross-section in the N-S direction, the location of which is indicated in Fig. 2. A relatively thin top Holocene soil layer (denoted by As) is underlain by terrace deposits of the later Pleistocene Epoch (Ts), which is underlain by middle Pleistocene deposits of Osaka Group (Os-g). The thickness of these Holocene and later Pleistocene deposits decreases to the north.

The surface soil layer consists of relatively stiff terrace soils (Figs. 12d and e), located next to older gravelly fans in the east and north. Yet, this ground condition is much better than that of a thicker Holocene clay deposit in the southern areas (Fig. 3).

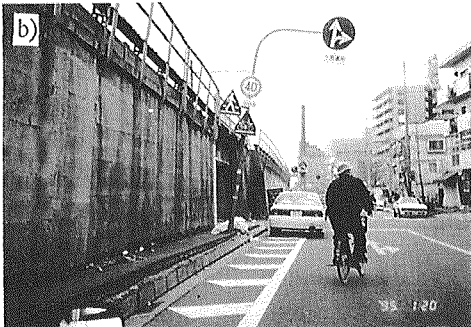
Cantilever and inverted T-shaped RC RWs: This is a rather modern type. They were aseismic designed (as described later). **Fig. 9** shows a typical damaged cantilever RC RW, constructed about 30 years ago, without using a pile foundation. The RW largely tilted outward inducing a large settlement at the crest of railway embankment. The footpath in front of the RW was pushed out laterally by this wall movement.

Fig. 9 Typical damage to cantilever RC RWs for embankment of JR Sanyo Line between Hyogo and Shin-Nagata Stations (Site CL1 in Fig. 2); a) sketch and b) pictures

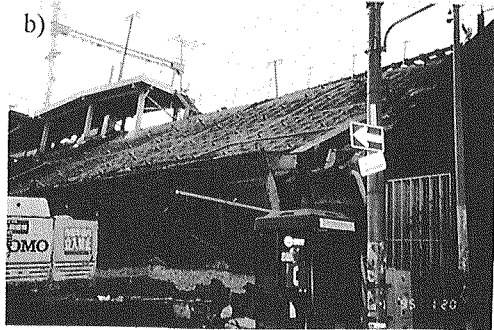
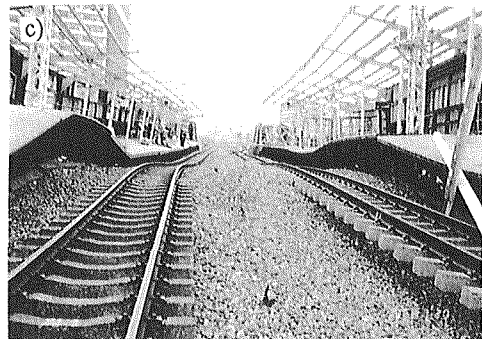
Shin-Nagata station of JR Sanyo Line was constructed about 30 years ago atop an embankment with the both sides being supported by a slope and this type of RW for a total length of about 800 m (**Fig. 10a**). Most of these RWs tilted and slid out at the bottom, but the most serious damage is cracking in the facing (**Fig. 10b**). It seems that this type of failure can be explained only by extra-ordinary large seismic earth pressure which resulted from the slope above the RW. Due to the failure of these RWs, Shin-Nagata station and the railway tracks at the site were seriously damaged (**Fig. 10c**). The previous cantilever RC RWs which were seriously damaged have been removed, and GRS-RWs are planned to be constructed in place of them, while relatively lightly damaged ones were repaired by anchoring from one side to the other side.

Fig. 10 Rupture of the facing of cantilever RC RW; embankment of JR Shin-Nagata Station (Site CL2 in Fig. 2); a) sketch and b) picture of damaged RC RW, and c) view of the previous Shin-Nagata station
