## Digital Damage Detection Due to the 1999 Kocaeli, Turkey Earthquake

### ABSTRACT

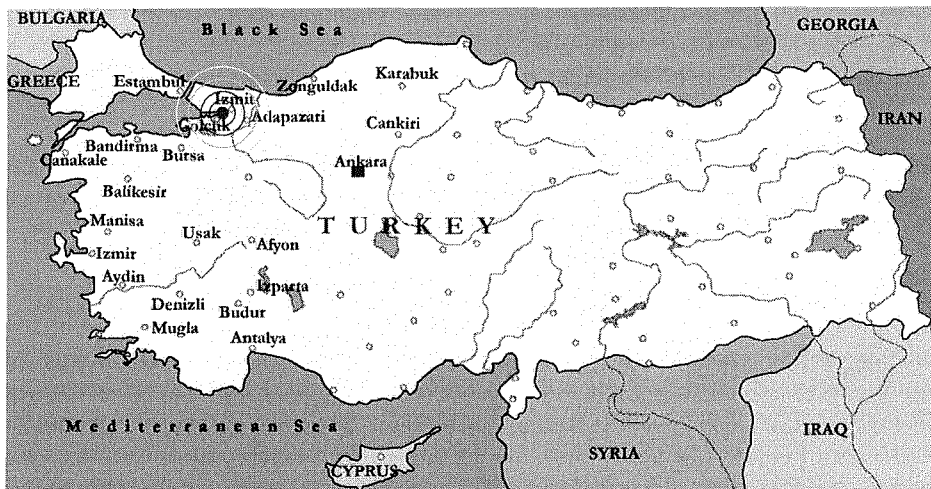
Figure 1. Map of Turkey and the epicenter of the earthquake.

Some general information about the 1999 Kocaeli Earthquake from U.S. Geological Survey and Kandili Observatory is: origin time: 00:01:38.56 (UTC), Mw = 7.4, epicenter: Lat. = 40.702N, Long. = 29.987E (Fig. 1), source depth= 17 km. According to the Government of Turkey, 17439 people were killed and 43953 were injured. 60000 to 115000 buildings were estimated to be collapsed or damaged beyond repair (EERI, 2000).

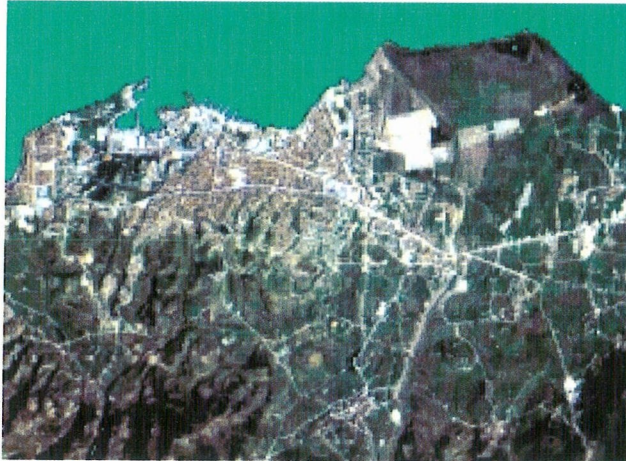
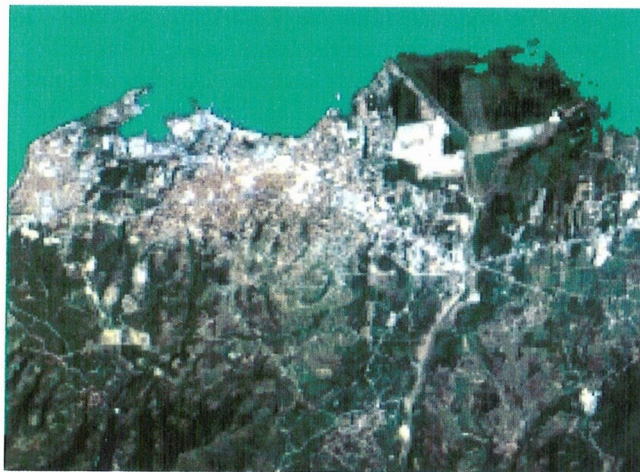
(a) Pre-event (March 27, 1999)

(b) Post-event (August 18, 1999)

Figure 7. Coastline in Gölcük, after matching the histograms. As can be seen in the post-event image (b) in the upper-right part of the image is covered by water. The composite color image (321) was superposed to get better details of the area.

Landsat/TM images are composed of 30 m ground-resolution-cells for all of its bands (except band 6, which has 120 m resolution). If we take a difference of these two images, we can find the number of pixels that differ from one image to another. Multiplying the number of pixels obtained by this difference by the area of each pixel, we can obtain the total extent of the sunken area. Although this estimation is rather crude, it gives an idea of the extension of the damage.

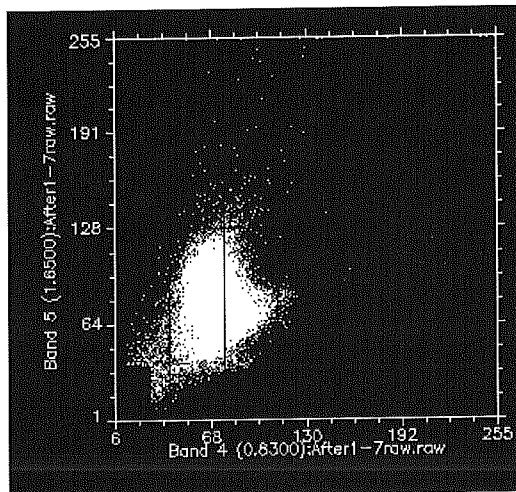
(a) pre-event (March 27, 1999)

(b) post-event (August 18, 1999)

Figure 8. 2-D Scatter diagram Band 4 vs. Band 5 for calculating sunken areas near Gölçük

With the threshold values shown in the Table 1 and the 2-D scatter diagrams shown in Figure 8, the number of pixels that belong to water before and after the event was obtained.

Number of pixels that belong to water: 8430 pixels (before), 9413 pixels (after),  
Difference: 983 pixels.

Thus, the total sunken area is estimated as  $983 \times 30 \times 30 = 884,700 \text{ m}^2$ .

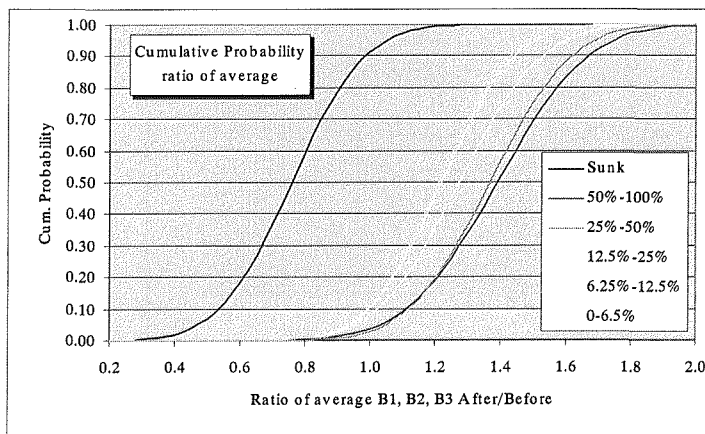
Figure 11. Cumulative probability of the ratio (after/before) of the averaged images using March-August image pair

The digital number of the pixels for the third principal component image also follows the same distribution shown in Figure 11. Based on the distribution of the digital number and using the maximum likelihood classifier (Campbell, 1996), the spatial distribution of the building damage in Gölcük was obtained as shown in Figure 12. The figure shows the distribution of the different levels of damage from Level 1 (no damage) up to Level 5 (high level of damage) and the sunken area. This estimation seems to be in good agreement with the ground truth data shown in Figure 10. However, since the area covered by the field survey is rather limited, a further study may be required to discuss the accuracy of the estimated damage distribution from Landsat/TM data.

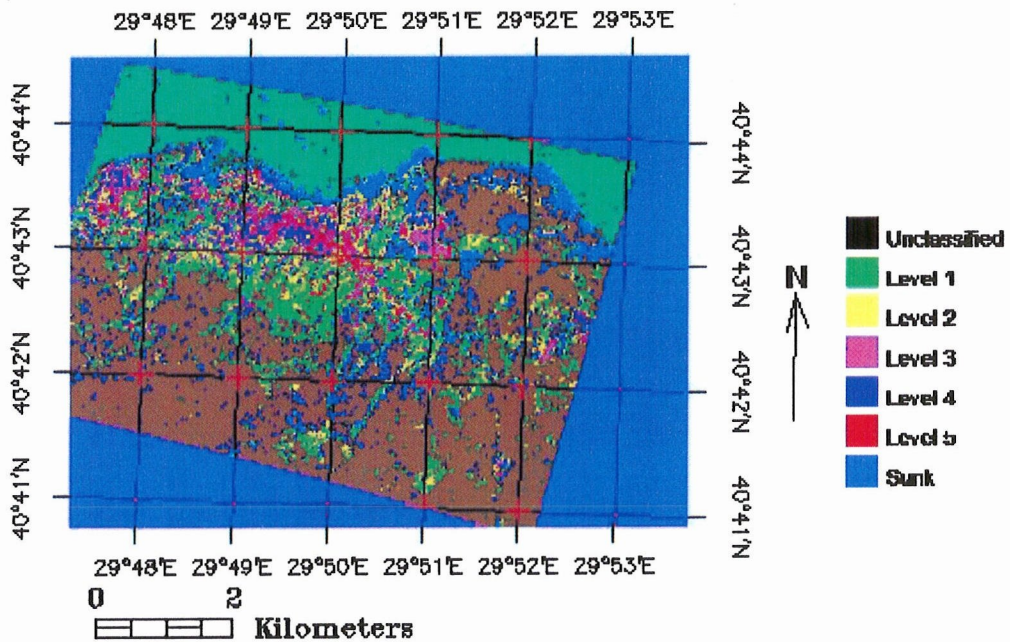
Figure 13. Spatial distribution of damage using the maximum likelihood classifier for Gölçük using March-September image pair

The same procedure used for March-August image pair was employed to March-September image pair. The result of the analysis is shown in Figure 13. The estimated damage distribution from this new image pair looks very similar to that using March-August image pair shown in Figure 12. Note that the August image was taken one day after the earthquake. It is observed that the area corresponding to damage level 5 expanded compared with that from the previous image pair. This expansion of the hard-hit area, which means a big change in reflectance, is probably due to demolition and cleaning works after the earthquakes.
