SEISMIC FAULT AND SOIL-RELATED DAMAGE IN THE JUNE 22, 2002, CHANGUREH EARTHQUAKE, IRAN*

Kazuo KONAGAI¹, Takashi AZUMA², Hideaki GOTO³, Assadollah NOORZAD⁴,
Siamak K. HOOSHIAR⁵ and Amir SADR⁶

Among those investigated, this report highlights damage to dwellings and geotechnical problems found along the surface fault rupture.

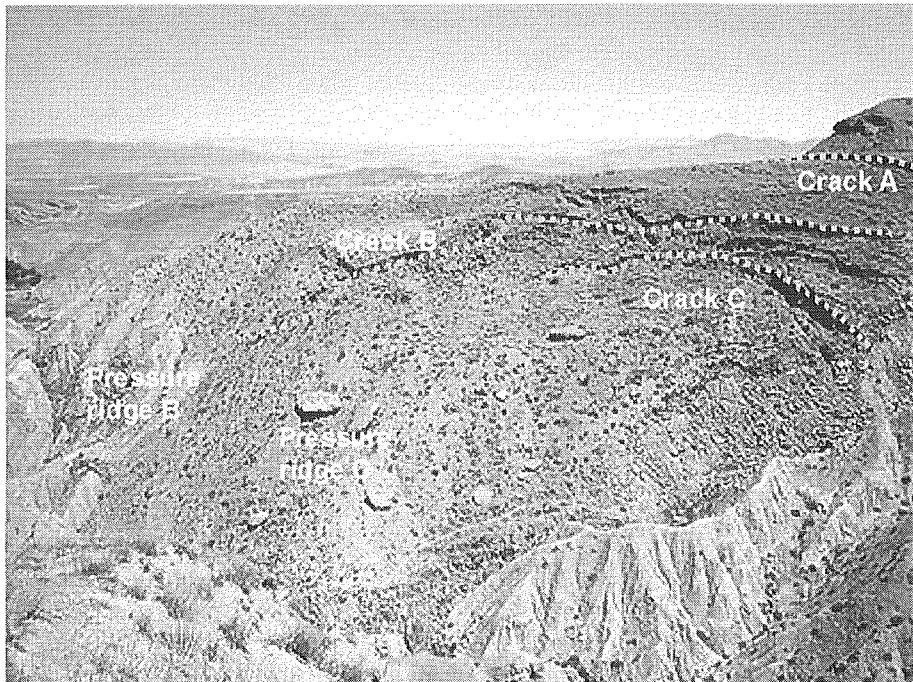
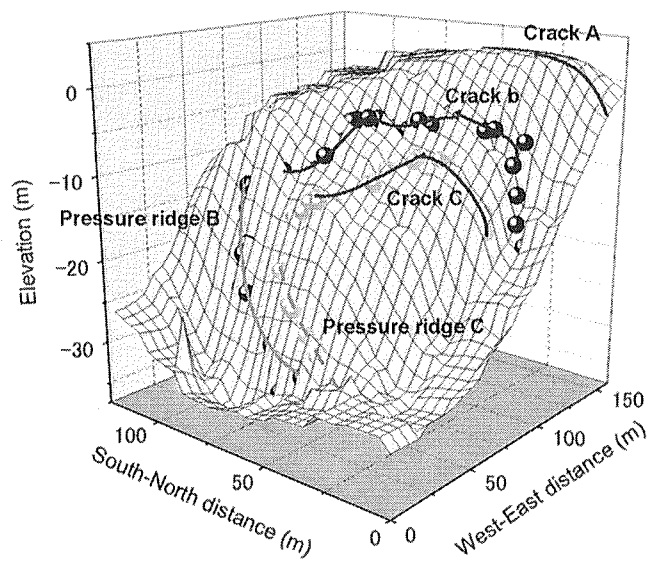
Figure 10. Slipped rockmass

The slid rock mass of about 150m long, 100m wide and 30m high is barely caught on the slope, and its configuration was measured by using a laser theodolite (**Figure 10**). The upper part of the rock mass was cracked along the perimeter of the slipped mass, and major cracks were mapped on **Figure 10**. The opening of cracks became wider as we came closer to the top, and the maximum opening and depth of 3.5-4 m and 5m were reached at **Point A** on Crack A (see **Figure 11** showing the plan of Crack A). It is noted in **Figure 11** that there was little difference between elevations of both sides of this crack; this fact suggests that the failure surface geometry could be planar.

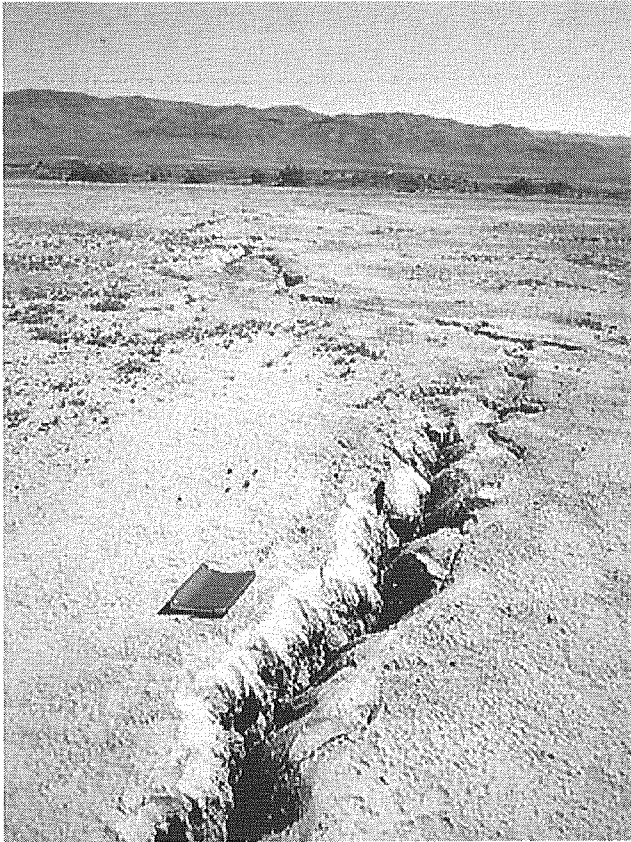
Figure 12. Liquefied sand at Point A

Hesar, about 5km north of Abdarreh, lies in the middle of a valley of about 15km wide extending in NW-SE direction. A liquefaction took place in a flat area of a little grassy land about 2 km northwest of Hesar (**Figure 12**). **Figure 13** shows the traces of liquefied sand. The bunch of cracks appearing across the area seems to be winding along a small river trace, which is dried up in hot weather. Soils along the crack at **Point A** are covered 5-10 cm thick with fine sand (about 0.5 mm in diameter, **Figure 12**), while gravels were found at **Point B** (**Figure 14a**). The flat mass of gravel stopped there was cut upright (**Figure 14b**) to discuss its possible sedimentation process. The bottom part was full of middle size grains of about 3-5 mm diameter, which was then covered thick with finer sand. And lastly, a number of bigger grains (5-15 mm) were found all over the sand mass. This fact suggests that the liquefied matter was forcibly spouted twice.
