MICROTREMOR MEASUREMENTS FOR THE ESTIMATION OF SEISMIC RESPONSE IN BOUMERDES ALGERIA

ABSTRACT: On May 21, 2003 a destructive, shallow earthquake of moment magnitude $M_w = 6.8$ occurred in Boumerdes, a city located 50 km east of the capital city of Algeria and caused damage in five provinces in the north central part of the country. Nearly two months after the event, Japan Society of Civil Engineers (JSCE) dispatched a reconnaissance team to the damage site for post-earthquake investigation. As JSCE team members, we summarize important findings on the local site effects, and structural damage based on microtremor measurements. In this study Nakamura's technique is adopted since it allows a quick evaluation of site seismic response. The main advantage of this technique is that it does not require any information about geotechnical or geological properties of the soil deposit at the investigated site.

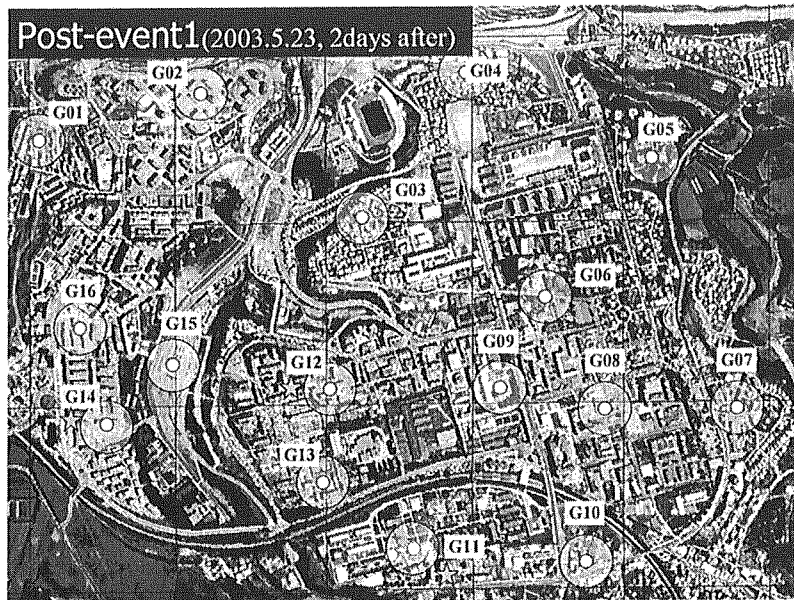
Figure 1 Locations of microtremor observation points and inspected buildings (☆)

Microtremors were measured in Boumerdes city to investigate the relation between structure damage level and local site effect. Nearly two months after the earthquake, microtremor measurements were conducted at sixteen different sites in Boumerdes city (G01-G16). **Figure 1** shows the locations of the measurement points plotted on a post-event satellite image of Boumerdes city.

A quick inspection of three buildings (**Figure 7**) in Boumerdes city was carried out to investigate the fundamental periods of sample structures in the damaged area. The location of each structure is marked on a post-event satellite image as shown in **Figure 1**. The fundamental period was obtained with microtremor measurements. Since damage increases the fundamental period of structures (Abe et al., 1979), microtremor measurements may be used to identify damage by recognizing changes in the fundamental period. **Table 3** shows the number of stories, building height, the predicted and obtained fundamental period in longitudinal and transverse directions, and damage level based on the National Earthquake Engineering Center (CGS) survey. The approximate values of fundamental period were calculate according to the simplified equation [$T=0.02H$, where T is a fundamental period in second, H is a building height in meter]. The fundamental period for each building was obtained also from five 40.96 s microtremor measurements for each building. The corresponding five spectra were averaged to obtain the fundamental period as shown in **Figure 8**. The procedure was carried out in both longitudinal and transverse directions. It should be noted that heavy demolition equipments that were in operation near to the observation area might have affected the measurements. It should also be reported that the first observed structure was a four-story buildings with “soft story” type of damage. From **Table 3**, it is clear that the fundamental period for each structure increased, compared with the predicted values, with different levels. This incensement meanly depends on the damage level of each building. The results highlight the possibility of using microtremor measurements to identify damage level by recognizing changes in fundamental period.

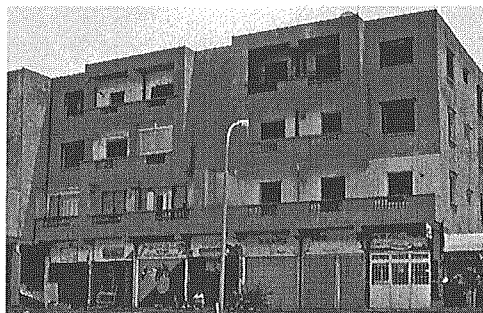
(a) Structure 1 (4-story RC structure with soft floor type of damage)

Figure 7: Investigated structures

No.	Building name	Location	No. of stories	Height	Predict Period (s) $T=0.02H$	Fundamental Period (s)		Damage Level
						Longitudinal	Transverse	
1	Residential building	G14	4	15.00	0.30	0.68	0.70	5
2	Boumerdes University	G11	4	25.00	0.50	0.66	0.45	3
3	Residential building	G12	5	15.00	0.30	0.29	0.40	3

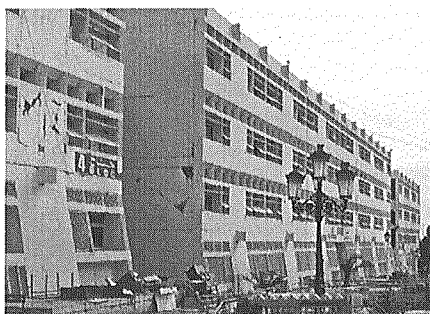
(b) Structure 2 (Boumerdes University)

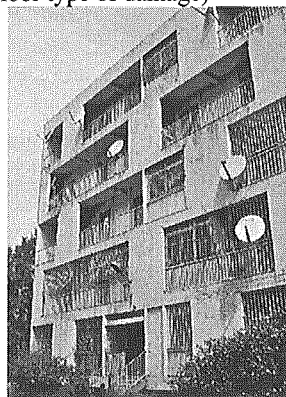
(c) Structure 3 (5-story RC building)
