DAMAGE AND REHABILITATION IN AREAS AFFECTED BY THE OCTOBER 8, 2005 KASHMIR EARTHQUAKE, PAKISTAN*

Key Words: Kashmir earthquake, geotechnical issues, rehabilitations

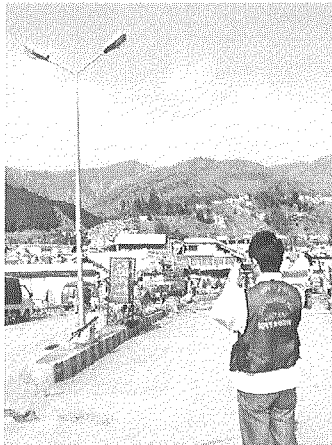
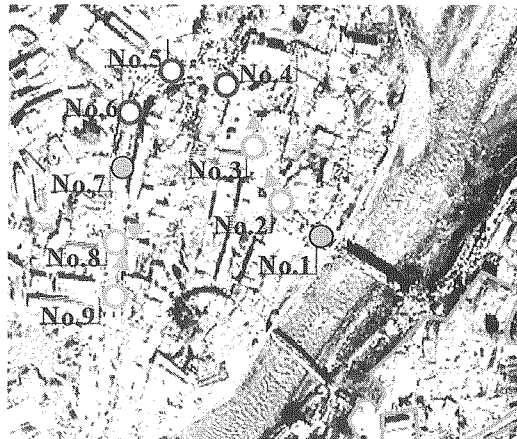
Fig. 7. Location and the inclination of the lampposts (●: sound, ○: shaky, ◐: bent). Arrows show the direction and the amount of the inclination (20degree=1cm). Imagery taken from UNOSAT website (<http://unosat.web.cern.ch/unosat/asp/> [4])

Measuring traces of strong ground motions remaining in structures, which are seen everywhere and have common features, will provide useful information for discussing shakes at particular areas. In our short preliminary investigation, only the direction of strong motion was estimated by measuring inclinations and directions of the inclined lampposts. We took total 9 lampposts lining Route #15 (Fig. 7). Two lampposts (1, 7) were standing almost upright and slightly damaged. Three lampposts (4, 5, 6) had screws broken at their base plates (22.5cm × 22.5cm) and stood loose. Four lampposts (2, 3, 8, 9) were bent at their toes and inclined north. All these show that the ground motion was strong in NS direction.

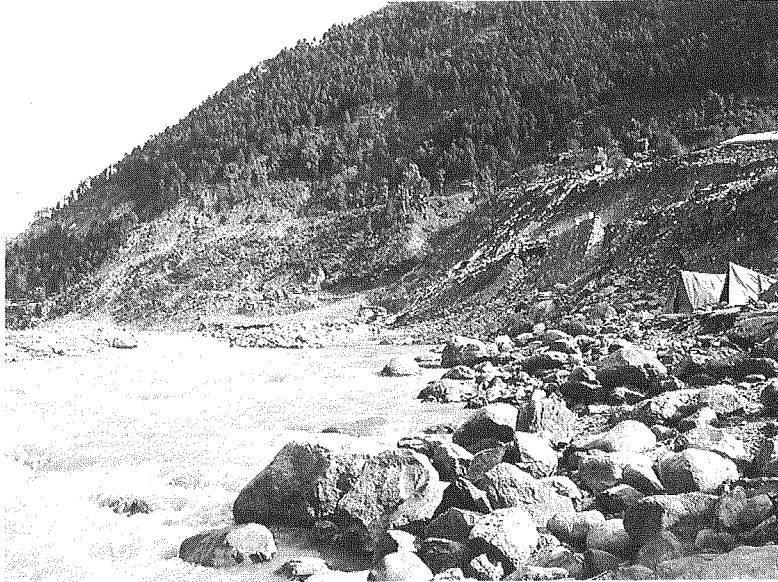
Fig. 8. Terrace slope northeast of Balakot bridge

Hills and terraces near the northern end of Balakot basin are composed of either highly weathered sand rock or conglomerate of rounded to sub rounded boulders, cobbles, gravel, sand, silt, clay and other suspended matters that the glacier (or River Kunhar) have carried over centuries (See Fig. 8). They are heterogeneous in nature. Foundations of buildings on these terraces may have not been properly designed. Fig. 9 shows a foundation found in the rubble covering up the entire slope of the abovementioned long-bean-shaped hill. The foundation was lying on the sandy slope surface with its column-foundation joint intact, indicating that the foundation didn't suffer any cracking but the foundation lost its soil support. A similar pattern of damage was also found in Muzaffarabad (Fig. 10). Houses along the rim of the terrace were completely destroyed, while those on the flat land are seemingly standing upright. Soil cracks were visible along the rim.

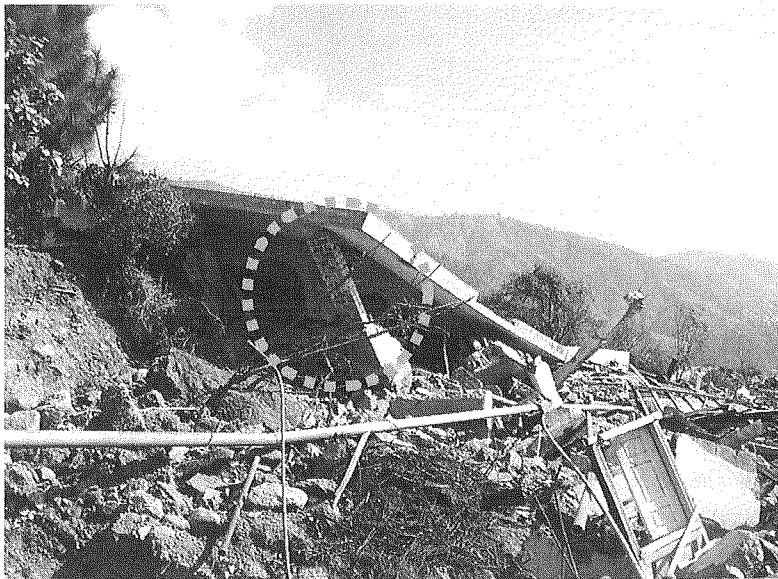
Fig. 9. Foundation and column of a dwelling at the long-bean-shaped hill

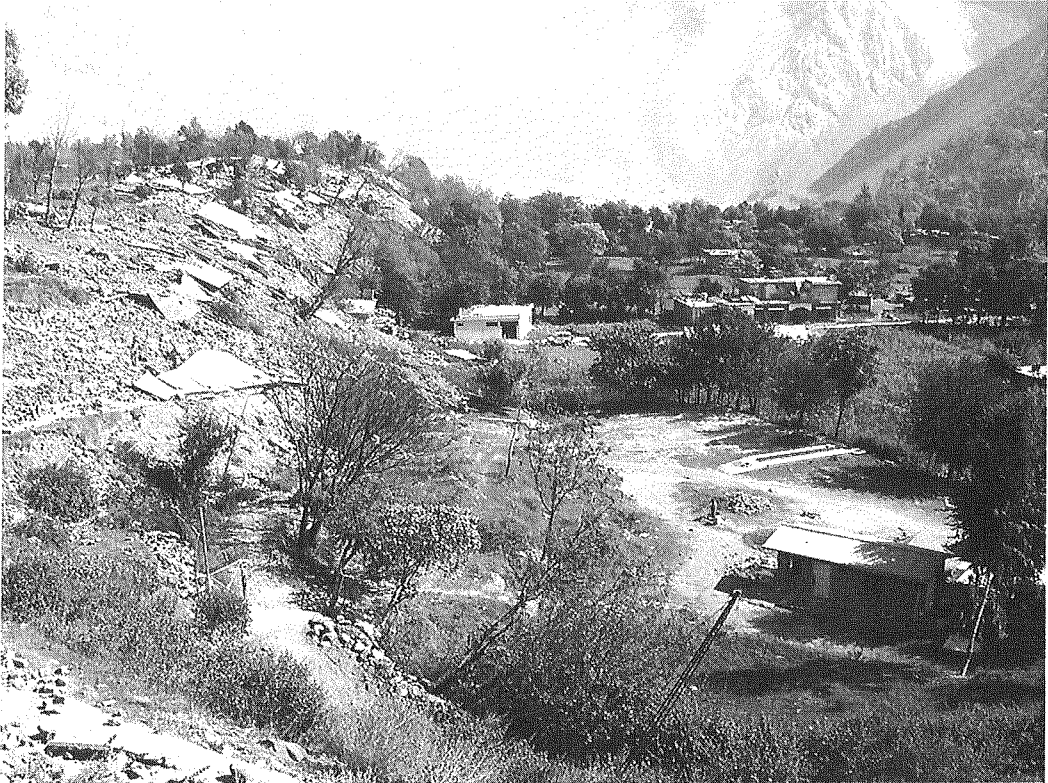
Walls of structures are mostly made from cement sand blocks. Roofs are made from RC slabs. Almost complete collapses of these structures were often found on sloping grounds. These houses were attached to each other. When one house anywhere on the slope collapsed, it triggered the collapse of the others in domino-like manner and the result was the collapse of entire houses. Half-detached or completely detached houses also suffered cracking, but there were some narrowly escaped from complete collapse.

Fig. 10, Houses along terrace rim and those on flatland, north of Muzaffarabad

1. There is a need to study engineering (physical) and geological features of soils and rocks of mountains existing in the affected areas for rational measures to stabilize slopes.
2. Where possible, two or more storey structures should be constructed on piles. Where not possible or difficult such as on slopes, shallow foundations can be used if they are properly designed to withstand/resist differential settlement. Providing a connecting beam on or slightly below the ground level can reduce the effect of the differential settlement.
3. Frame structure buildings consisting of RC columns, beams and slabs will be more resistant. Alternatively, if affordable, steel frame structures will definitely be more resistant.
4. If possible, houses on slopes should be kept detached from each other.

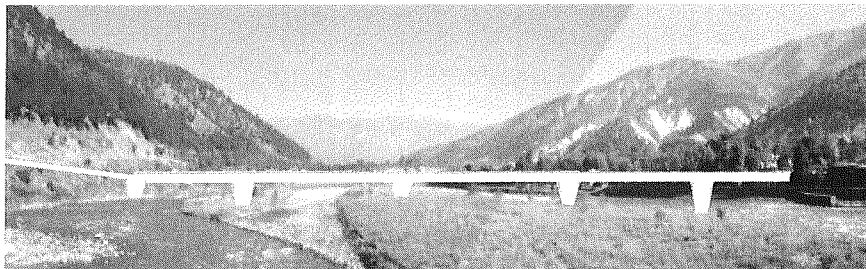
Fig. 12 Idea for enhancing redundancy by constructing bypass

Connecting existing roads point-wise by constructing new bridges etc, a cost-effective bypass can be constructed allowing bi-directional traffic to be realized. One of candidate sites for Balakot can be approx. 4km south of the city (**Fig. 12**). Realizing a smooth traffic would make people to migrate easily, and new colonies will be formed.

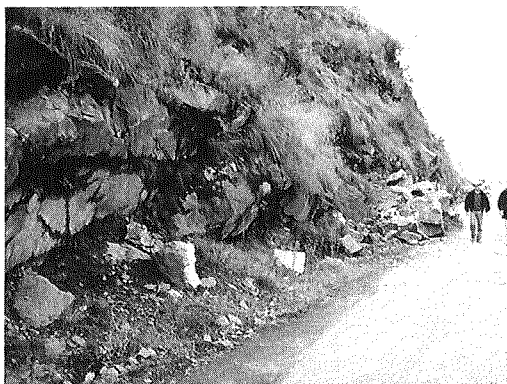
Greater part of the Jhelum valley road is on the western side of the river. Slopes on the western side indicates the outcrops of intercalated shale and sandstone strata, and the strata dips about some 30 to 40 degrees towards the Jhelum river. Layers of shale and sandstone are jointed and rock mass of slopes is blocky. The joints were opened due to the shaking of the Oct. 8 Earthquake with water seeping through the discontinuity network (Fig. 15). Therefore, these blocks can be easily toppled and fall down the slope to the river blocking the road, or the entire surface rock mass can topple as a consistent body. Rerouting at some dangerous locations will be necessary for enhancing the redundancy.

Fig. 15. Blocky rock mass along western mountain side of Jehlum valley: Water is seeping through cracks
