A New Base-Isolation System using Gage-Pendulum Principle for Light Timber Structures for the Safety of Their Structural and Non-Structural Components

Key Words: Base-Isolation, Timber Structures, Non-Structural Components, Ceilings

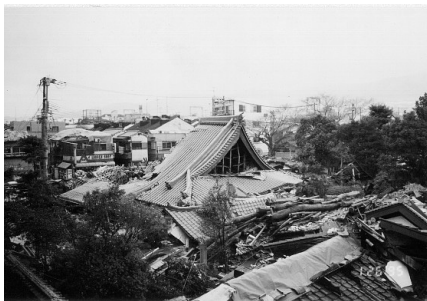
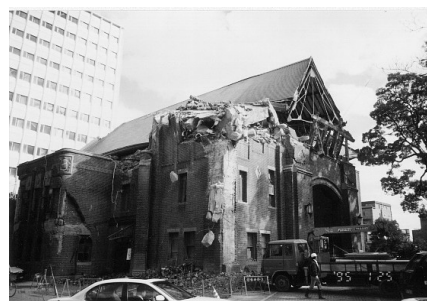
Figure 1: Historical structures collapsed by Kobe Earthquake in January, 1995

(a) A historical timber temple

(b) An old church

Earthquake is the critical problem for every structure constructed in seismic regions (figs.1 and 2). In order to avoid fatal collapses of the structure against the heavy inertia force under the excitation of ground motion during earthquakes structures in seismic regions are usually constructed with stronger skeleton and old existent structures are reinforced to be “earthquake resistant”. However since

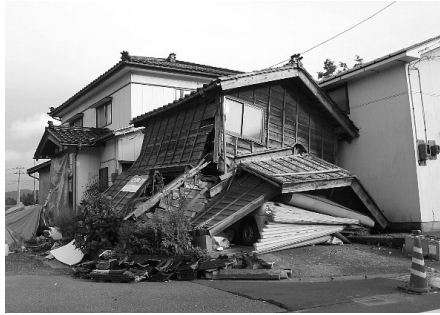
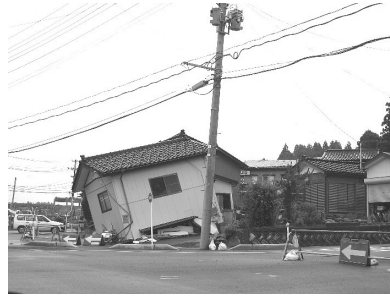
Figure 2: Wooden houses collapsed by Chuetsu-Oki Earthquake in July, 2007

(a) A Wooden house 1

(b) A Wooden house 2

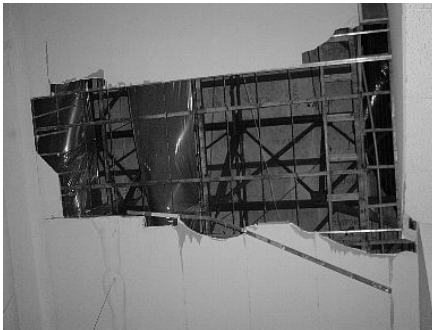
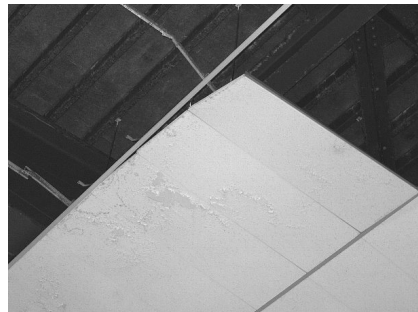
Figure 3: Non-structural components damaged by earthquakes

(a) Collapse of ceilings 1

(b) Collapse of ceilings 2

the purpose of the “earthquake resistant structure” is “not to collapse” it never relieves the seismic load. Therefore “non-earthquake resistant” parts, especially “non-structural components”, are exposed to the seismic load and deformation that is induced during earthquake (fig.3). Damage to non-structural components are sometimes very dangerous to the people using the structures and when the structures are of the historical importance it may cause serious damage to the historical heritages preserved in and around the structures. In 1997 the famous wall paintings in the church in Assisi were damaged by an earthquake although the church itself survived.

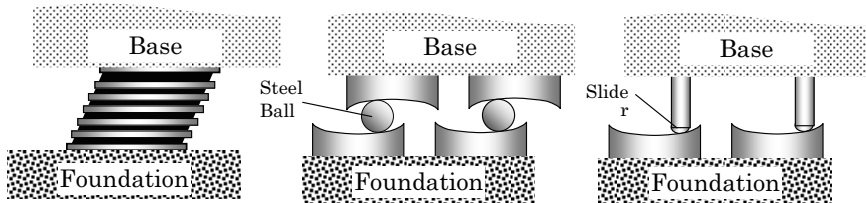
Figure 4: Typical Base-isolation devices with recovering mechanisms

(a) Rubber Bearing

(b) Friction Pendulum 1

(c) Friction Pendulum 2

Base-isolation systems are the structural systems that isolate the super structures, using special bearing devices (fig.4), from the ground motion during earthquakes. Base-isolation systems make it possible to drastically reduce the seismic loads and deformations induced to both the structural components and non-structural components. In this paper a new base-isolation system for timber structures is proposed and the results of its real scale shaking table tests are reported.

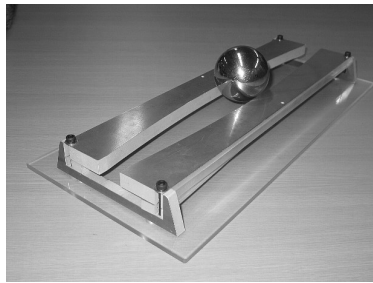
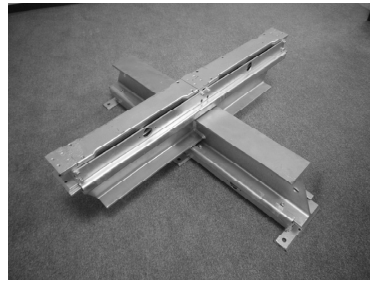
Figure 5: The new base isolation device

(a) Gage pendulum

(b) VP-isolator

The base-isolation system proposed is based on the new concept of pendulum, the gage pendulum (fig.5(a)), of which recovering force generated by the gravity force and the shape of the gap between a pair of curved lines. This system does not require any slope for the ball to roll to produce the pendulum movement. Using this concept the final configuration of the base-isolation device became cross rail style as shown in fig.5 (b) and was named “VP-isolator”.
