A QUANTITATIVE APPROACH TO ASSESS LANDFORM CHANGES OF HATTIAN BALLAH LANDSLIDE DAM FORMED BY 2005 KASHMIR EARTHQUAKE

SLOPE FAILURE INDUCED DEBRIS FLOW HAZARDS IN THE OCTOBER 8, 2005, KASHMIR EARTHQUAKE

GEOTECHNICAL ISSUES CAUSED BY THE MAY 12th 2008, WENCHUAN EARTHQUAKE, CHINA

PROVISIONAL REPORT OF THE DAMAGE CAUSED BY THE JUNE 14th 2008, IWATE-MIYAGI EARTHQUAKE

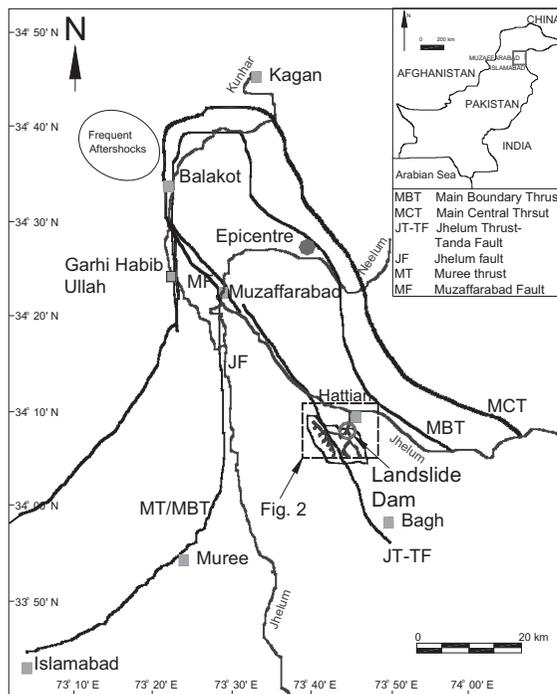
Fig. 1. Broad scale regional tectonics of Northern area of Pakistan. The Hattian Landslide is marked with a red circle with catchment area of streams. The epicenter of the 8-10-2005 earthquake is marked; the main cluster of aftershocks is located north west of it. The landslide dam is located near the SE-end of the Tanda Fault.

The huge landslide mass is a possible flood and debris flow hazard for the downstream areas including Muzaffarabad city. As shown in Fig. 1 Jhelum river takes a sharp turn southwards at Muzaffarabad city

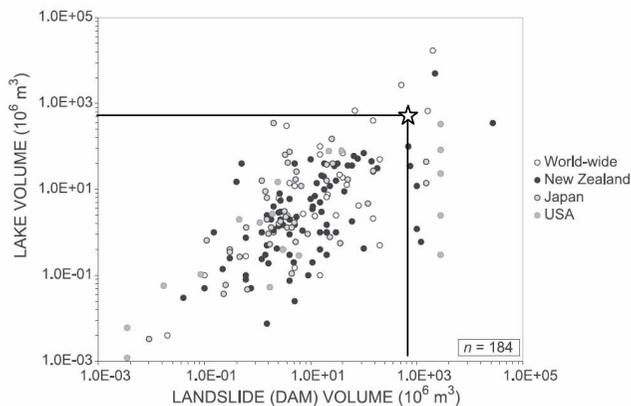
Fig. 3 Bivariate plot of landslide-dammed lake volumes versus landslide dam volume derived from a worldwide data set (n = 184), highlighting occurrences in New Zealand, Japan, and the USA according to Korup (2004) and data from Hattian-Ballah landslide dam and lakes.

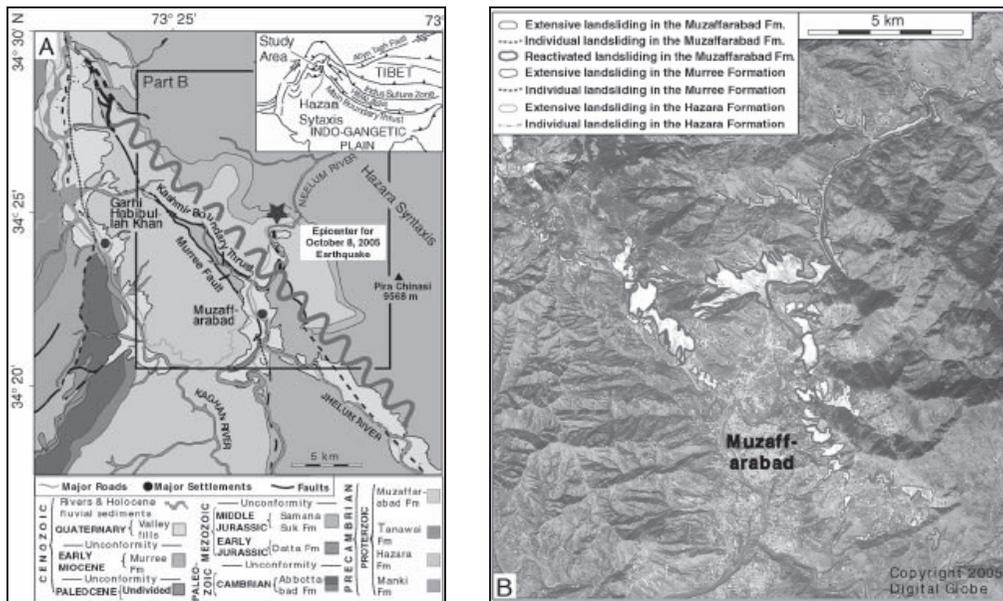
Fig.1 A) Simplified geological map of the area around Muzaffarabad and **B)** Quickbird image showing region of most extensive slope failure: Red wave indicates area of maximum crustal deformation (after Geological Survey Institute, 2006; Avouac et al., 2006).

occurred in Muzaffarabad Formation, which forms steep valley slopes, many $>50^\circ$ above the main rivers of the alluvial and valley fills. The Muzaffarabad Formation comprises thinly bedded and highly fractured dolomite constituting the lower beds in the hanging wall of Balakot-Garhi fault. This fractured loose material is a big source of debris flow with favorable conditions for the phenomena to occur. Fig.2 shows average rainfall data at Muzaffarabad from 2005 to 2008.

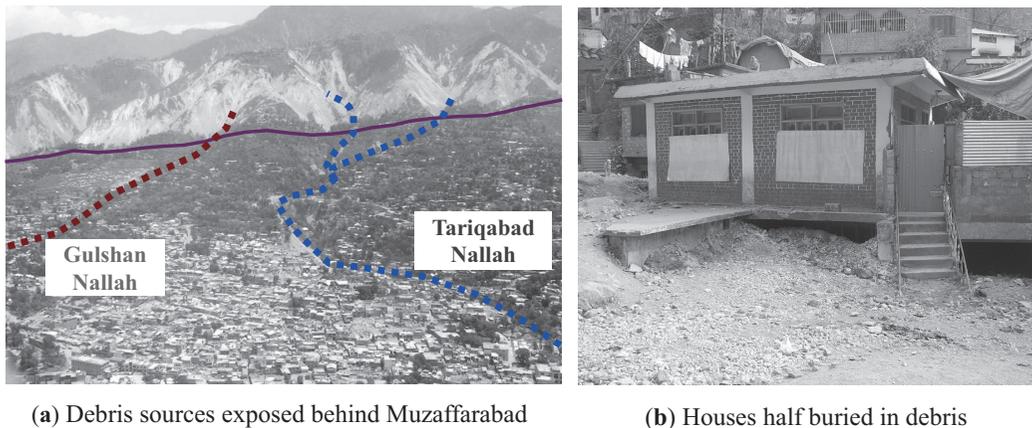
Fig. 3: Debris deposit from activated fault in Kashmir (Muzaffarabad): Purple line show the causative fault (Balakot-Garhi fault) of Kashmir Earthquake

The causative Balakot-Garhi fault passing just behind the Muzaffarabad city, with city on its footwall, caused a widespread linear slope failure, with a huge amount of highly sheared and fractured loose material exposed (Fig.3a). During heavy rains of monsoon, this loose material combined with water moves as debris flows in the deeply incised nallahs (Urdu word used for channel) and hits the inhabitants. These nallahs directly pass through the Muzaffarabad city and feed the Neelum river flowing southward immediately at the western end of the city. People living in the valley along these nallahs are seriously effected by the debris flow with there houses half or full buried (Fig.3b). We selected two most damaging, Gulshan and Tariqabad nallahs (Fig.3a) passing through highly populated valley of Muzaffarabad city and carried out GPS measurements at two different times, June 2008 and November 2008, measured channel morphometric parameters and observed the changes. Processing the GPS data to formulate digital elevation data of the target area, flow is simulated for Gulshan nallah to understand actual flow behavior and damage distribution.

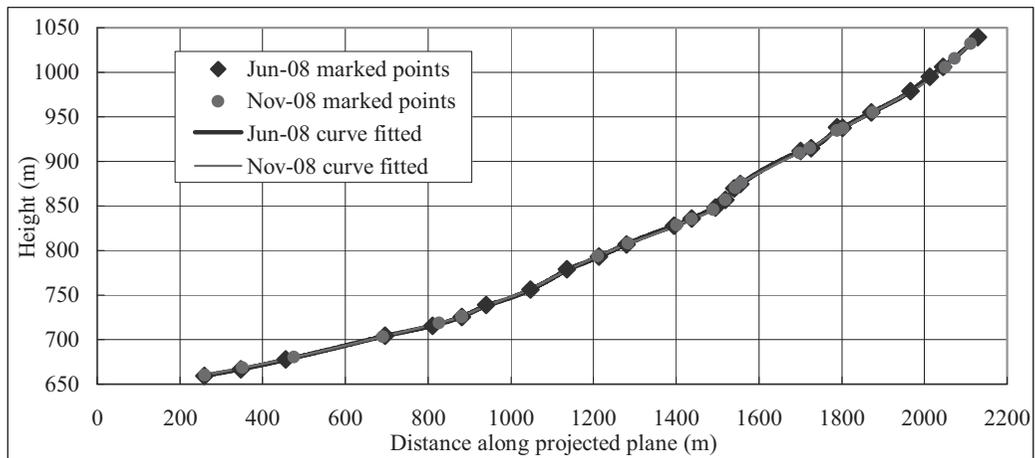
Fig. 8: Plot of June 2008 and November 2008 measured data points with curves fitted using cubic *spline* function

Tariqabad nallah has a total length of about 1900m with an irregular configuration. Due to mismatching location of June and November measurements (**Fig.8**), curves were fitted using cubic *spline* function to the measured data points (**Fig.8**). Due to complex configuration of Tariqabad nallah, measured data points were divided into about 10 groups each following certain trend for smooth curve fitting. This curve fitting gives assumed profile of elevation between two measured points and may involve some error but makes quantitative evaluation possible. By taking June data as reference, erosion and deposition analysis is carried out along the nallah bed. **Fig.9(a)** shows the elevation changes of November measured points from curve fitted to June measured data while **Fig.9(b)** shows detail erosion and deposition comparing the curves fitted to measured data (negative values indicate erosion) with nallah bed gradient shown in **Fig.9(c)**. The length of nallah above point of 2000m along the projected plane is responsible for the initiation of the debris flow with a bed gradient of $\geq 18^\circ$. This reach has very steep channel banks with highly fractured loose debris material. This material flows down the steep slopes and is accumulated in nallah from where it is transported by already mobilized debris mass little upstream of it. GPS data indicates erosion in this reach which is the transportation of accumulated material and takes time to accumulate again. Downstream of point of 875m along projected plane, data shows deposition along the channel with a gradient of $<10^\circ$ defining the deposition zone. Depositional reach is relatively long with more depositional depth as compared to Gulshan nallah. This may be attributed to long length, irregular configuration and tributaries feeding at lower reach of nallah. Some points in this depositional zone indicate erosion which is resulted by man made changes and excavation of deposited material, observed during survey. Between both of the above mentioned points is flow and transportation zone where both erosion and deposition are indicated depending on the channel configuration and bed gradient. This flow and transportation zone has the bed gradient between 10° - 18° with some local high values.

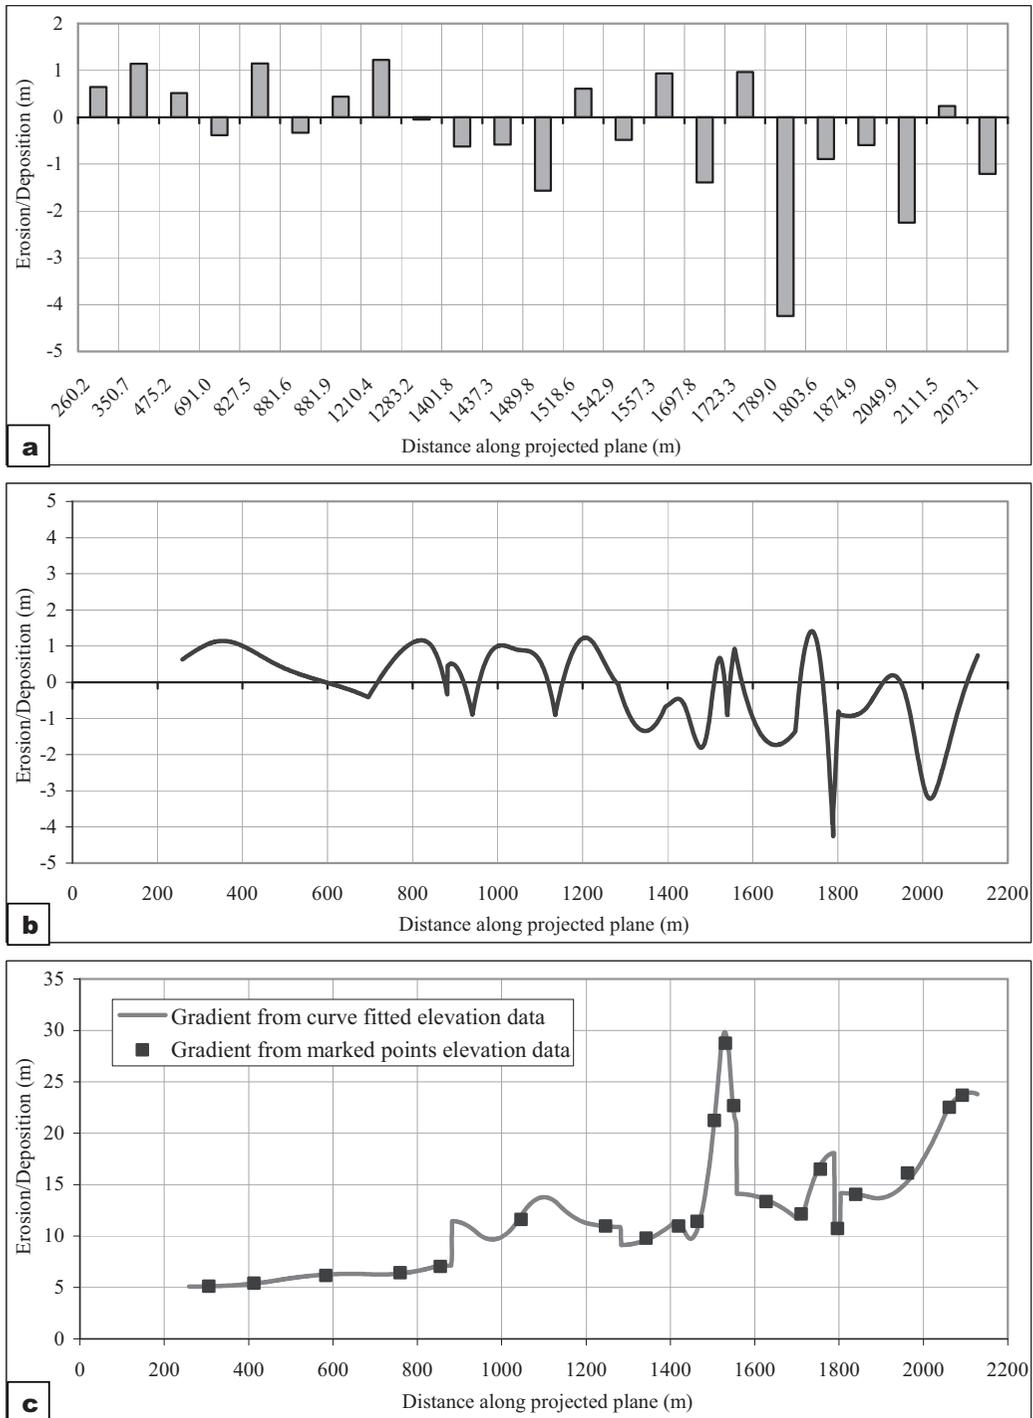
Fig. 9: a) Elevation changes of November measured points with reference to curve fitted to June measurement **b)** elevation changes along total length of nallah from curve fitted data **c)** nallah bed gradient

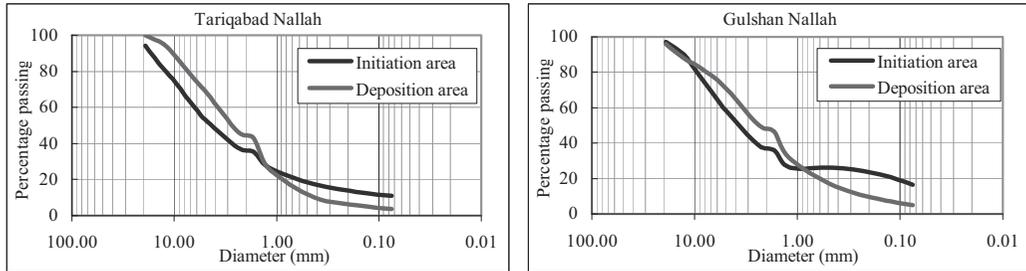
Fig.12 Grain size distribution of source and deposited material in Gulshan and Tariqabad nallahs

Grain size distribution has been performed on material sampled in deposition and source area. The grain size distribution, obtained on the fraction passing 20mm sieve, shows a difference between two areas (**Fig.12**). While flowing from initiation to deposition area percentage of fines (less than about 1 mm) is decreased but the fraction ranging from 1-20mm has significantly increased in both the nallahs. High shearing effect at the initiation area due to the fault may have caused extremely fine particles which may have washed during flow or flowed down the depositional reach as hyperconcentrated flow. But the sand size particles are increased due to the rolling and collision effect as well due to entrapping the bank material which consists of Murree formation having a good fraction of sand size particles.

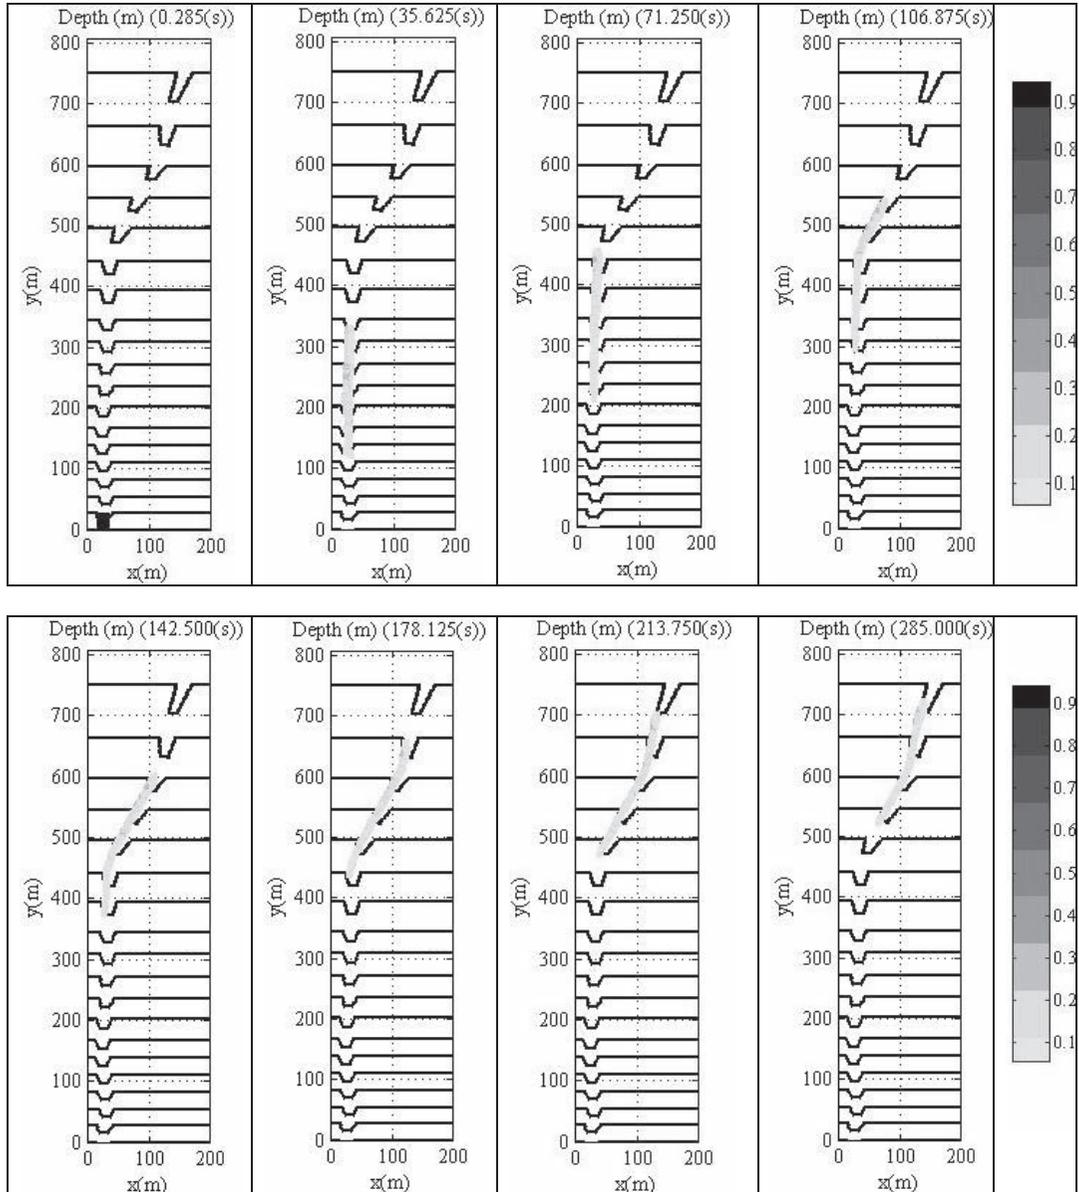
Fig.13 Flow depth distribution and flow behavior along the entire reach of Gulshan Nallah

The simulation results showing the flow depth and velocity distributions along the entire nallah are shown in **Fig.13** and **14** respectively. Color bars show the magnitude of the flow depth and flow velocity while solid lines in the figure are elevation contours showing three dimensional terrain in two dimensional setting (Pseudo 3D). Flow behavior (e.g. concentration of flow at outer edges of bend sections and front bore having high velocity) can also be observed from these animations. Computational parameters used as input for these animations are summarized in **Table2**.

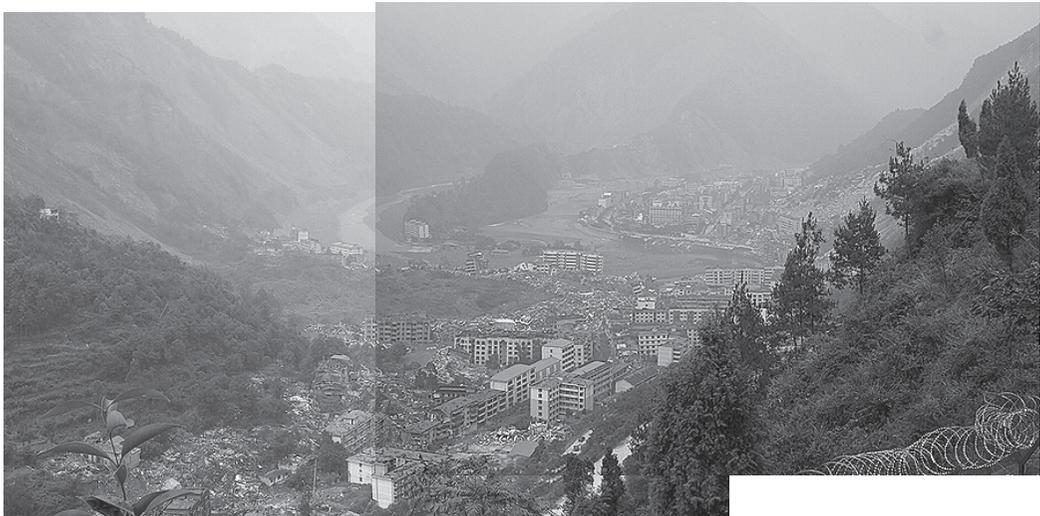
Photo 1. Downtown of Beichuan County. Two major built-up areas were completely destroyed by two major slope failures.

- (1) The shake must have been intense enough to destroy many houses and buildings to be sure, but two major slope failures on both sides of the city have certainly caused fatal and wide-spread damage to built-up downtown areas of the city.

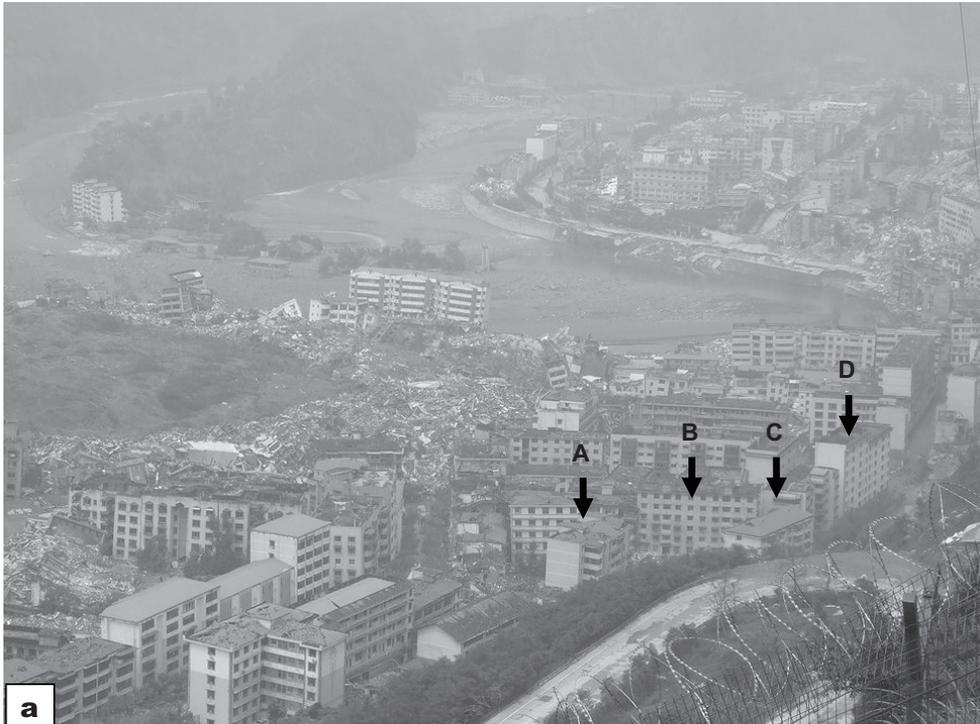
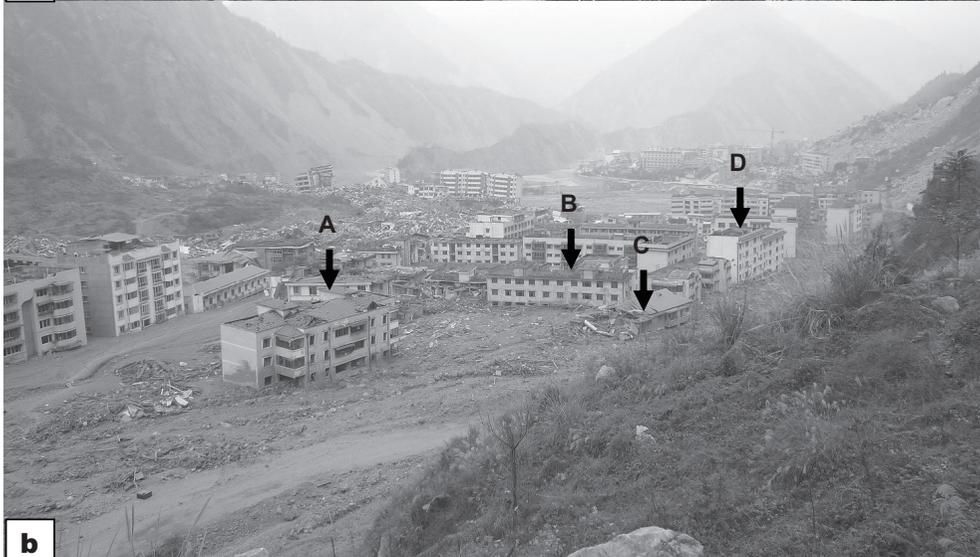
Photos 2a and 2b. South built-up area of Beichuan County. Photo 2a was taken on July 27th, 2008 while Photo 2b shows the same area in December, 2008, buried beneath thick debris mass. (Photo 2b by Maki, N., DPRI, Kyoto University)

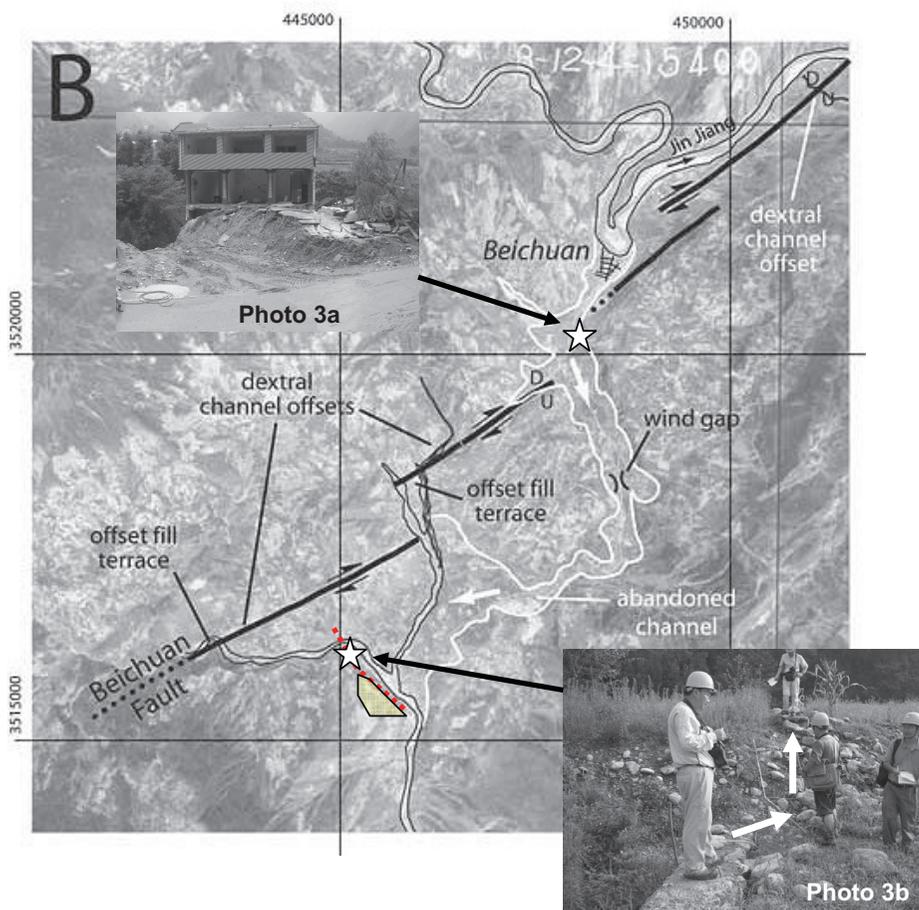
Fig. 2. Interpretation of fault traces in Beichuan and its vicinity by Densmore, A. et al. (2007): Thick lines show interpreted fault traces. Thin white lines show margins of abandoned channel of the Jin Jiang; white arrows show inferred flow direction. The Jin Jiang is now diverted at Beichuan and flows northeast, parallel to the Beichuan fault.

Fault ruptures appeared in Beichuan and its vicinity. Densmore et al. (2007) described the detailed geomorphologic features of the terrains along the Longmen-Shan fault (see Fig. 2). One of the observed rupture (Point A in Fig. 2) appeared almost on this recognized fault trace, while the other (Point B in Fig. 2) appeared off the trace. As is often the case, the thrust faults seem to make up a wide brush, which extend across the central areas of Beichuan. Some serious devastations and landslides may have been due to fault offsets. To have a clear perspective on how the area should be rehabilitated, fault traces are to be precisely mapped.

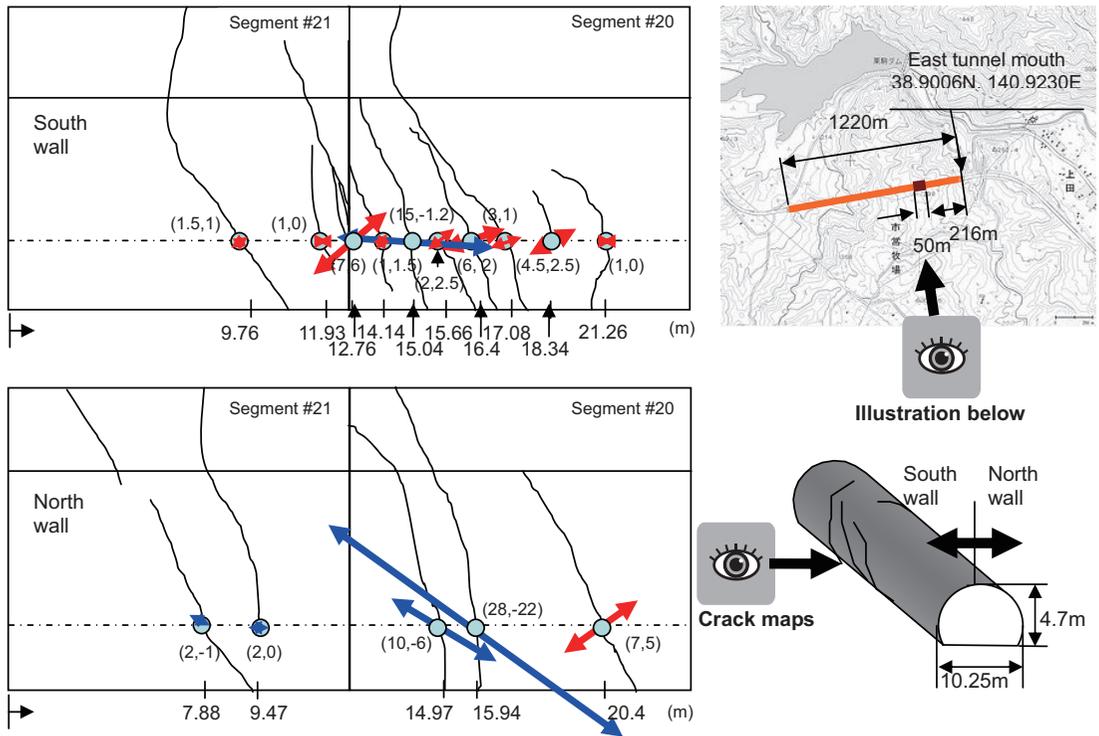
Fig. 7. Cracks in Shin-Tamayama Tunnel:

A 36m-long segment at 216m inside the eastern end (38.9006°N, 140.9230°E) of the 1220-m-long tunnel was diagonally cracked. Fig. 7 shows projections of the cracked south and north walls on a virtual screen. These cracks were all opened. Black arrows show that the eastern segment moved down with respect to the western segment, while gray ones show the opposite. Numbers in parentheses show these relative displacements in millimeters. If a deep-seated landslide was the cause, long-term monitoring will be a must for rational repairs.

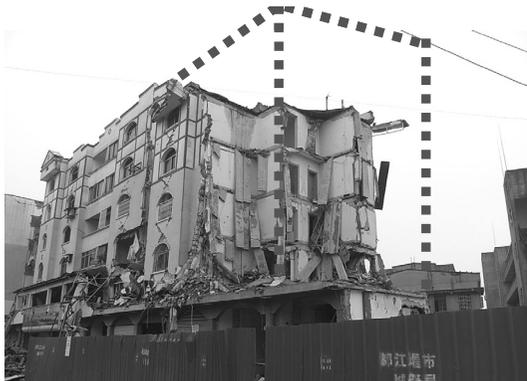
Photo 2. Partially collapsed brick buildings with precast concrete hollow-core slabs (Dujiangyan city)

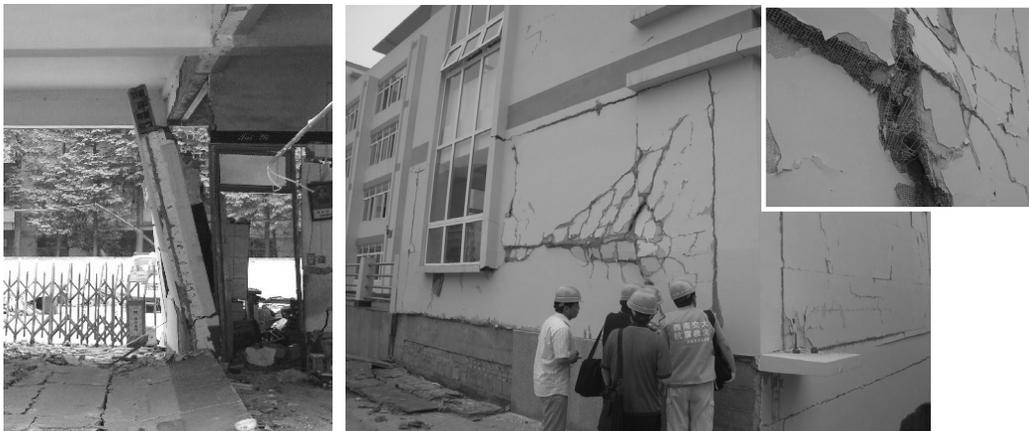
Photo 3 Failed brick wall (left) and survived brick wall (right)

Reinforced concrete shear walls are much less frequently provided in RC buildings than UR brick walls. Lightly reinforced small-sized columns (tie columns) are often placed later between UR brick walls so that the walls should serve as the form in casting concrete of RC tie columns. During the surveys, shear cracks and failure of brick walls are found in many buildings as shown in Photo 3. It

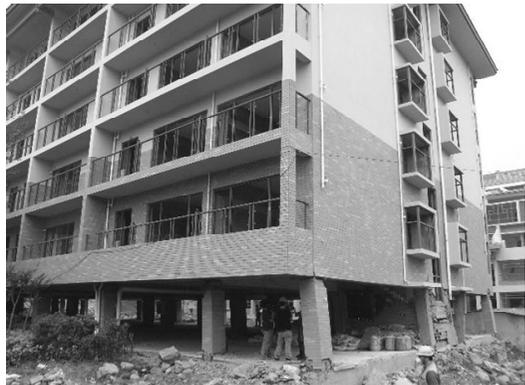
Photo 6. Soft first story of a 6 story RC apartment house

flexural compression failure at the top and bottom of their columns. Photos 6 and 7 show the damage to columns in the first story of a six story apartment building in Dujiangyan city. Hooks of lateral reinforcement are pulled out of crushed concrete core. Main rebars buckle and fracture as shown in the photos. As will be found later in this paper, the building is employed for a sample building to investigate possible restoration schemes and to discuss their feasibility with Chinese engineers.

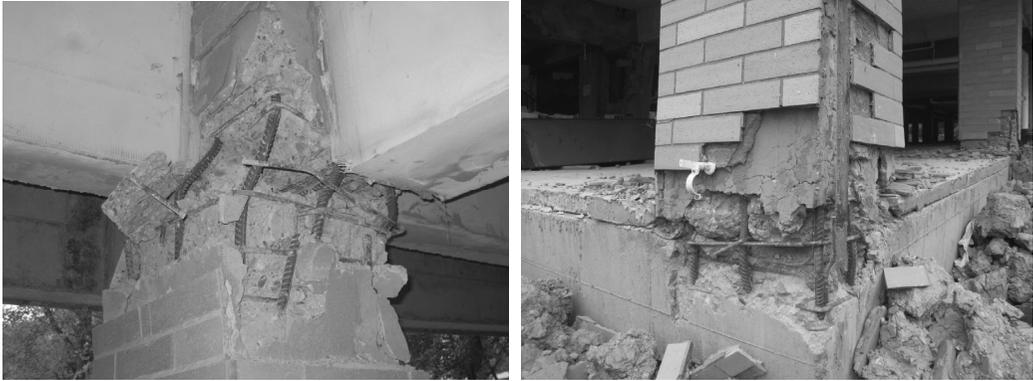
Photo 7. Flexural compression failure at the top and bottom of columns

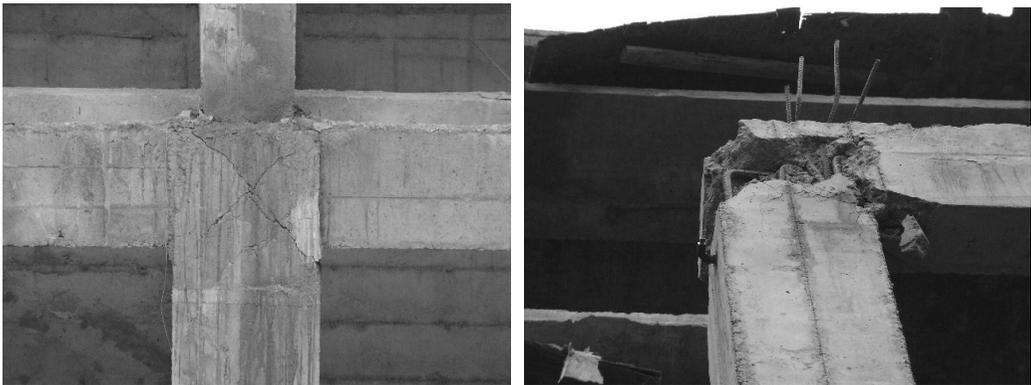
Photo 8. Failure in beam-column joint

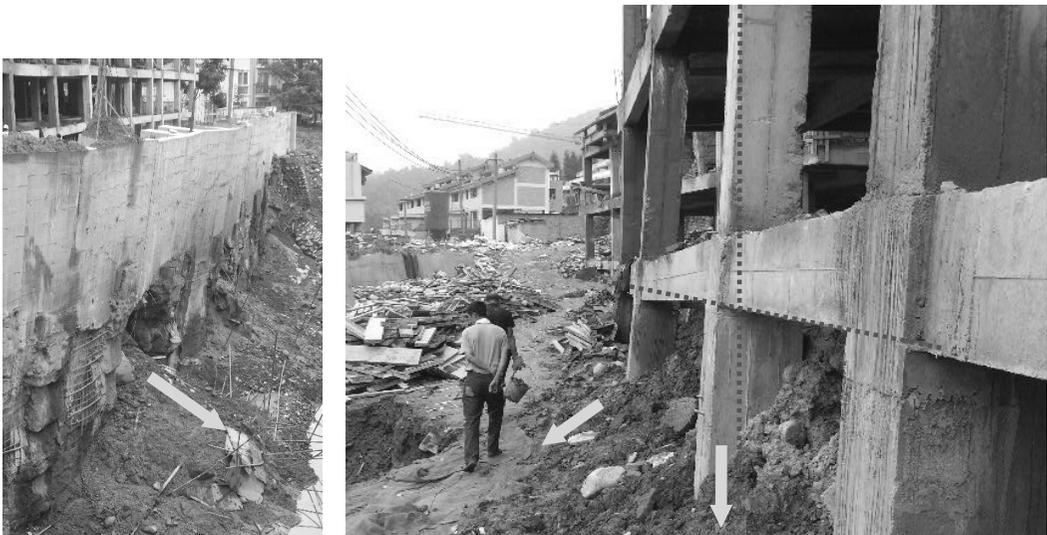
Photo 9. Structural damage due to failure in retaining wall

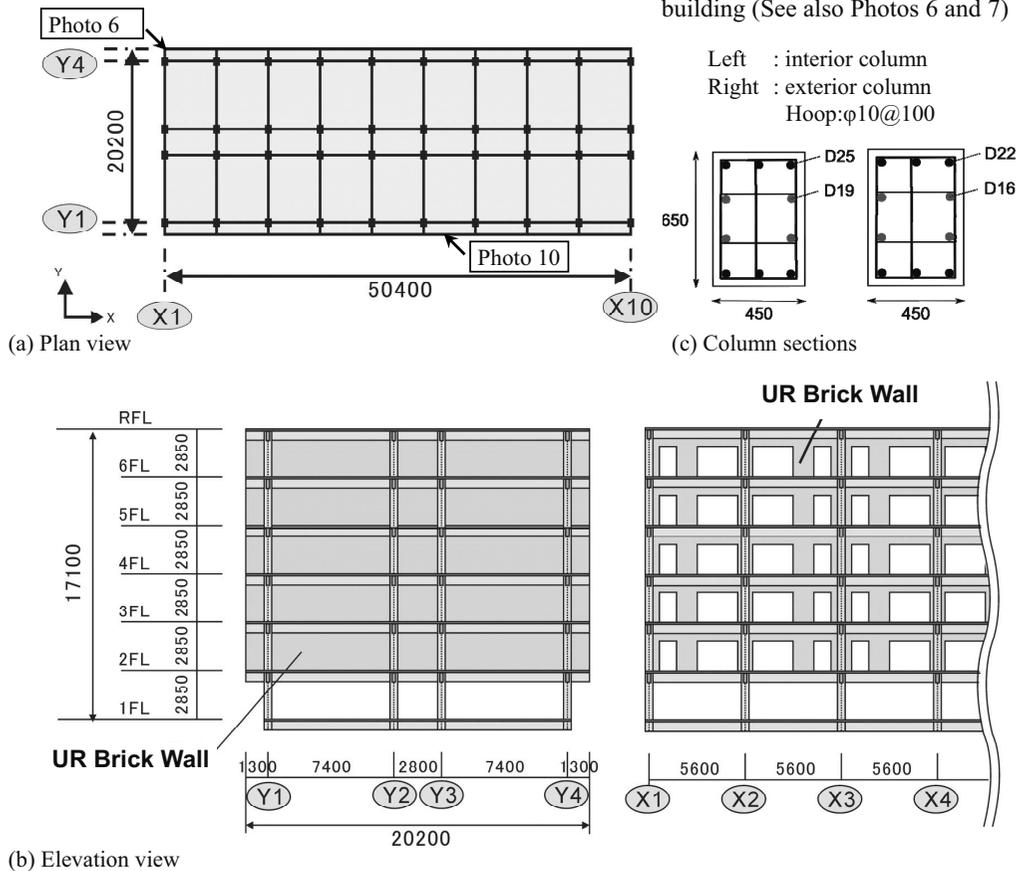
Figure 2. Structural configuration and column size of example RC building

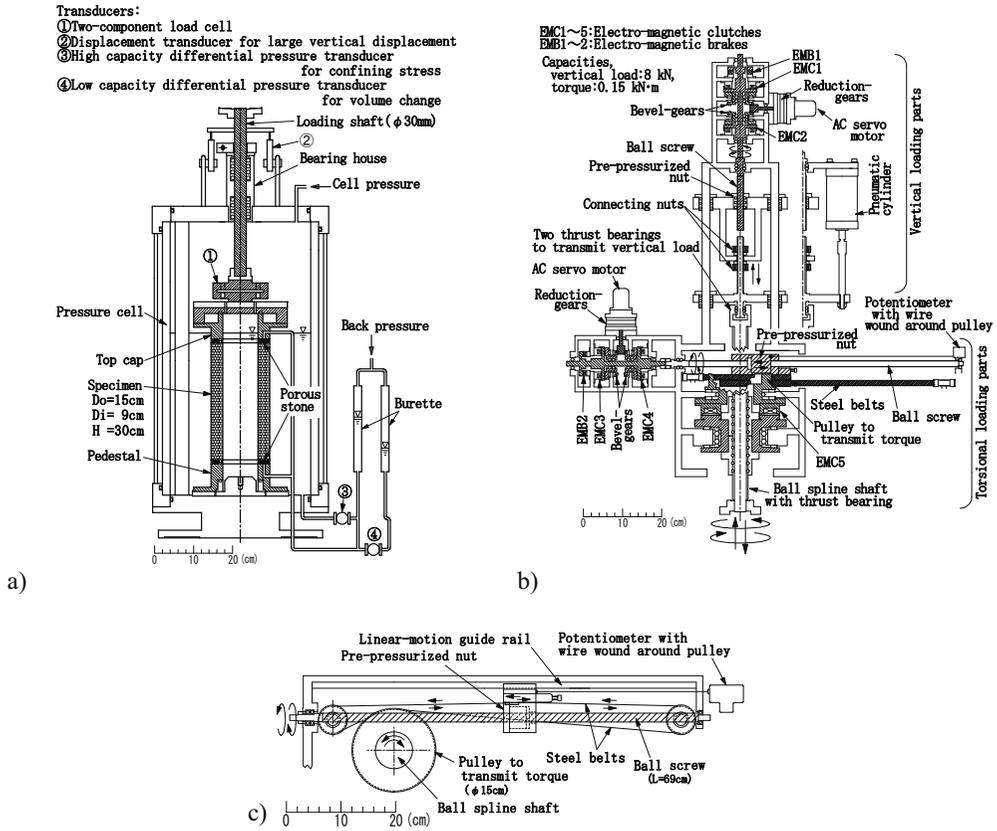
Figure 1 a) Torsional shear test apparatus on hollow cylindrical specimen; b) loading device and c) plan view of torque-transmission part.

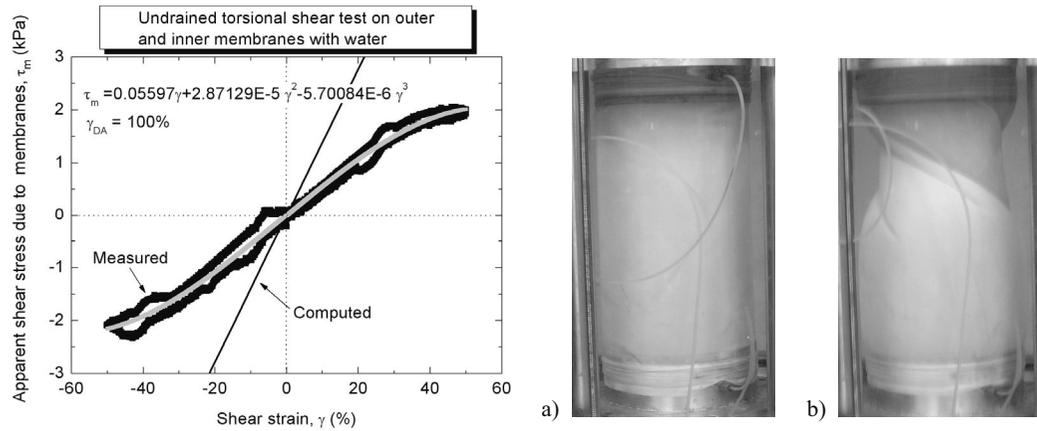
Figure 2 Relationships between apparent shear stress due to membrane force and shear strain

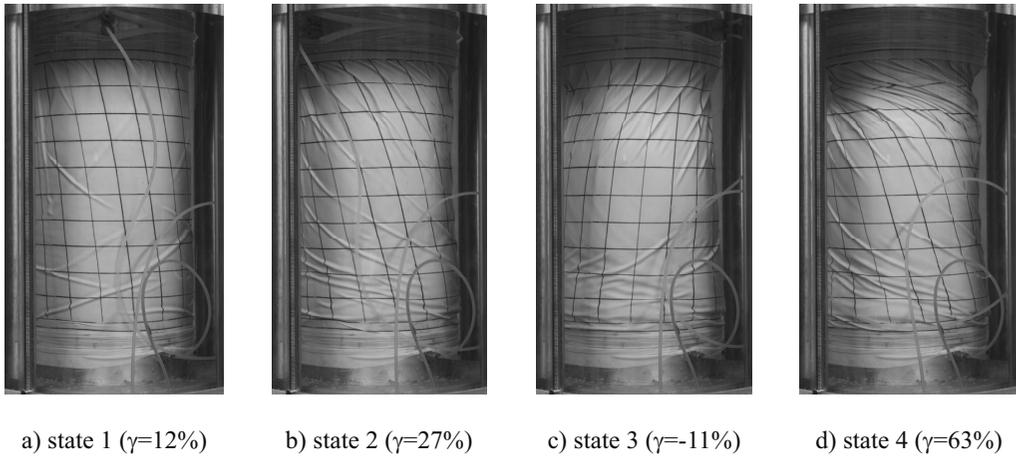
Photo 2 Specimen deformation at states 1 through 4 shown in Fig. 4

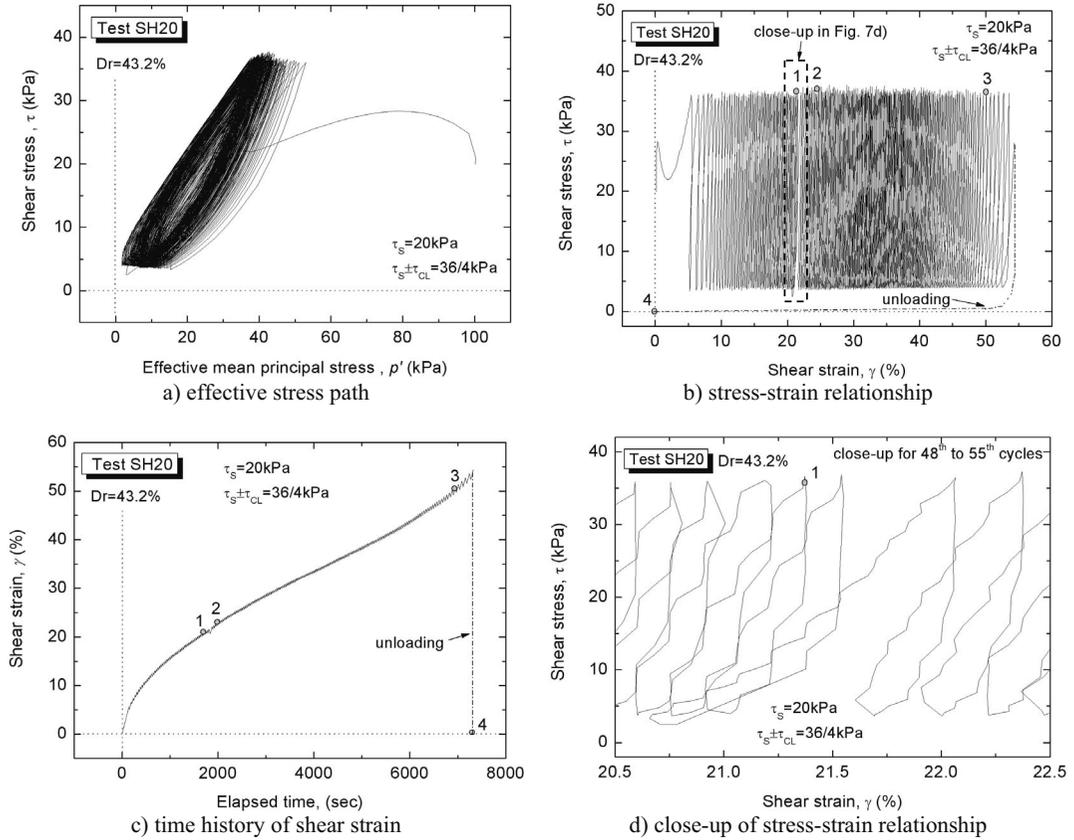
Figure 6 Typical test result on Toyoura sand applying static shear stress ($\tau_s = 20 \text{ kPa}$)

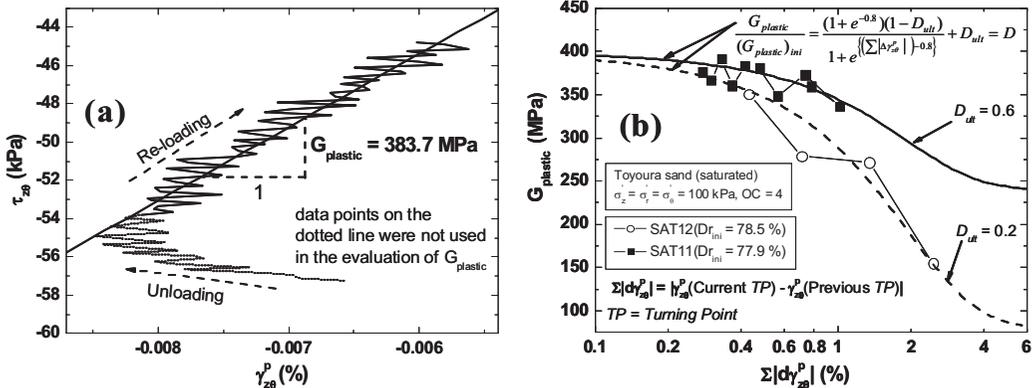
Figure 4. Damage to plastic shear modulus during large amplitude cyclic loading

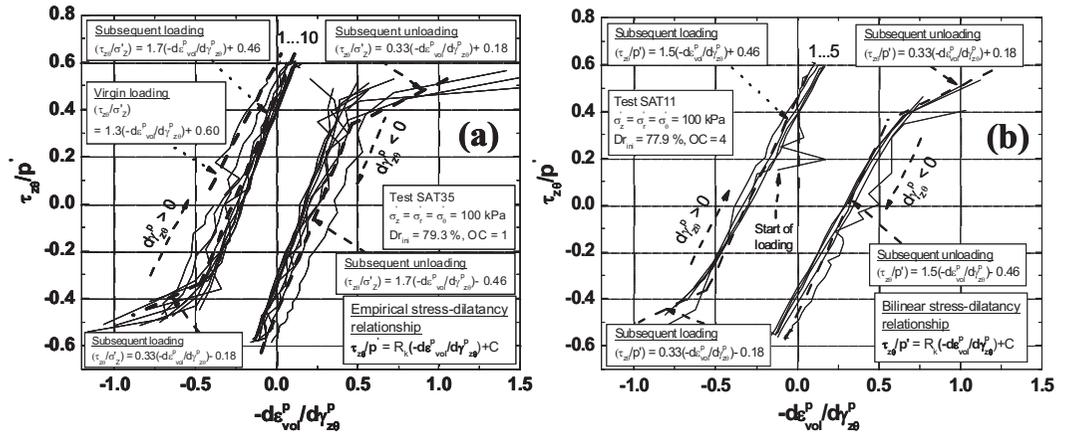
Figure 5. Bilinear stress-dilatancy relationship

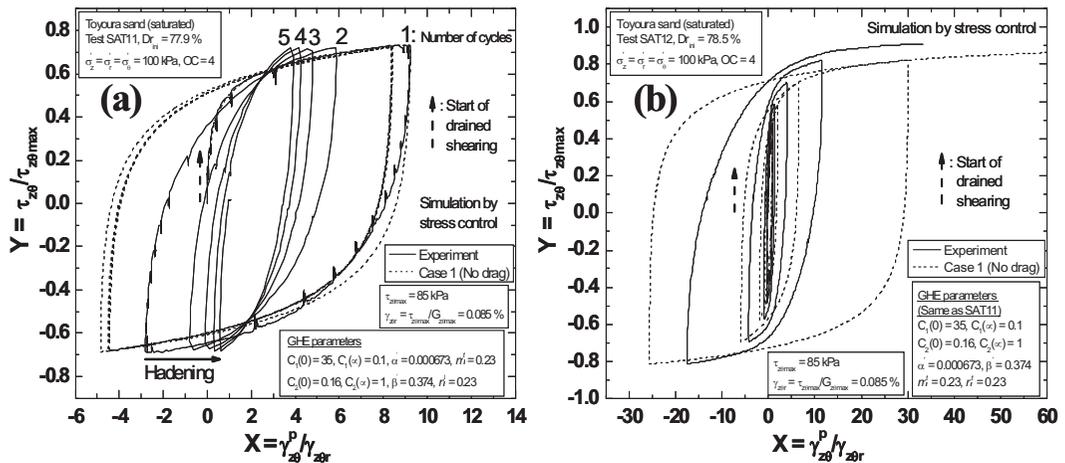
Figure 7. Simulation of stress-strain relationship using the original Masing's rule

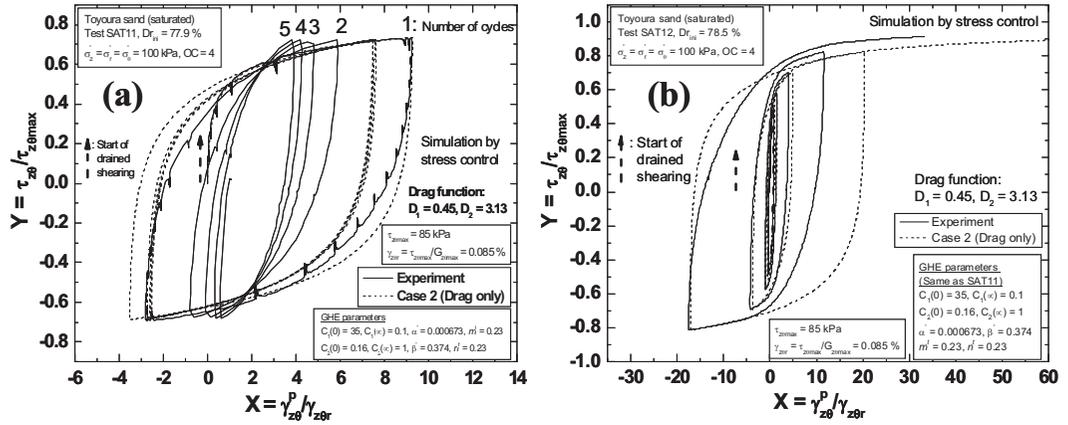
Figure 8. Simulation of stress-strain relationship using the Extended Masing's rule

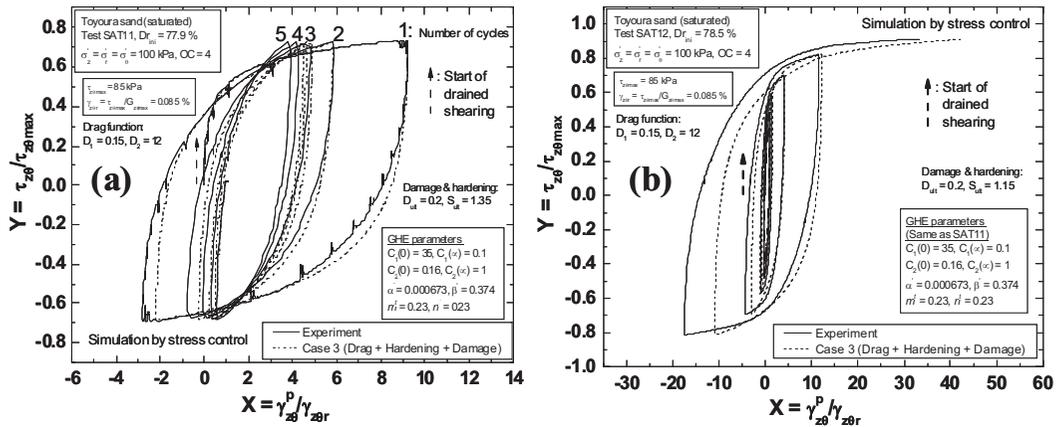
Figure 9. Simulation of stress-strain relationship with hardening and damage

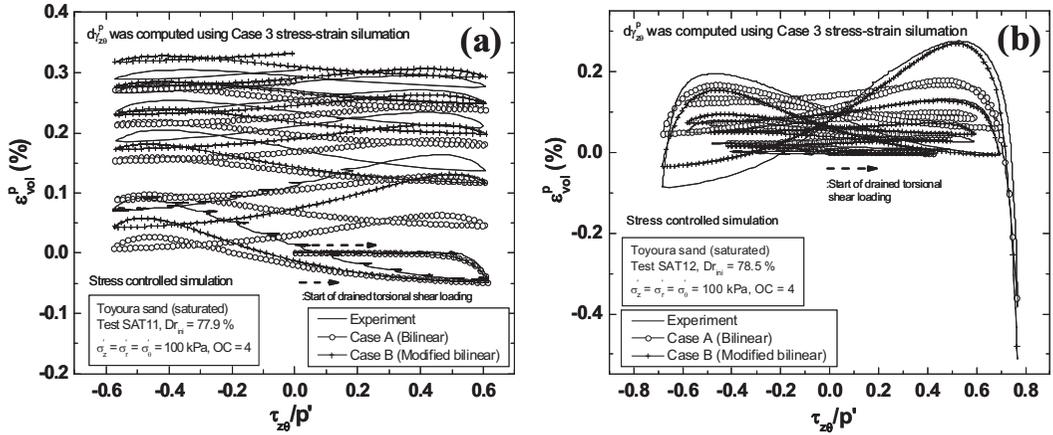
Figure 10. Simulation of volumetric strain

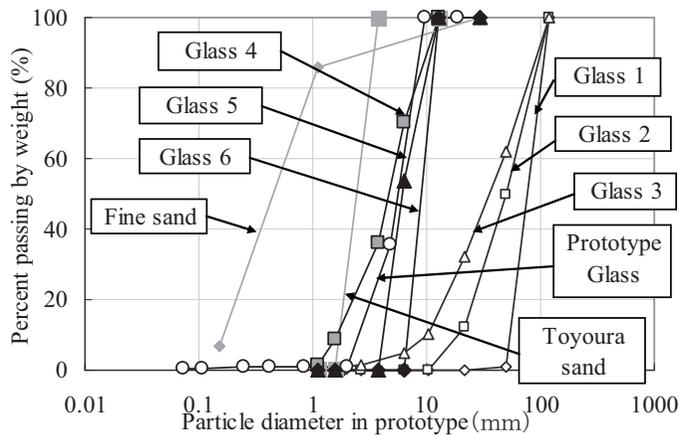
Figure 1. Particle size distributions

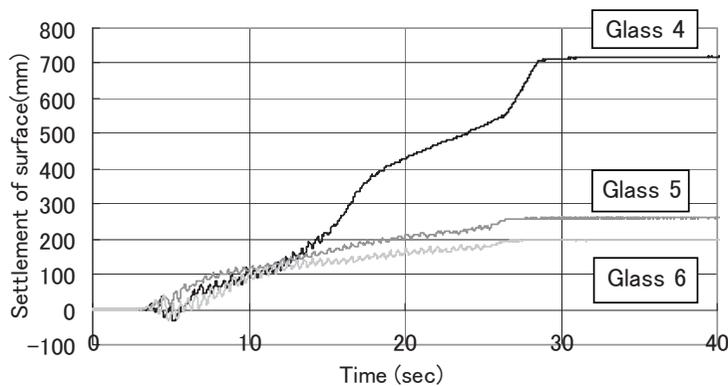
Figure 6. Time history of settlement at ground surface

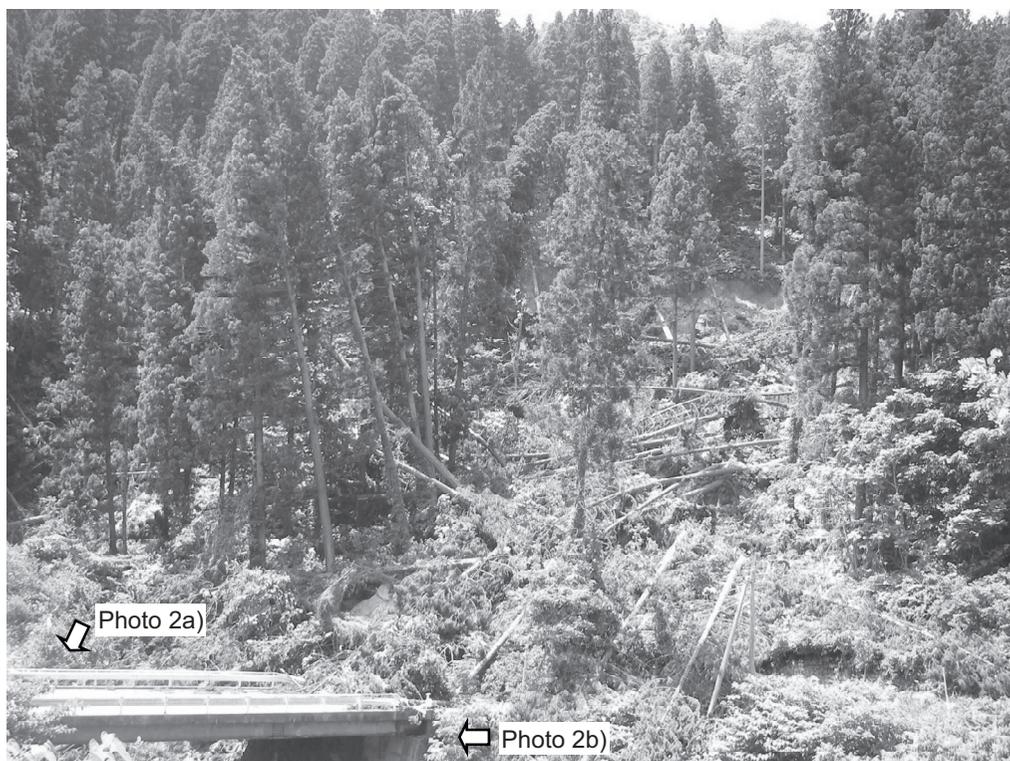
Photo 1. Slope failure at west side of Kurotaki bridge along prefectural road No. 51 (site A in Figure 2)

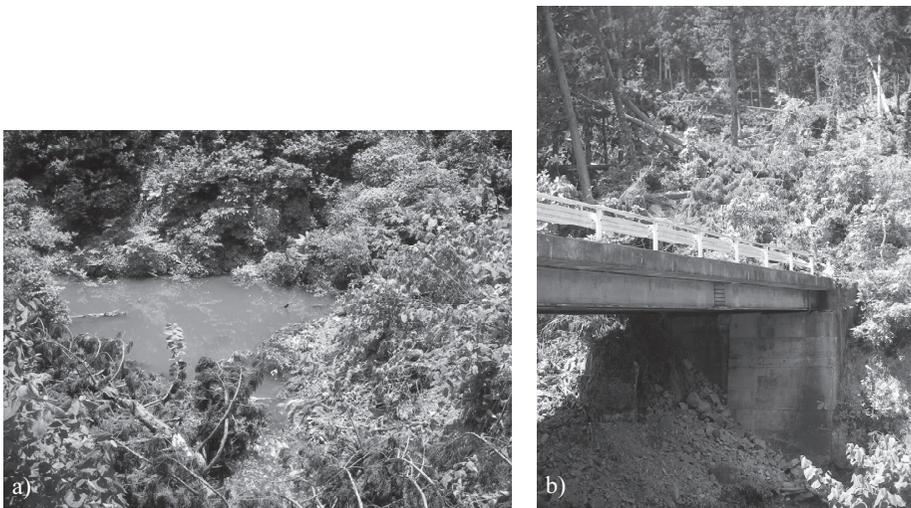
Photo 2. a) River course closure of Takamatsu river due to collapsed soil
b) Abutment of Kurotaki bridge on the side of slope failure

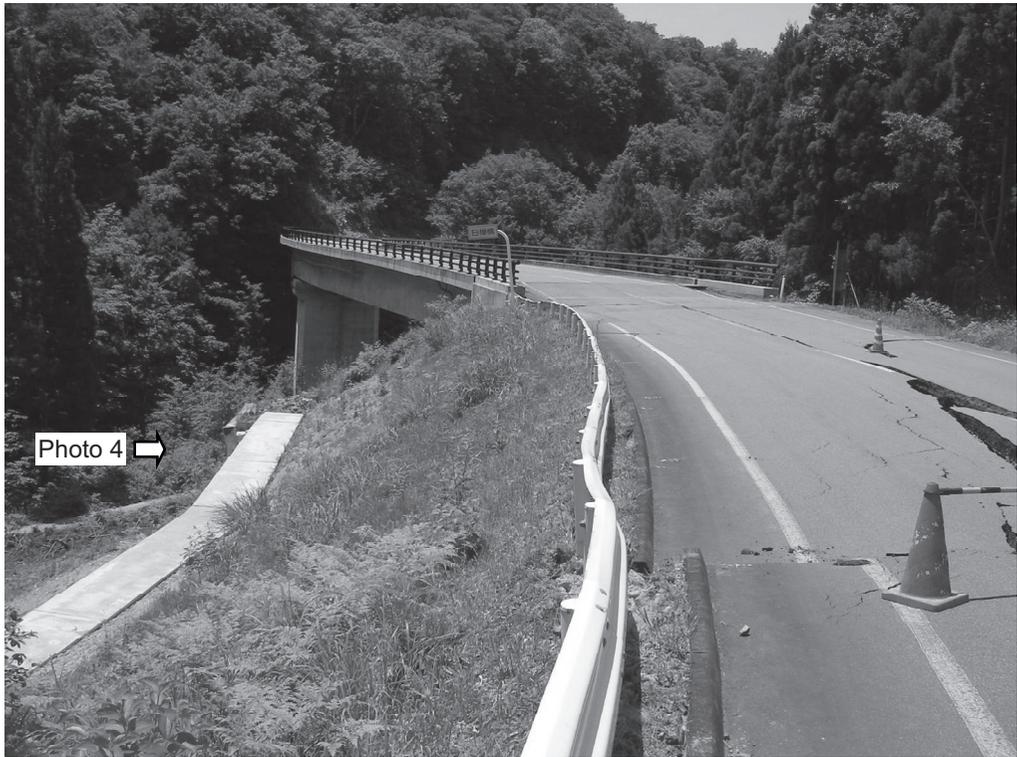
Photo 3. Settlement of approach embankment for Shirakaba bridge along national highway route No. 398 (site B in Figure 2)
