A QUANTITATIVE APPROACH TO ASSESS LANDFORM CHANGES OF HATTIAN BALLAH LANDSLIDE DAM FORMED BY 2005 KASHMIR EARTHQUAKE

SLOPE FAILURE INDUCED DEBRIS FLOW HAZARDS IN THE OCTOBER 8, 2005, KASHMIR EARTHQUAKE

GEOTECHNICAL ISSUES CAUSED BY THE MAY 12th 2008, WENCHUAN EARTHQUAKE, CHINA

PROVISIONAL REPORT OF THE DAMAGE CAUSED BY THE JUNE 14th 2008, IWATE-MIYAGI EARTHQUAKE

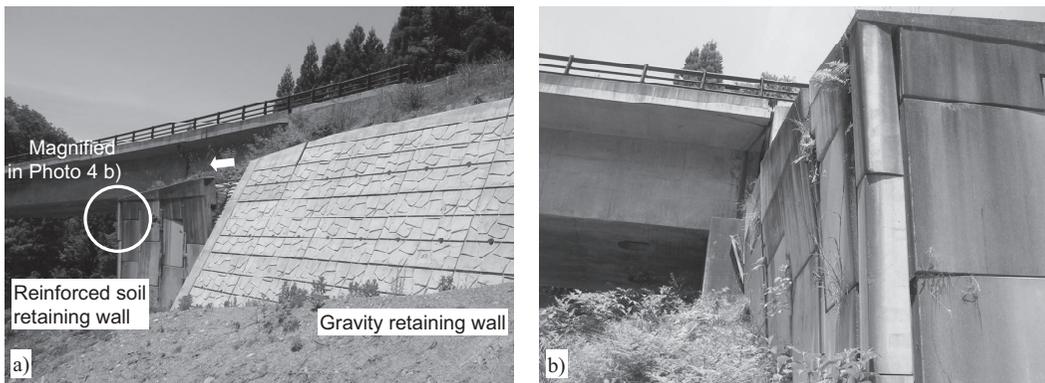
Photo 4. a) Retaining walls supporting approach embankment for Shirakaba bridge
 b) Damage to reinforced soil retaining wall in a)

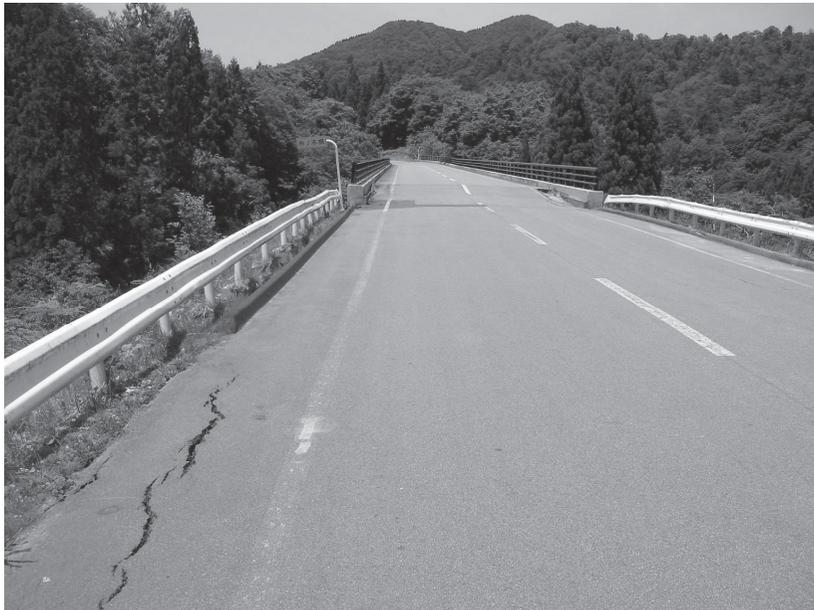
Photo 5. Settlement of approach embankment for Tochinoki bridge along national highway route No. 398 (site B in Figure 2)

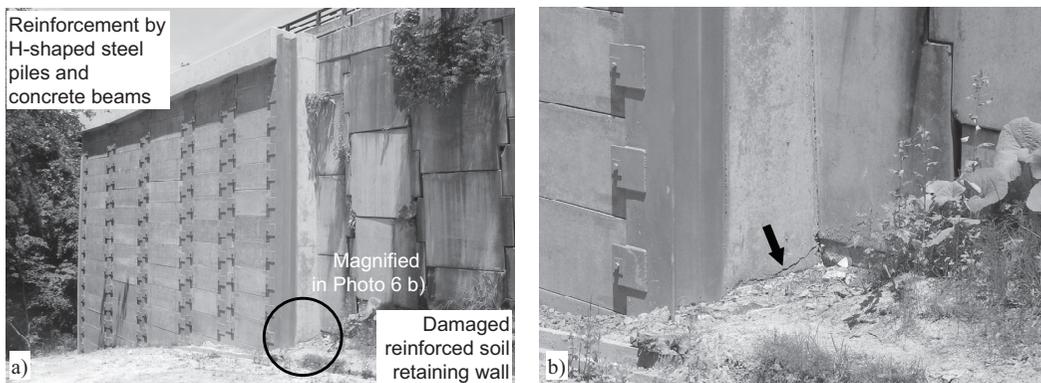
Photo 6. a) Reinforcement of approach embankment for Tochinoki bridge and adjacent reinforced soil retaining wall, b) Crack in reinforcement concrete beam of approach embankment

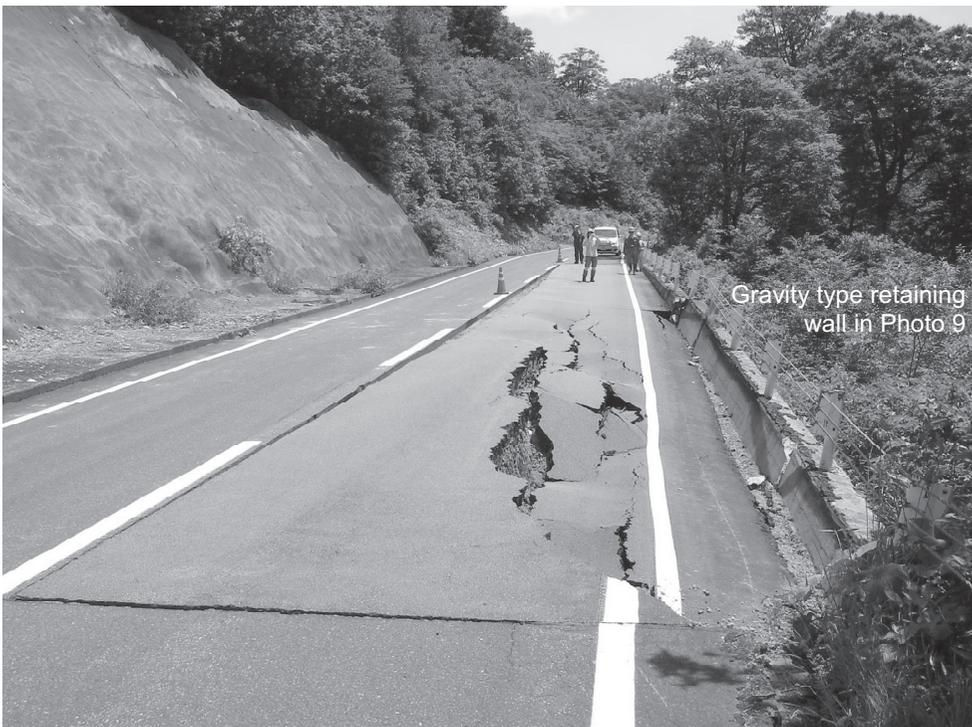
Photo 8. Collapse of embankment along national highway route No. 398 (site C in Figure 2)

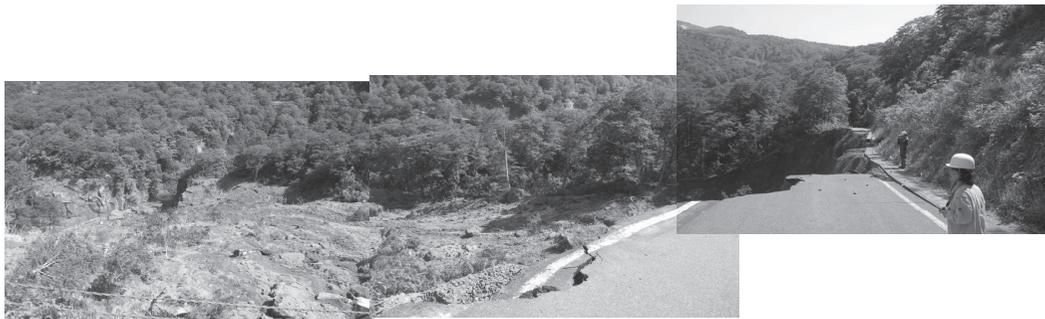
Photo 11. Large slope failure including embankment along National Highway route No. 342 (site D in Figure 2)

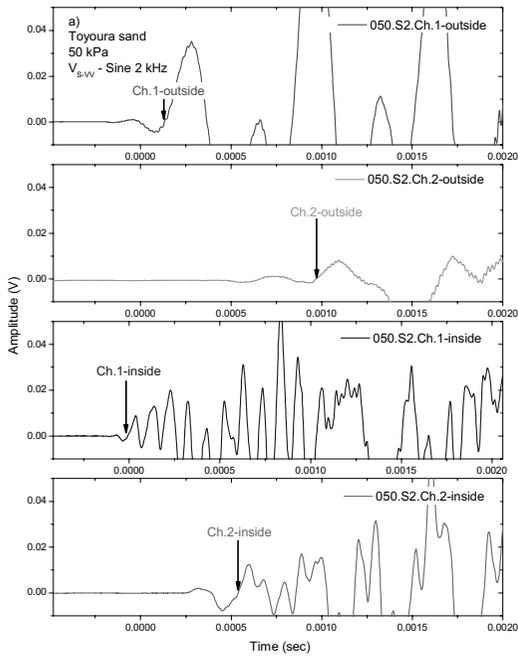
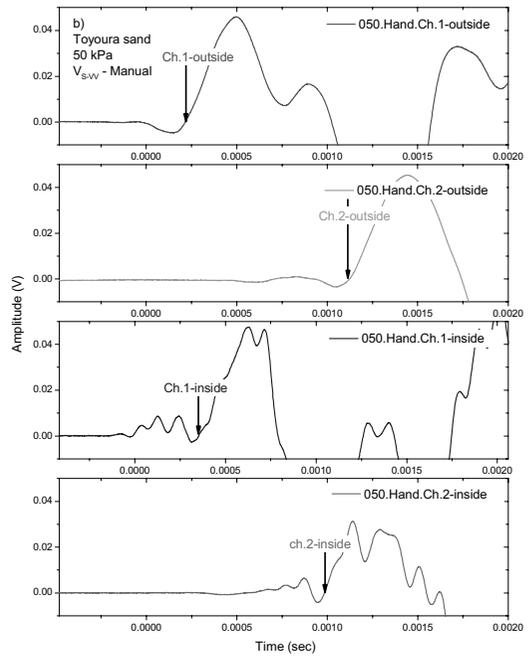
Figure 10. Time history of the input and the output V_s waves: a) Sine 2 kHz; b) hit by hammer

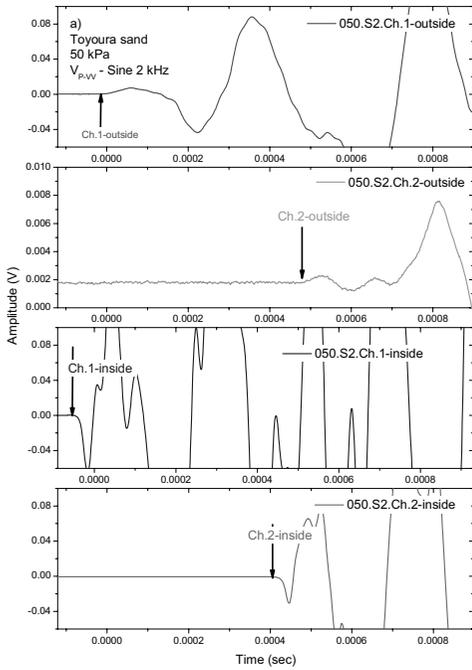
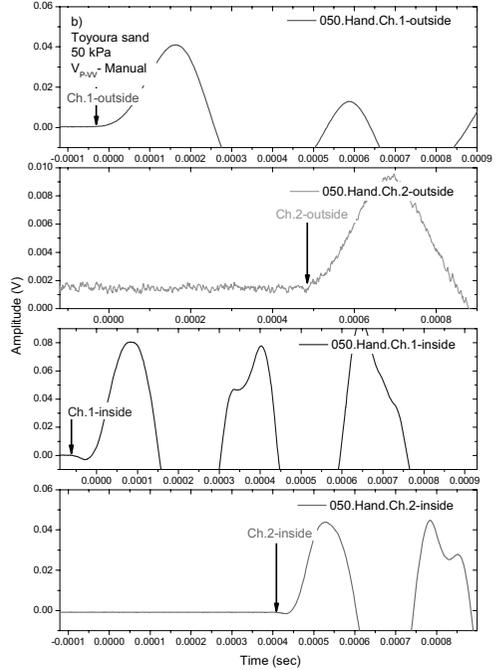
Figure 11. Time history of the input and the output V_p waves: a) Sine 2 kHz; b) hit by hammer

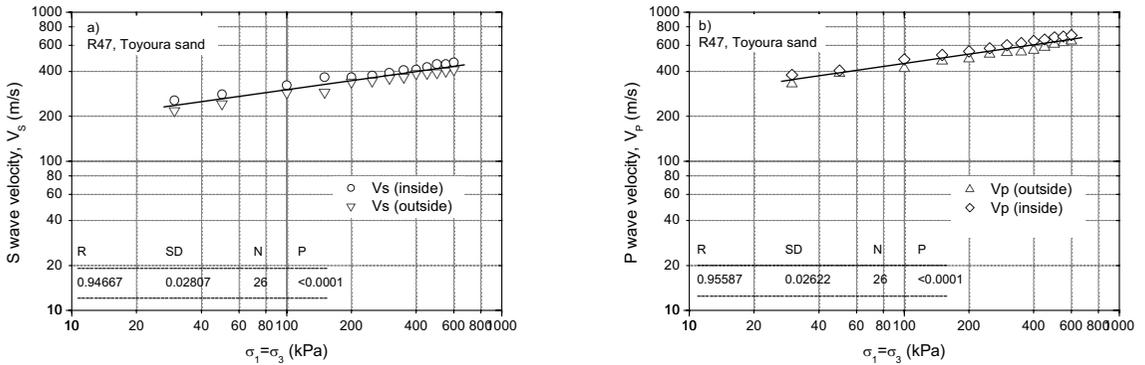
Figure 12. Wave velocity with accelerometers inside and outside the specimen: a) with TA-S wave; b) with TA-P wave

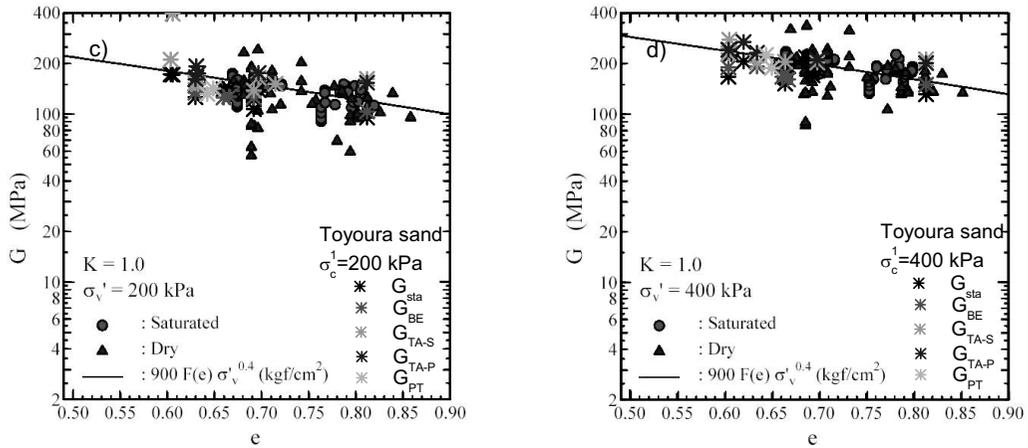
Figure 13 (continue). Comparison between results from this study and from round robin test organized by the TC-29, at the confining pressure (σ'_c) of: c) 200 kPa; d) 400 kPa

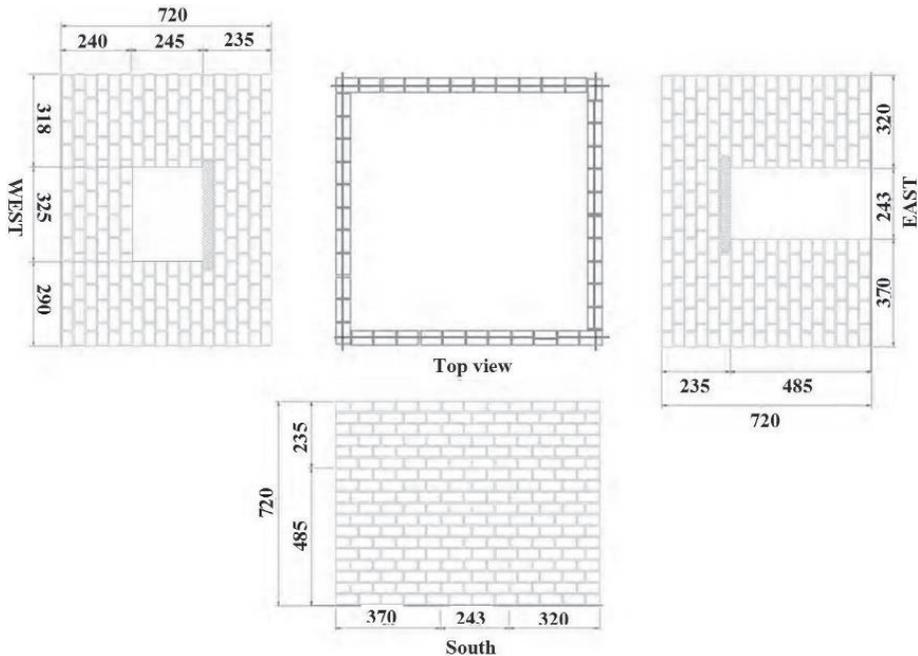
Figure 1. Model dimension (mm)

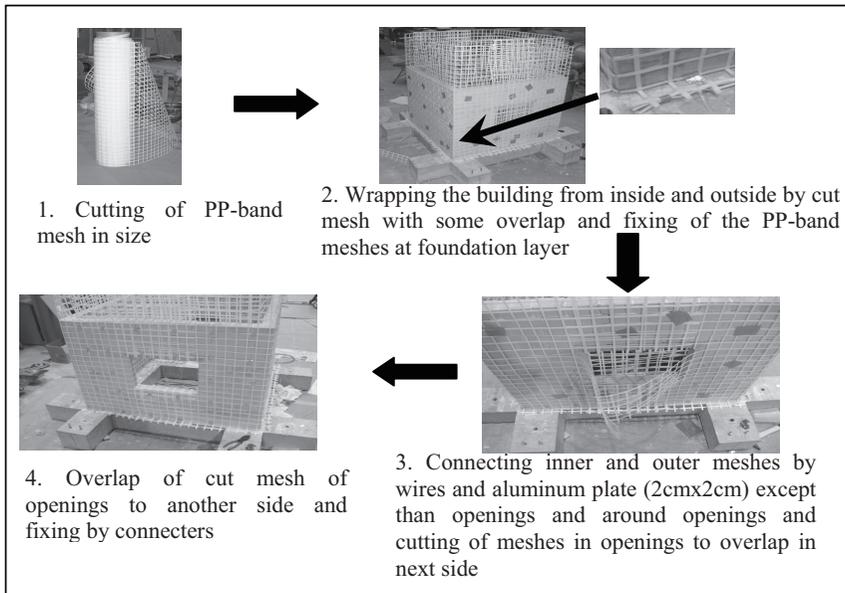
Figure 2. Retrofitting process by PP-band

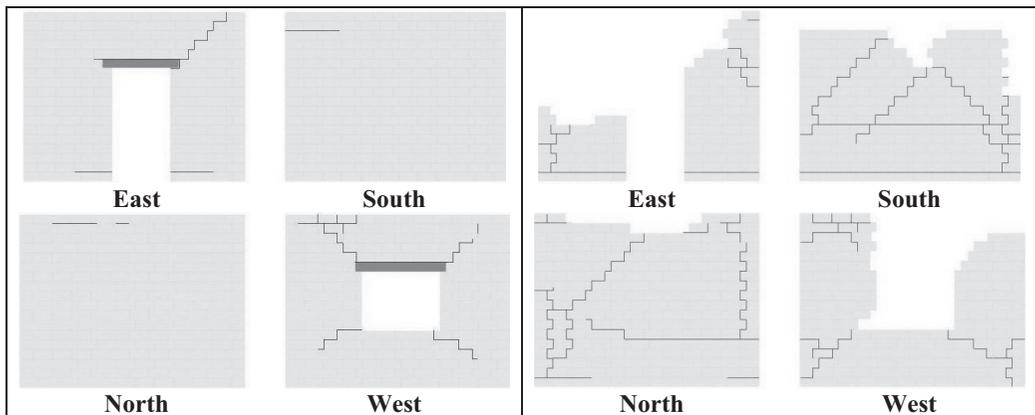
Figure 4. Crack pattern after Run 28 (left) and after run 45(right) for specimen A-4-NR-X

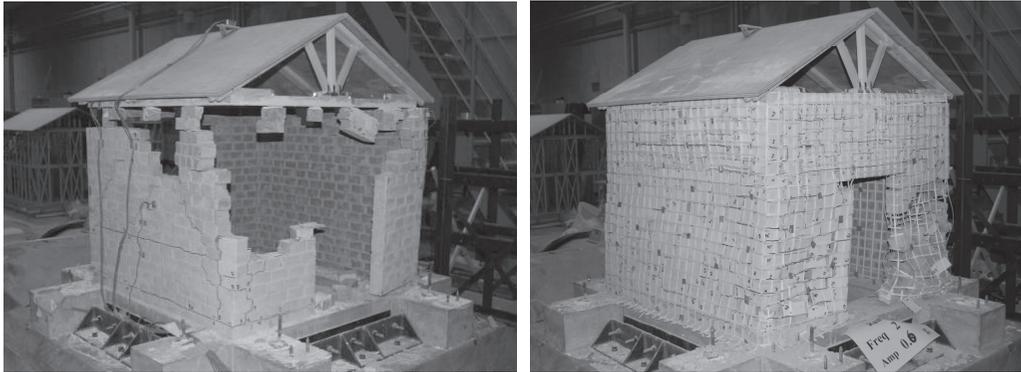
Figure 5. Specimen A-4-NR-X after run 45 (left) & Specimen A-4-RE-X after run 52 (right)

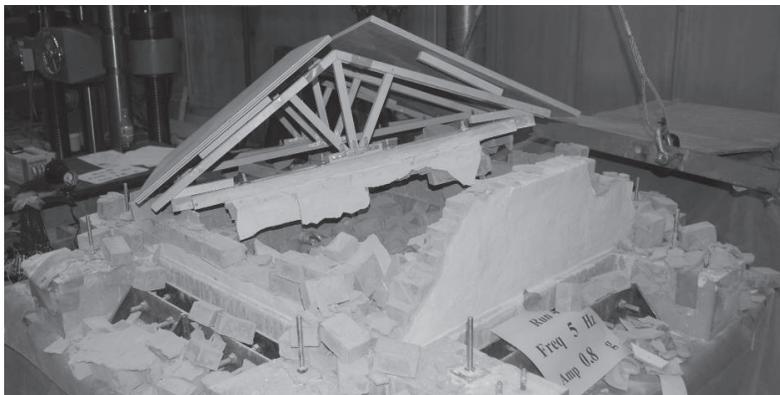
Figure 6. Specimen A-4-NR-P after run47

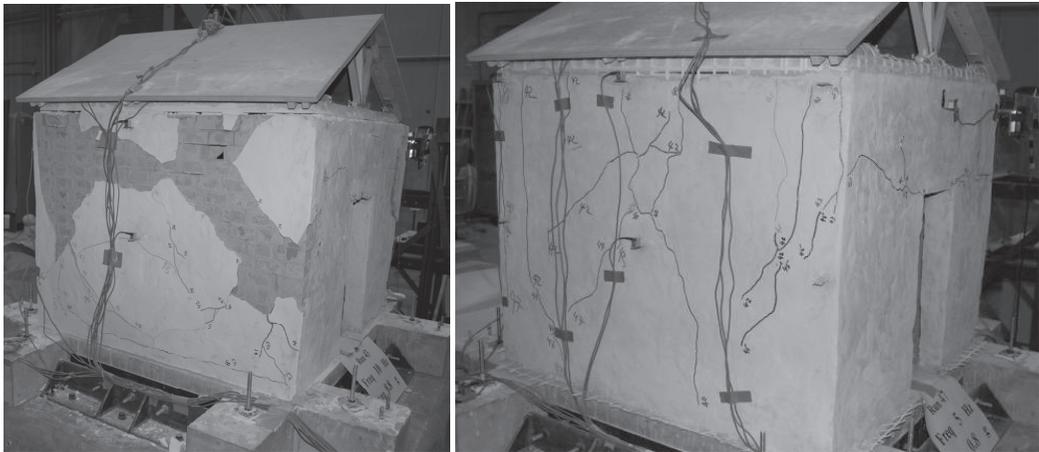
Figure 7. Specimen A-4-NR-P after run 43 (left) & Specimen A-4-RE-P after run 48 (right)

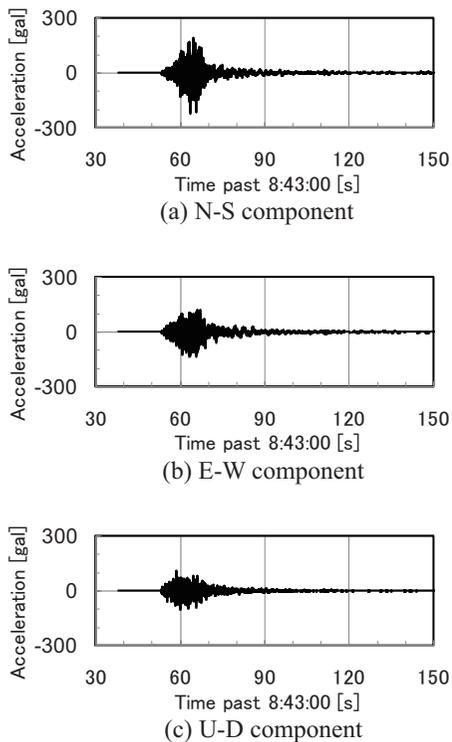
**Figure 4.** Acceleration of the Iwate-Miyagi Nairiku Earthquake recorded at Yokote city (39.3N, 140.6E)

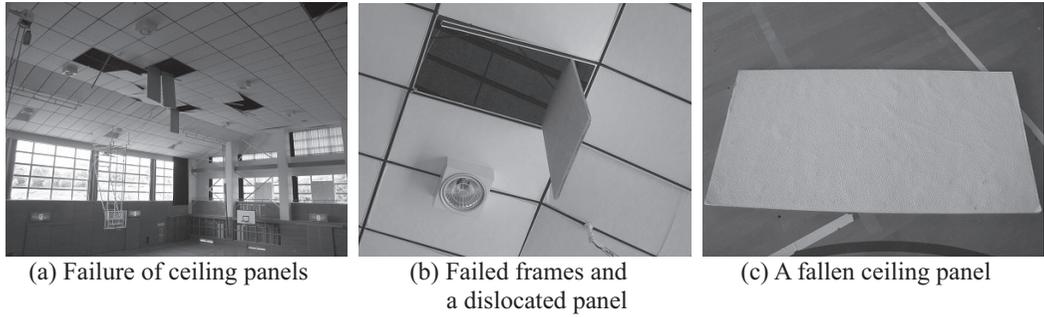
Figure 15. Damage to Gymnasium-4

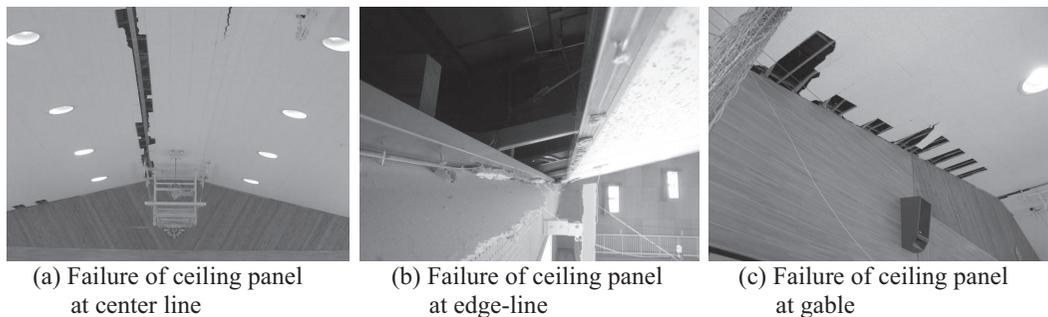
Figure 19. Damage to Gymnasium-5

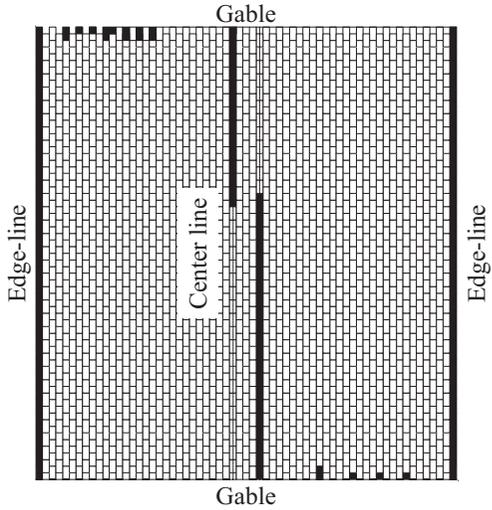
Figure 21. Plan view of failed ceiling panel of Gymnasium-5
