A QUANTITATIVE APPROACH TO ASSESS LANDFORM CHANGES OF HATTIAN BALLAH LANDSLIDE DAM FORMED BY 2005 KASHMIR EARTHQUAKE

Ahsan SATTAR¹, Kazuo KONAGAI², Takaaki IKEDA³, Takashi KIYOTA⁴,
Zaheer Abbas KAZMI¹, Masahiro KOIKE⁵

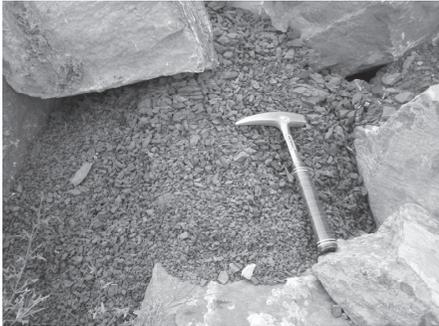
Fig. 6a

Fig. 6(a) Shale of Murree formation crumbled apart due to slaking process. The resulting material is relatively impermeable which is also filling the pours between bigger boulders on the surface. (b) Boulders of Murree formation weathered to form soil dunes around the middle portion of landslide mass. (c) Washout process of weathered material. Dried up path of water during monsoon season show clear reddish sediments deposited on grey sand stones.

Rocks from Murree formation are going through the slaking process over the landmass body. The clayey and silty reddish material is crumbled apart due to moisture contact (Fig. 6a). Resulting soil is relatively impermeable and in fact consolidating the land mass. Boulders of Murree formation are disintegrated to form soil dunes around the middle portion of mass body (Fig. 6b).

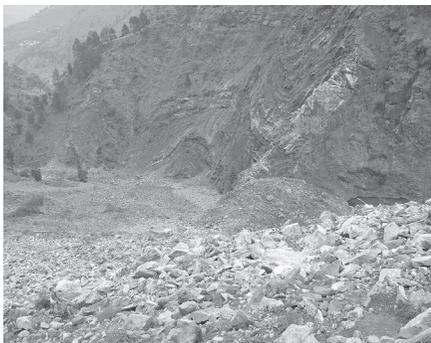
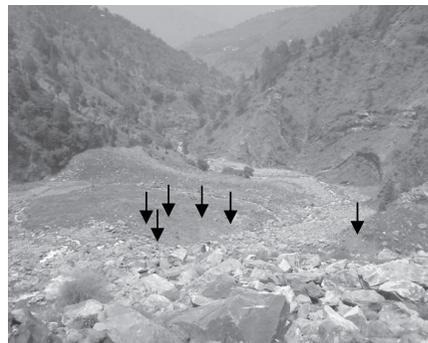
Fig. 13 Toe part of landslide dam. Gradual erosion at parts indicated by arrows.

Deformations vectors and settlements of GPS points are composed of three main factors. Mass movement of dam body, the slaking process and subsequent washing and consolidation processes are components of resulting deformations. Last two factors are prominent near the toe part where the mass movement is less prominent because of lesser thickness of debris mass. Fig. 13 shows changes in the toe part from November 2006 till June 2008.
