GEOTECHNICAL ISSUES CAUSED BY THE MAY 12th 2008, WENCHUAN EARTHQUAKE, CHINA

Key Words: Wenchuan Earthquake, geotechnical issues, rehabilitations

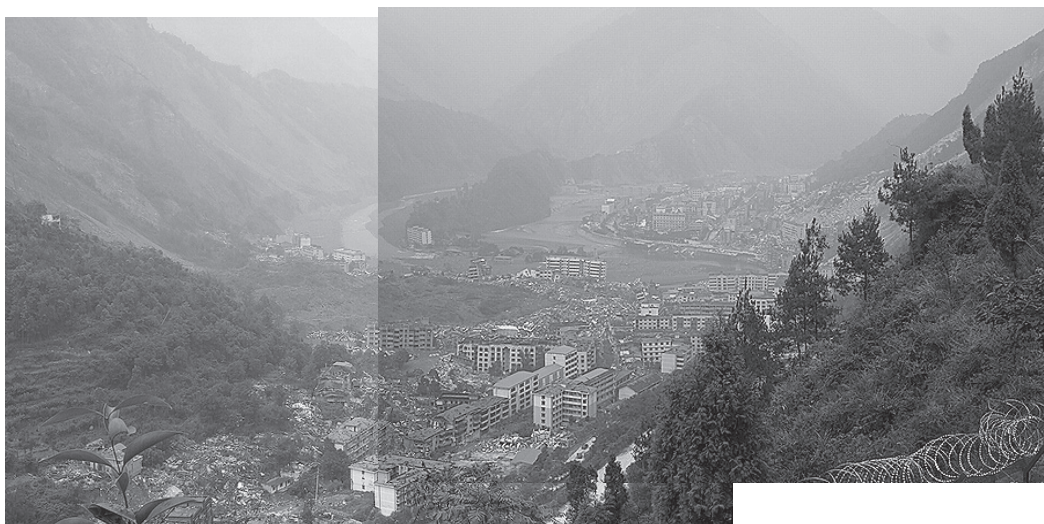
Photo 1. Downtown of Beichuan County. Two major built-up areas were completely destroyed by two major slope failures.

- (1) The shake must have been intense enough to destroy many houses and buildings to be sure, but two major slope failures on both sides of the city have certainly caused fatal and wide-spread damage to built-up downtown areas of the city.

- (2) The western slip surface is about 300 m high, and dips about 35 degrees east-northeast. The landslide mass from this west slope was about 400 m wide and surged about 430m of downtown area. The landslide reached its maximum thickness near its distal end because of being slowed down as it traveled further onto the built-up area. The total volume of the soil mass was estimated to be about 5,200,000 m³ presuming its average thickness as 30 m.

- (3) The eastern slip surface was about 300 m high, and dips about 40 degrees northwest. The landslide mass was about 400m long, 400 m wide and 20m thick. The volume of the landslide mass was presumably 3,200,000 m³. The landslide mass included much larger rocks than those in the mass from the west slope.

- (4) There are some dolomite rocks exposed along the eastern mountain slopes. Solubility of dolomite allows water to seep easily through its cracks and water enlarges the cracks in such a way that cavity systems are formed in its interior. Dolomite rocks are often weak enough and eventually break into pieces.

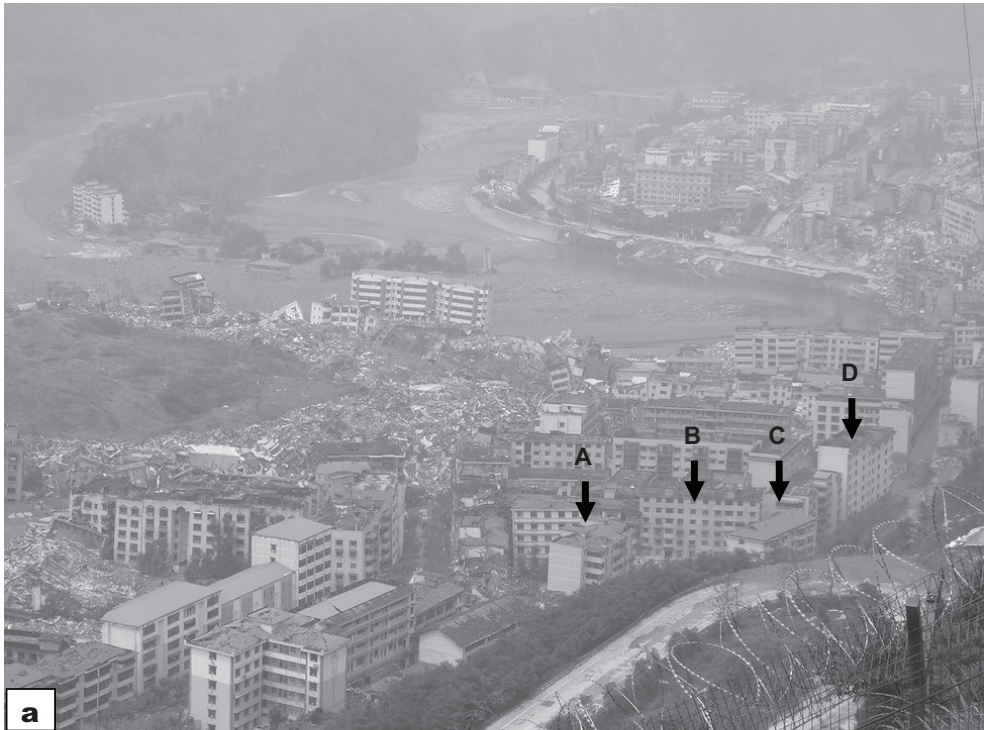
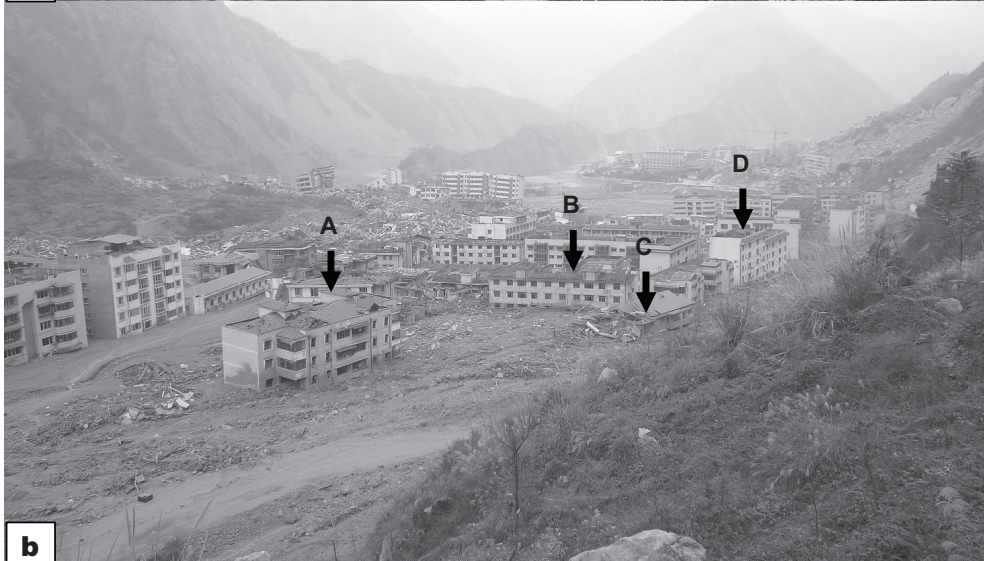
Photos 2a and 2b. South built-up area of Beichuan County. Photo 2a was taken on July 27th, 2008 while Photo 2b shows the same area in December, 2008, buried beneath thick debris mass. (Photo 2b by Maki, N., DPRI, Kyoto University)

At later date, on September 24th, it was reported that two-day heavy rain at Beichuan county triggered debris flow and larger parts of the southern half of the city was buried. As a consequence, the plan to preserve quake-devastated Beichuan as an earthquake museum was put on hold. Photo 2b (by Maki, N.) shows the debris mass remaining in the southern part of the city. Comparing Photos 2a and 2b, the

debris mass which have been carried over the three months (September, 2008 to December, 2008) is estimated to be about 10 to 12 m thick at this location.

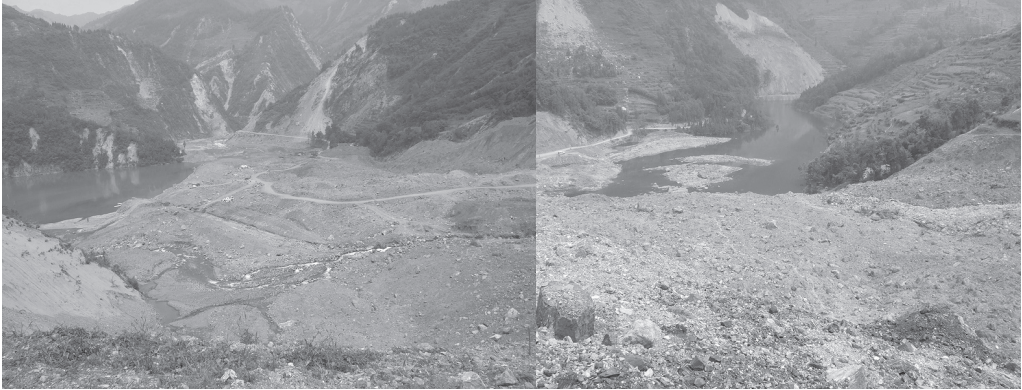
Photo 4. Debris mass flowed down to TongHeKuo village: The debris mass is stopping waters of the major flow of TongHeKuo river (left) and its tributary (right). (Photo taken on July 28, 2008, at 32°23'55.1"N, 105°07'13.3"E: Location estimated from Google earth: See Fig. 3)

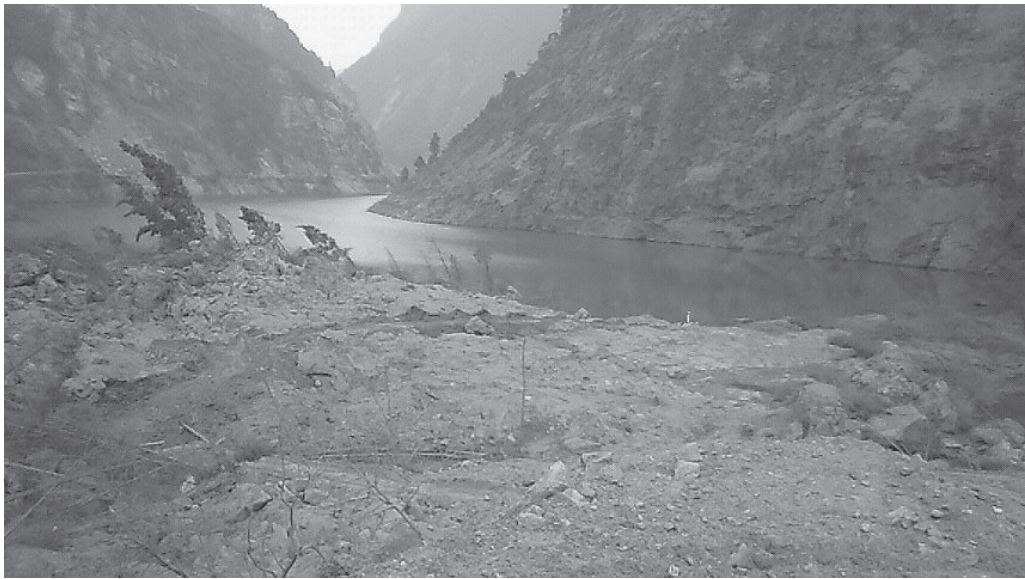
Photo 5. Landslide mass at “ShiBan-Gou” (Slate-Valley in English): (Photo taken on July 28, 2008, at 32° 25'55.5"N, 105° 06'32.2"E: Location estimated from Google earth: See Fig. 3)
