# DYNAMIC BEHAVIOR OF TIMBER ROOF MASONRY HOUSE MODELS RETROFITTED BY PP-BAND MESHES

**ABSTRACT:** Unreinforced masonry is one of the most popular construction materials in the world. It is also unfortunately, the most vulnerable against earthquakes. Damage to unreinforced masonry buildings has caused huge number of human casualties historically and during recent earthquakes in developing countries. Therefore, retrofitting of low earthquake-resistant masonry structures is the key issue for earthquake disaster mitigation in developing countries to reduce the casualties significantly. When we propose the retrofitting in developing countries, retrofitting method should respond to the structural demand on strength and/or deformability as well as to availability of material with low cost including manufacturing and delivery, practicability of construction method and durability in each region. Considering these issues of developing appropriate seismic retrofitting techniques for masonry buildings to reduce the possible number of casualties due to future earthquakes in developing countries, a technically feasible and economically affordable PP-band (polypropylene bands) retrofitting tech

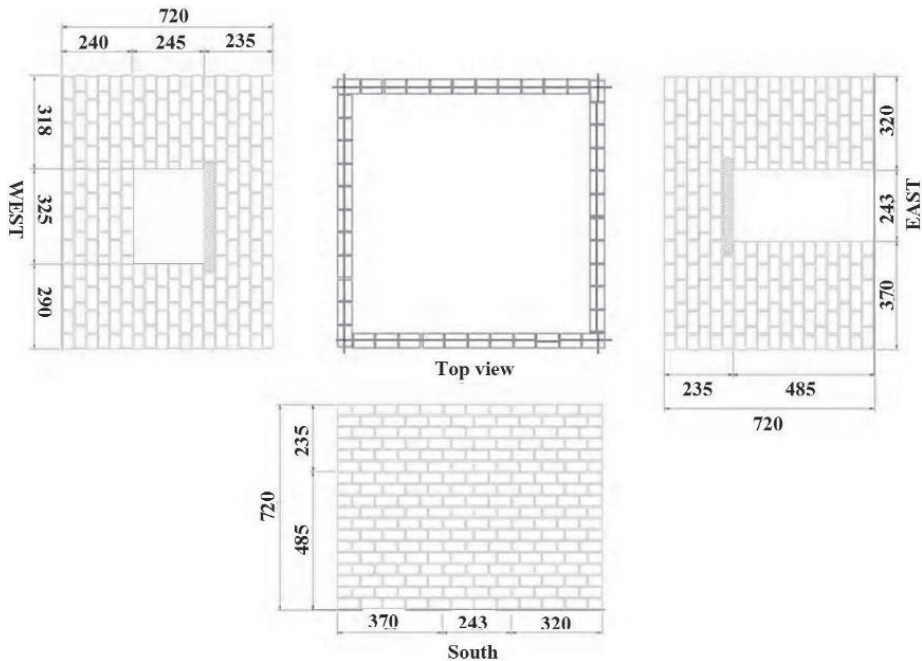
All the building models dimensions were 933mmx933mmx720mm with 50mm thick walls. The sizes of door and window in opposite walls were 243x485mm<sup>2</sup> and 325x245mm<sup>2</sup> respectively.

**Figure 1.** Model dimension (mm)

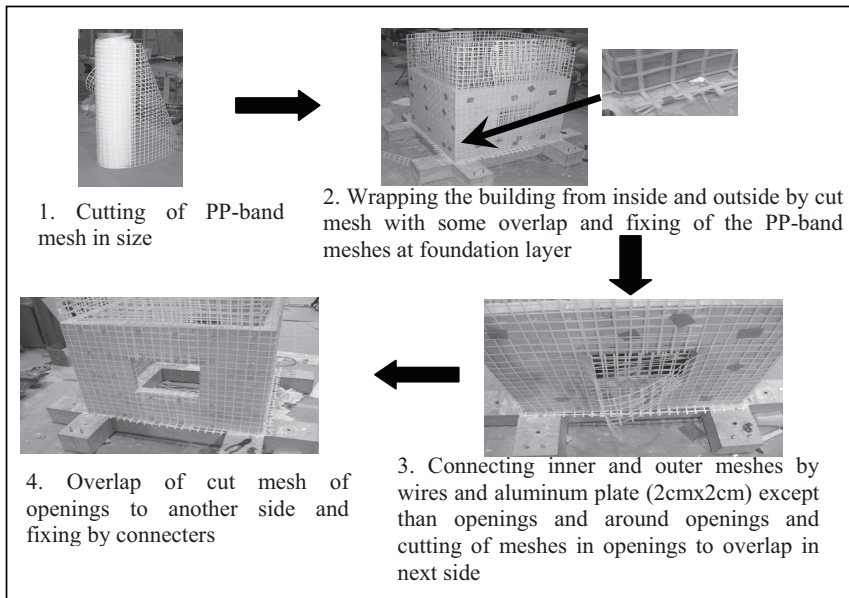
- PP-band mesh was cut in convenient size according to the dimension of the house.
- Straw, which placed in holes are removed (in this experiment, during construction of model house, we placed the straw in where we required a holes. Straw are placed at approximately 200mm pitch. In real case holes can be prepared by drilling through the wall) and the model house walls are cleaned.

- The meshes are installed on both sides of the wall and wrapped around the corner wall edges. An overlapping length of approximately 300mm is recommendable.

- Wire is passed through the holes and used to connect the meshes on the both wall sides. In order to prevent the wires cutting the PP-bands, aluminum plates (20mm×20mm) were placed between the band and the wire. Initially, fixing the meshes with connectors along the wall and at the foundation is recommendable.

- Connecting inner and outer meshes by wires and aluminum plates except around the openings.
- Fixed connectors around the openings after the mesh was cut and overlapped on the other side.

**Figure 2.** Retrofitting process by PP-band

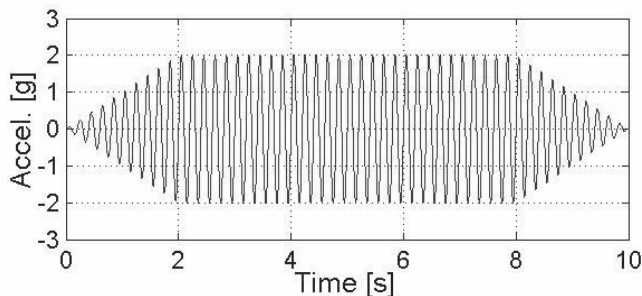
Simple easy-to-use sinusoidal motions of frequencies ranging from 2Hz to 35 Hz and amplitudes ranging from 0.05g to 1.4g were applied to obtain the dynamic response of both retrofitted and non-retrofitted structures. This simple input motion was applied because of its adequacy for later use in the numerical modeling. Figure 3 shows the typical shape of the applied sinusoidal wave.

**Figure 3.** Typical Shape of Input Sinusoidal Motion

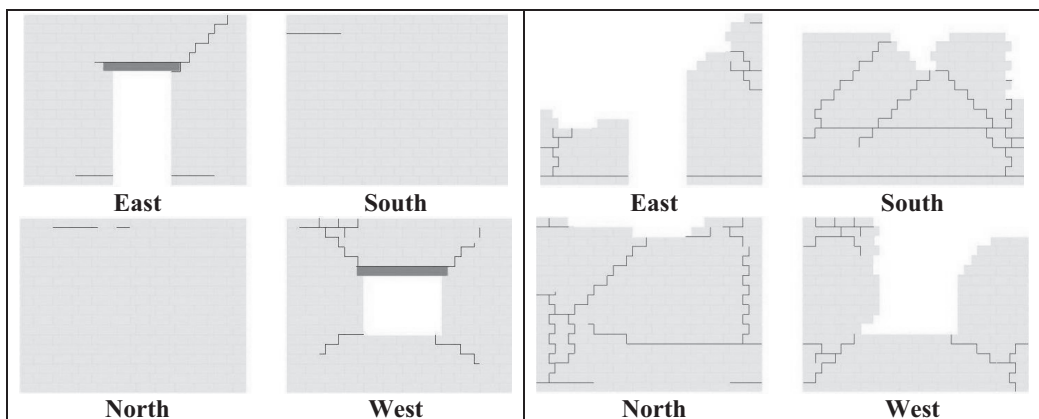
In both specimens, due to shrinkage, some minor cracks were observed before the test. These cracks mainly appear closer to opening in horizontal direction. For non-retrofitted specimen (A-4-NR-X) up to Run 21, no major crack was observed. Major cracks were observed closer to openings from Run 23. At run 28, crack was observed at one of the top corner of the door opening and it propagates up to top layer of the wall. After that, cracks widened with each successive run. At run 44, there were large amount cracks observed in walls in the direction of shaking. Exciting cracks widened and connection between adjacent walls was become weak. In case of walls perpendicular to shaking direction, top part of the east wall (part, above the door opening) was totally separated from the specimen. It was removed from specimen before next test run proceed. At run 45, all top part of the wall with opening was totally separated from the specimen. It was fallen from specimen. Now the roof only supported by two walls, which were in the direction of shaking. Therefore, due to walls subjected to out-of-plane load; they were bursts outwards in shaking direction. This finally led to the structure collapse.

**Figure 4.** Crack pattern after Run 28 (left) and after run 45(right) for specimen A-4-NR-X

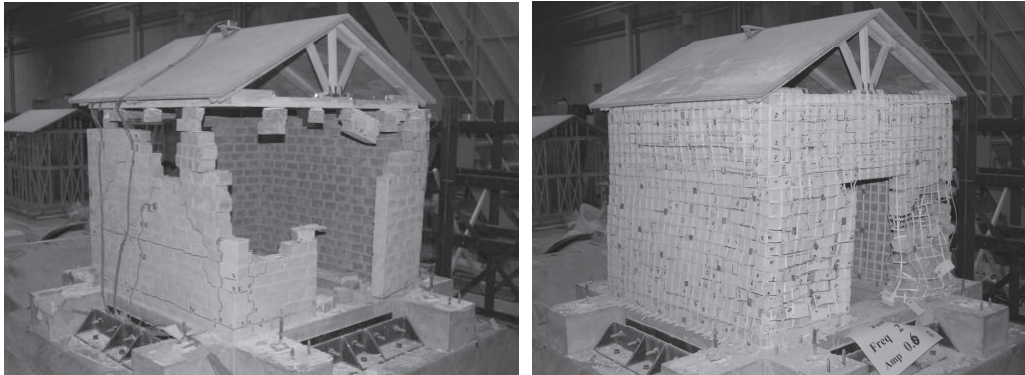
For retrofitted specimen (A-4-RE-X) up to run 21, no major crack was observed in this model. Major cracks were observed closer to openings from Run 25. After those new cracks appear in each run and cracks widened with each successive run, thus, extensive cracking was observed. Although the PP-band mesh kept the structure integral during the shaking, it allowed the sliding of the bricks along these cracks to some extent. In later stages, there was significant permanent deformation of the structure. At the final stage of the test, run 52, with 37.3mm base displacement, 6 times more than the input displacement applied in run 45 and 2.5 times more velocity, virtually all the brick joints were cracked and the building had substantial permanent deformations. However, building did not lose the overall integrity as well as stability and collapse was prevented in such a high intensity of shaking.

**Figure 5.** Specimen A-4-NR-X after run 45 (left) & Specimen A-4-RE-X after run 52 (right)

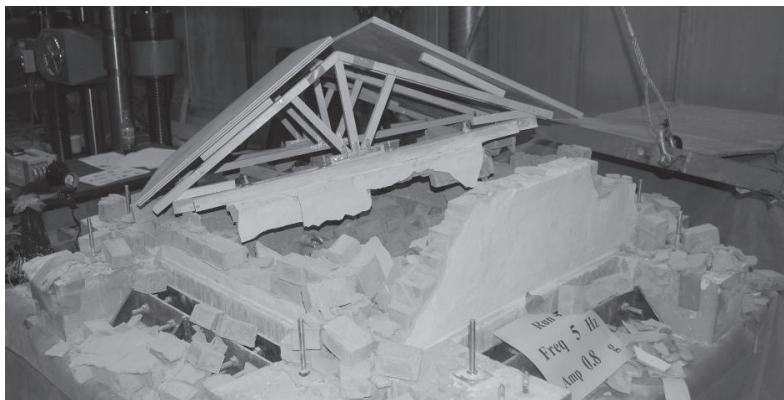
For specimen A-4-NR-P, at run 26, major cracks were observed close to connection between roof and south wall. At run 43, lot of damage observed in the modal. Separation between east wall and its adjacent walls was observed. Also lot of surface finishing separated from the walls. At run 44, Top corner of the east wall and its adjacent walls was totally separated from specimen. At run 45, all the top part of the north and south walls was totally separated form specimen. Now roof only supported by two walls, which are in the perpendicular direction of shaking. This finally led to the structure collapse at run 47 (Figure 6).

**Figure 6.** Specimen A-4-NR-P after run47

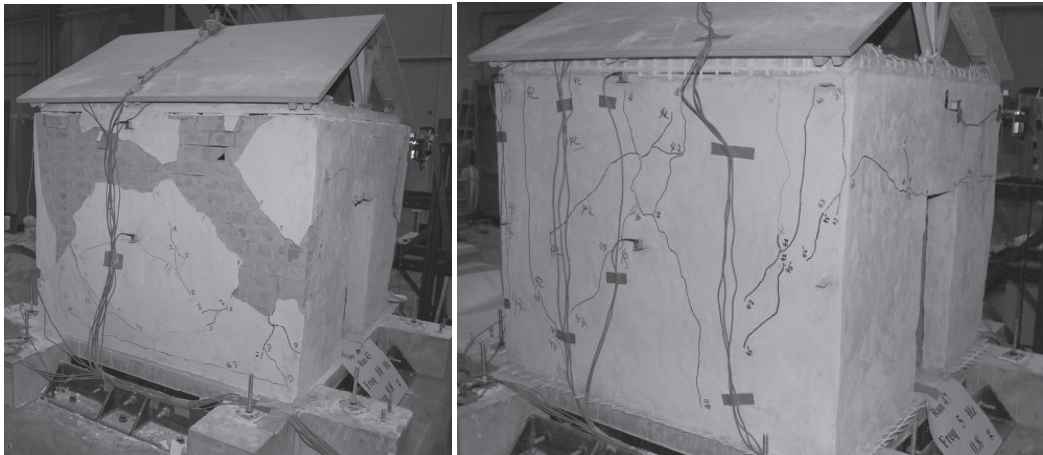
In case of the retrofitted model A-4-RE-P, similar cracks as non-retrofitted building started from top corner of the south wall in the run 33. After that, the process of widening of the cracks occurred and propagation of new cracks continues until the run 50. Although at the end of 50th run almost cracks observed in entire walls, the specimen did not lose stability. Some bricks from bottom part of east wall were spilled out from PP-band mesh. Therefore some looseness was observed in bottom part of the wall. Even this very high input motion, most of the surface finishing still attached with walls. At the final stage of the test, run 54, with 74.6 mm base displacement, 9 times more than the input displacement applied in run 47 and 3.7 times more velocity, virtually all the brick joints were cracked and the building had substantial permanent deformations. However, building did not loose the overall integrity as well as stability and collapse was prevented in such a high intensity of shaking. Thus, PP-band retrofitting technique maintained the integrity of the structural elements. Further, the retrofitted model showed the better energy dissipation mechanism as many new cracks were propagated without loosing the overall integrity and stability of the structure.

When we applied the surface finishing to house model, due to improve bond connection between PP-band and brick wall, surface plaster kept well with wall. This is not observed in non-retrofitted model. Because of this, brick unit confined effect inside the PP-band mesh is improved and it improves the overall earthquake resistant performance.

**Figure 7.** Specimen A-4-NR-P after run 43 (left) & Specimen A-4-RE-P after run 48 (right)

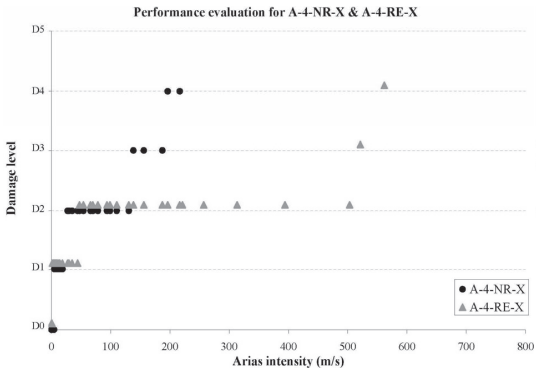
and was called scalar intensity. It is directly quantifiable through the acceleration record a(t), integrating it over the total duration of the earthquake. The arias intensity is claimed to be measure of the total seismic energy absorbed by the ground. Figure 8 & Figure 9 shows the performance level of each specimen against dynamic motion.

**Figure 8.** Performance evaluation for A-4-NR-X & A-4-RE-X

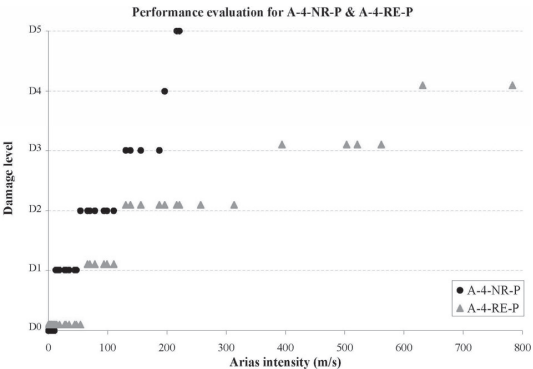
**Figure 9.** Performance evaluation for A-4-NR-P & A-4-RE-P
