EXPERIMENTAL STUDY OF IN-PLANE AND OUT-OF-PLANE BEHAVIOR OF PP-BAND RETROFITTED MASONRY WALLETTTE MADE OF SHAPELESS STONES

Kotaro SAKURAI¹, Navaratnarajah SATHIPARAN² and Kimiro MEGURO³

Key Words: Stone Masonry, PP-band Retrofitting, Diagonal Compression Test, Out-of-Plane Test

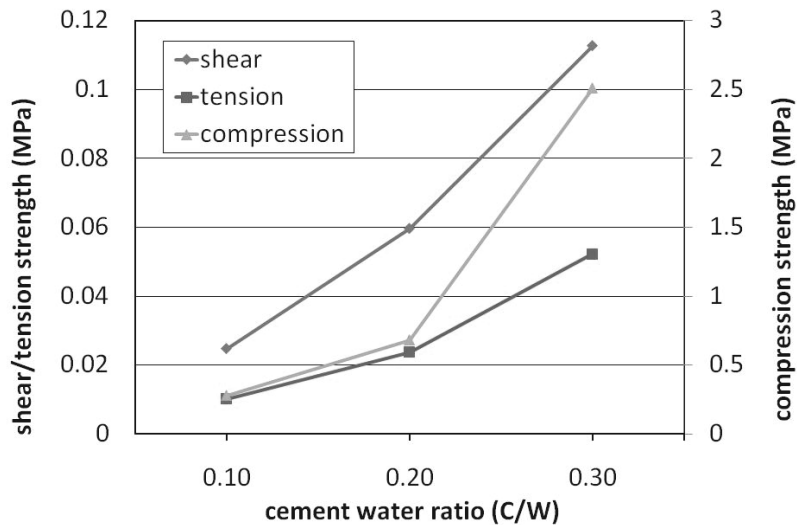
From the shear test's results, it is found that the failure pattern of masonry made of shapeless stones is type b) that is the separation along interface between stone surface and mortar because interface strength is less than that of mortar. Figure 2 shows the average strength of each test, i.e. shear, tension and compression tests. Figure 3 shows the failure pattern of stone masonry made of shapeless stones.

Figure 2. Mechanical properties obtained from material tests

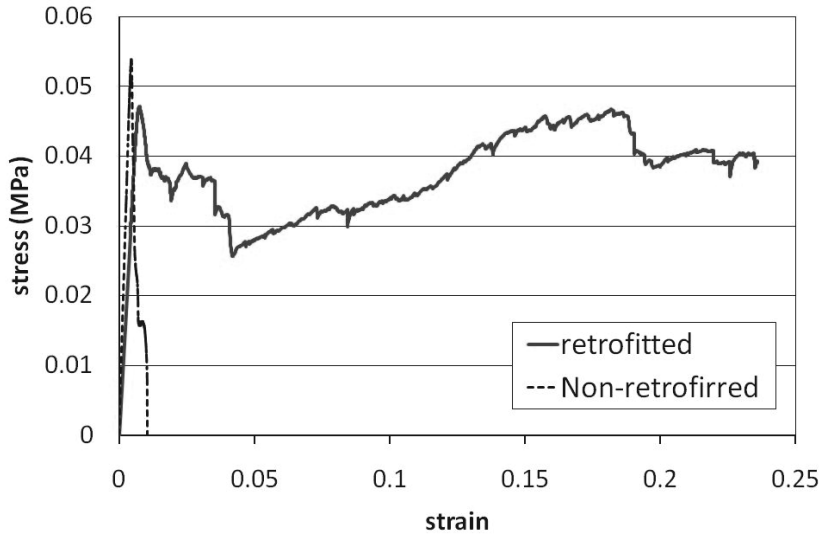
Figure 5 shows the diagonal shear stress variation with strain for the non-retrofitted and retrofitted specimens. In the non-retrofitted case, there was no residual strength after the first crack occurred and the specimens split into two pieces at strain equal to 1.1%. If we consider average behavior of retrofitted specimens, although the initial crack was followed by a sharp drop, at least 64% of the peak stress remained. As the matter of fact, 3 specimens were used for each non-retrofitted and retrofitted case. Subsequent drops were associated with new cracks such as the ones observed in the retrofitted specimen that shown in figure 5, at the strain of 2.5%. After this, the stress was regained by readjusting and packing by PP-band mesh. The stress equal to 72% and 81% of the initial peak stress was remained at the strain equal to 10% and 20%, respectively. The residual peak stress of the specimen was 99% of initial peak stress. If we consider the overall behavior of retrofitted specimens, specimen didn't break at the strain equal to 24%, which indicates that retrofitted specimen was at least 21 times more ductile than non-retrofitted one.

Figure 5. Stress vs. strain for stone masonry wallette with and without retrofitting by PP-band mesh

- 1) Masonry wallette without PP-band mesh lost the entire load bearing capacity after crack appeared.
- 2) Masonry wallette with PP-band mesh retrofitting lost some of load bearing capacity immediately after the crack-initiation, but 64% of the peak stress was remained. With the effects of the PP-band meshes, it could regain the load bearing capacity, and its strength and deformability improved. According to the experimental result, 1.3 times higher peak stress and at least 21 times larger ductility were observed.
- 3) By overlaying mortar onto PP-band mesh retrofitted masonry wallette, 77% of the peak stress was remained after the first crack. It was higher than that of the specimens without surface finishing.

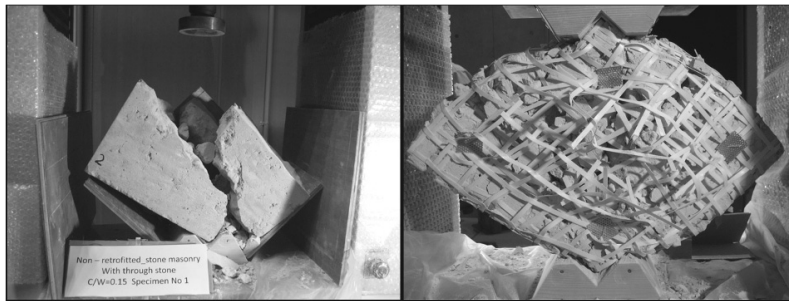
Figure 6 shows the non-retrofitted and retrofitted specimens at the end of test, which corresponded to the strain equal to 1.1% and 24%, respectively. As strain became larger, due to very low mortar strength, PP-band penetrated to the specimens. Therefore, increase of strength was not observed with strain. However, for specimens used for 1/4 scaled experiment, scaled PP-band whose width was approximately 6mm was used and it increased penetration-rate. But in case of full-scale structure, because 15mm PP-bands are used, penetration of PP-band meshes to the masonry houses are reduced relatively. Therefore additional increase of strength is expected, when the real masonry structures are retrofitted by PP-band meshes.

Figure 6. Failure pattern of stone masonry wallette (left: without retrofitting, right: with retrofitting)

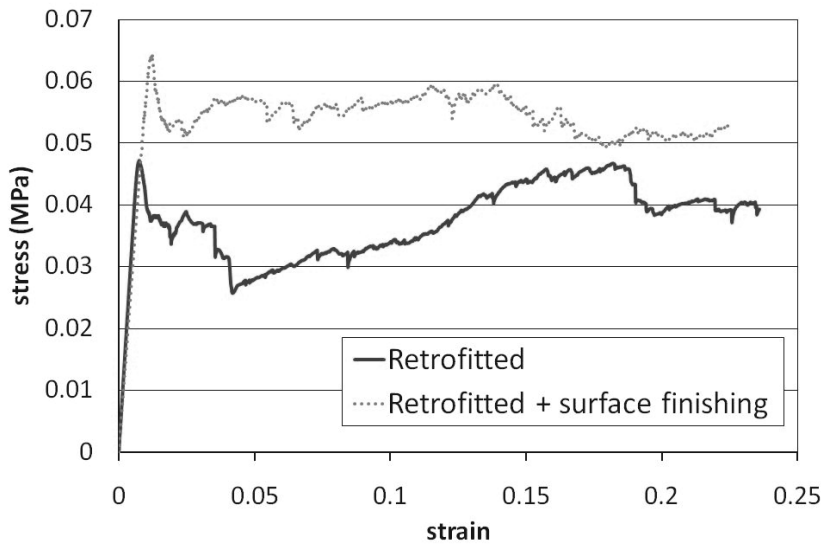
Figure 7 shows the diagonal shear stress variation with strain for retrofitted specimens with and without surface finishing. As a surface finishing, mortar with the thickness of 10mm was pasted on specimens. In case of retrofitted specimen without surface finishing, 64% of the peak stress remained after the first crack. On the other hand, if we consider average behavior of retrofitted specimens with surface finishing, 77% of the peak stress was remained after the first crack. By overlaying mortar onto PP-band mesh, surface finishing fill the gap between PP-band mesh and masonry wallette and the

residual strength became higher than that of the specimens without surface finishing. It was found that surface finishing makes beneficial effect in residual strength for masonry made of shapeless stones as well as for adobe and brick.

Figure 7. Stress vs. strain for retrofitted stone masonry wallette with and without surface finishing

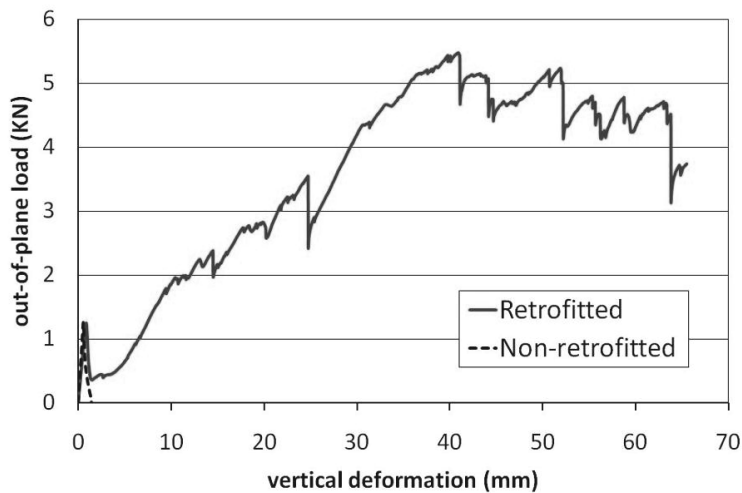
Figure 9 shows the out-of-plane load variation with net vertical deformation for the non-retrofitted and retrofitted specimens at the mid span. If we consider average behavior of non-retrofitted specimens, the initial strength was 1.34 KN and the specimens split into two pieces at the mid span deformation equal to 1.4mm. In the retrofitted case, although the initial crack was followed by a sharp drop, at least 33% of the peak strength remained. After this, the strength was regained progressively due to the PP-band mesh effects. In the retrofitted specimen shown in figure 9, the strength equal to 225% and 433% of the initial peak strength was observed at the mid span deformation equal to 20mm and 40mm, respectively. The residual peak strength of the specimen was 439% of initial peak strength. Specimen didn't break at the mid span deformation equal to 62mm, which indicates that; retrofitted specimen was at least 45 times more ductile than non-retrofitted one.

Figure 9 . Out-of-plane load variation vs. vertical deformation

- 1) In case of out-of-plane tests, the mesh effect was not observed before the wall cracking. After cracking, the mesh presence positively influenced the wallette behavior. Also in case of retrofitted wallette, 33% of the peak strength was remained after the first crack occurred, and then strength was regained and improved.
- 2) The retrofitted wallettes could have 2.9 times higher strength and 45 times larger deformation than those of the non-retrofitted ones.

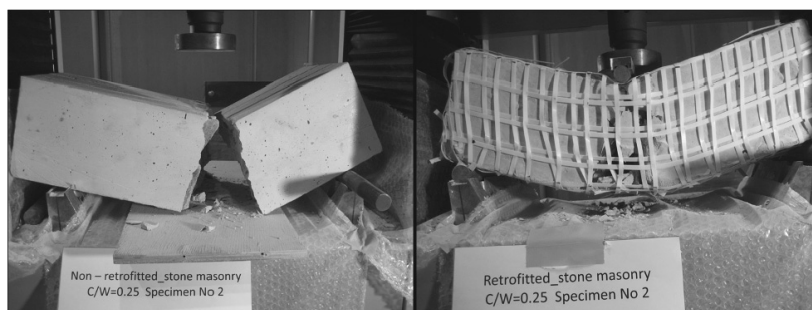
Figure 10 shows the non-retrofitted and retrofitted specimens at the end of test, which corresponded to deformation equal to 1.4mm and 62mm, respectively. In out-of-plane test, the improvement of final strength became much bigger than that of diagonal compression test. The cement/water ratio of the specimens used for the diagonal shear test was 0.15, but in case of out-of-plane test, the cement/water ratio equal to 0.25 was used. Because strength of mortar is high enough, PP-band didn't penetrate to the specimens and the drastic improvement of residual strength was observed.

Figure 10. Failure pattern of stone masonry wallette (left: without retrofitting, right: with retrofitting)
