SEISMIC STUDY OF 1/4 SCALE UNREINFORCED ADOBE MASONRY MODELS RETROFITTED WITH PP-BAND MESHES

Navaratnarajah SATHIPARAN¹, Paola MAYROCA² and Kimiro MEGURO³

Key Words: adobe masonry, polypropylene band, shaking table test, arias intensity

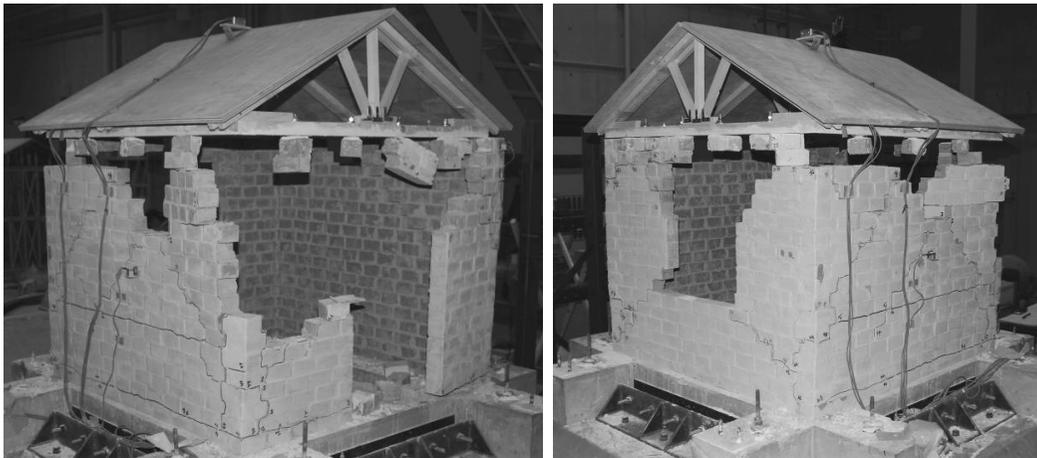
Figure 6. Crack patterns observed on for non-retrofitted model after Run 44

- Run 37 - Cracks appeared at the top of the north and south walls and propagated through out the whole wall. More cracks were observed in the part above the openings.

- Run 45 - All top part of the wall with opening was totally separated from the specimen and fallen from specimen. The roof was just supported by two walls, which were in the direction of shaking. Therefore, due to walls subjected to out-of-plane load; they were bursted outwards in shaking direction. This finally led to the structure collapse.

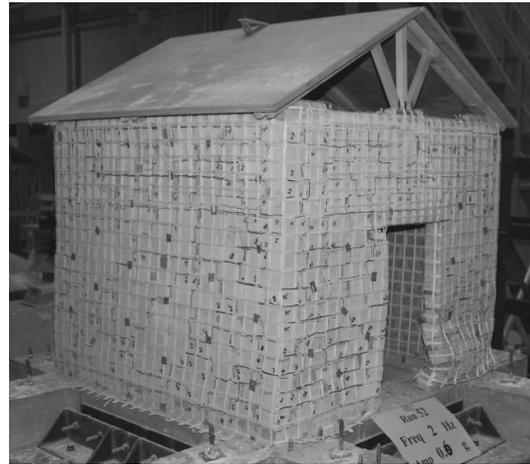
Figure 11. Retrofitted model after Run 53

- Run 49 - Although almost all the mortar joints were cracked at the end of this run, the specimen did not lose stability.
- Run 53 - Even some local failure was observed closer to door opening, the specimen did not lose stability. This input motion was 1.3 times larger acceleration and 2.7 times larger displacement than the input motion was applied in the Run 45. Another important point to mention was that the retrofitted model could sustain 8 more runs with higher input energy before this run.

At the final stage of the test, Run 53, with 50.6 mm base displacement, 8 times larger input displacement and 2.7 times larger input velocity than the Run 45 was applied. At this stage, most of the brick joints were cracked and the building had substantial permanent deformations. However, building did not lose the overall integrity as well as stability and collapse was prevented in such a high intensity of shaking. Thus, we could say that, PP-band retrofitting technique could maintain the integrity of the structural elements. Further, the retrofitted model showed the better energy dissipation mechanism as many new cracks were propagated without losing the overall integrity and stability of the structure.
