DOWN-HOLE SEISMOMETER ARRAYS NEAR LIQUEFIED TOKYO BAY AREA

ABSTRACT: The East Japan earthquake on March 11th, 2011 was responsible for extensive damage to not only the Tohoku-Pacific coast region but also south Kanto region including Tokyo Bay area. Tokyo Bay area, especially Urayasu city, has suffered serious ground liquefaction. The authors have been conducting down-hole seismometer array observations in commission from Tokyo Metro Subway, and seismic records were obtained at two observatories, which eventually turned to be the closest to the liquefied Tokyo Bay area. This report introduces these records and the ground subsidence in Urayasu, observed through Differential GPS surveys.

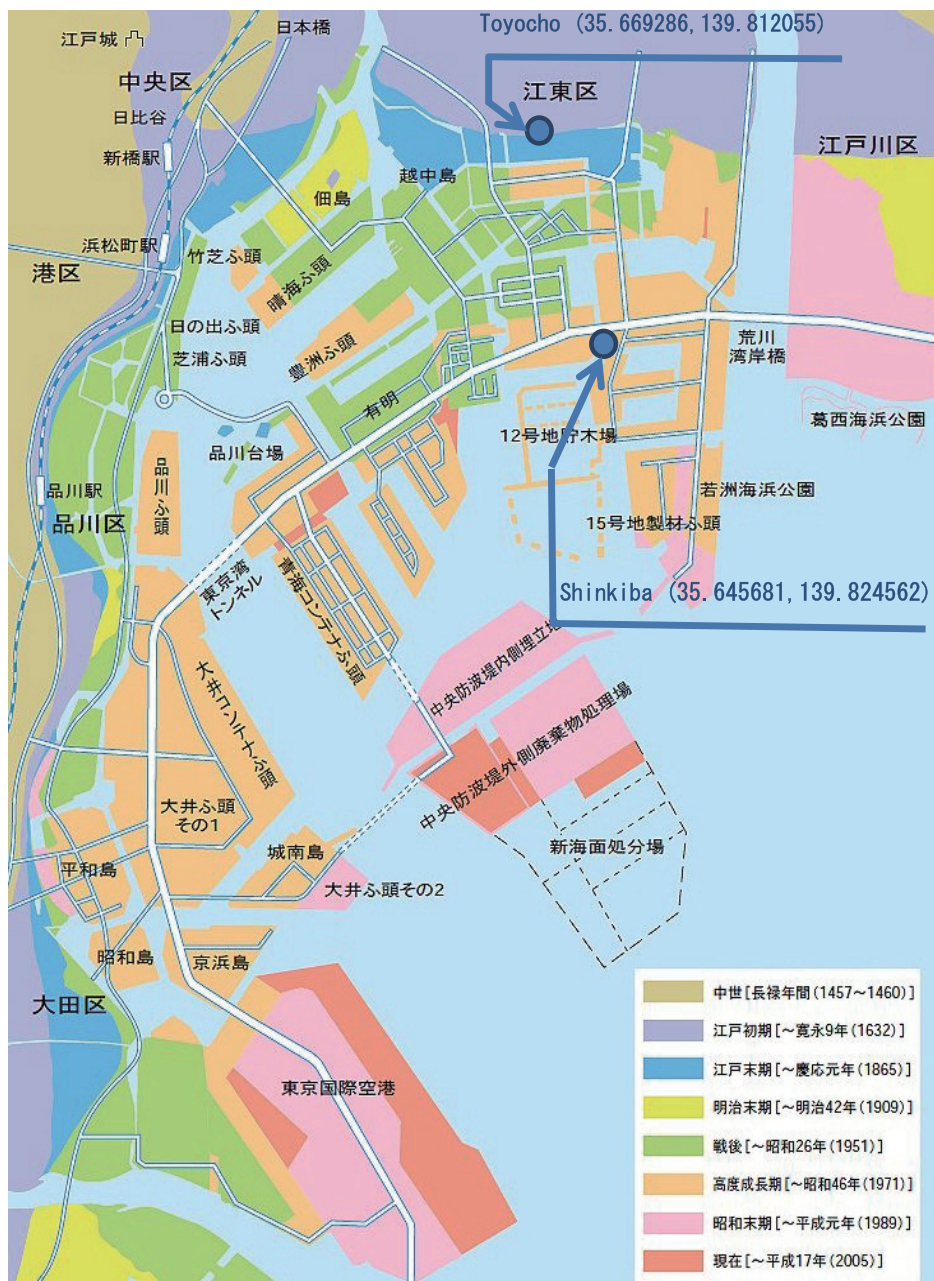
Figure 1 Locations of seismometers and times of landfilling (after “the history of Tokyo Port, MLIT”)

Figure 1 shows locations of seismometers at Toyochō and Shinkiba, and times of landfilling. A 124km² area behind the sea-frontal reclaimed lands had been suffering from serious ground subsidence due to overuse of ground water and gas. Subsidence finally stopped immediately after a set of laws for limiting excessive use of underground water was enacted in 1970th. However, the area remained several meters below sea level without any clear sign of rebound and thus a serious concern of inhabitants of the area. This earthquake with its epicenter 380km northeast of Tokyo has caused little damage to the low-lying areas. It was fortunate that no damage to river and sea banks, drainage pump stations was reported. However there were clear marks of tsunami surge along river banks (see Figure 3(b)), and inhabitants need to remain careful for a possible near-field earthquake.

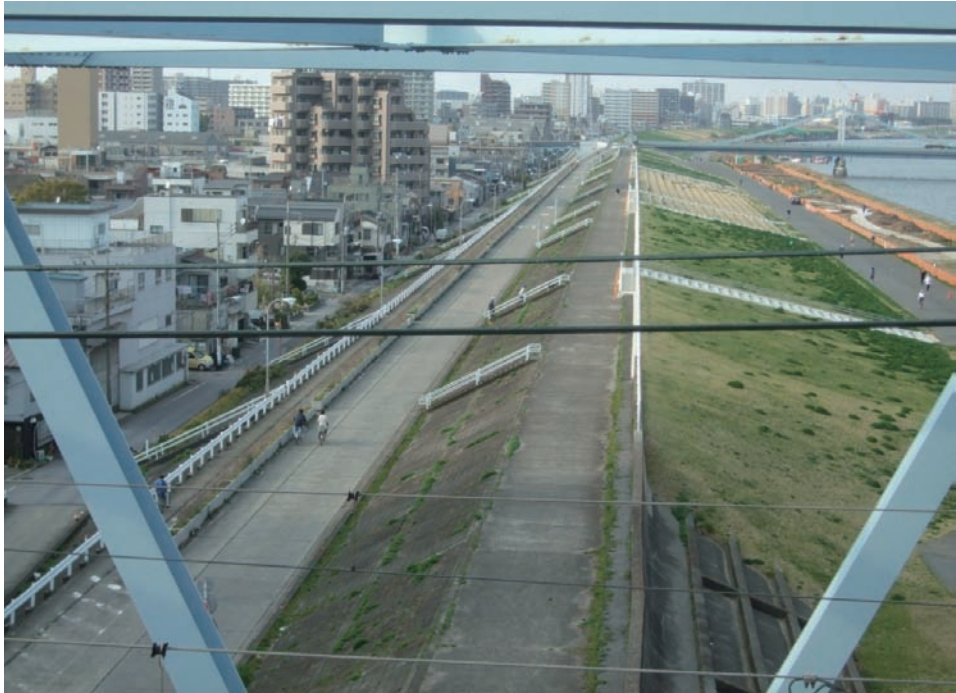
Figure 3(a) Upstream view of low-lying area near Arakawa Bridge of the subway Tozai line (35.665856,139.842868, Location is shown in Fig. 2): The area has been suffering from a serious land subsidence problem.

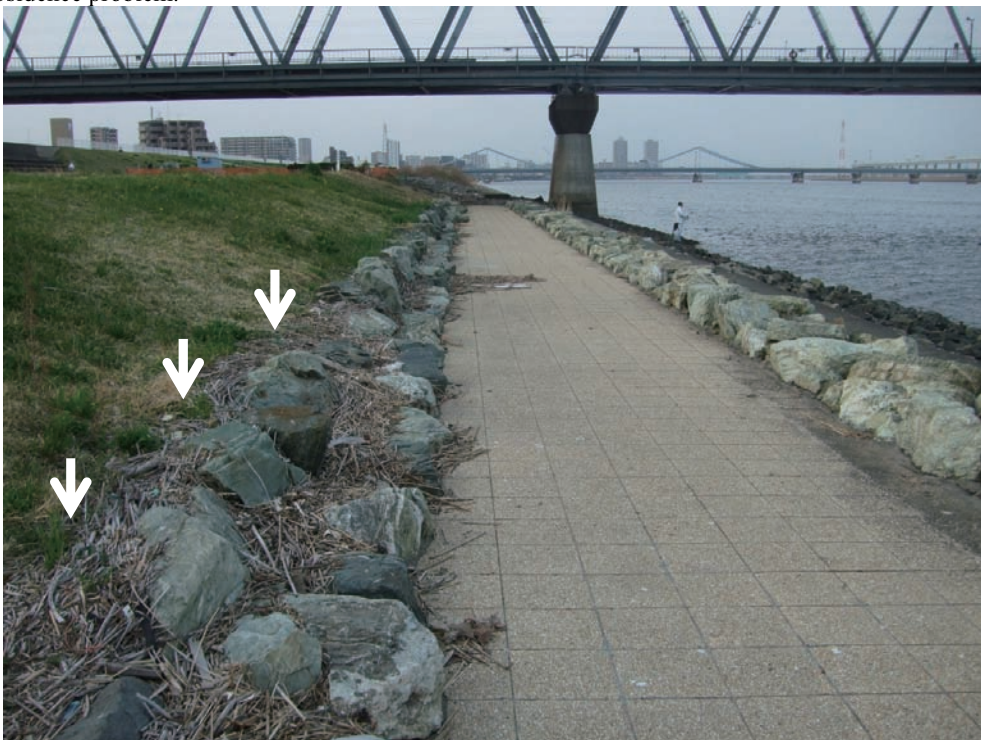
Figure 3(b) Tsunami marks along the right bank of Arakawa River

(Photo taken at 17:30, 2011/04/10, at 35.665856, 139.842868)

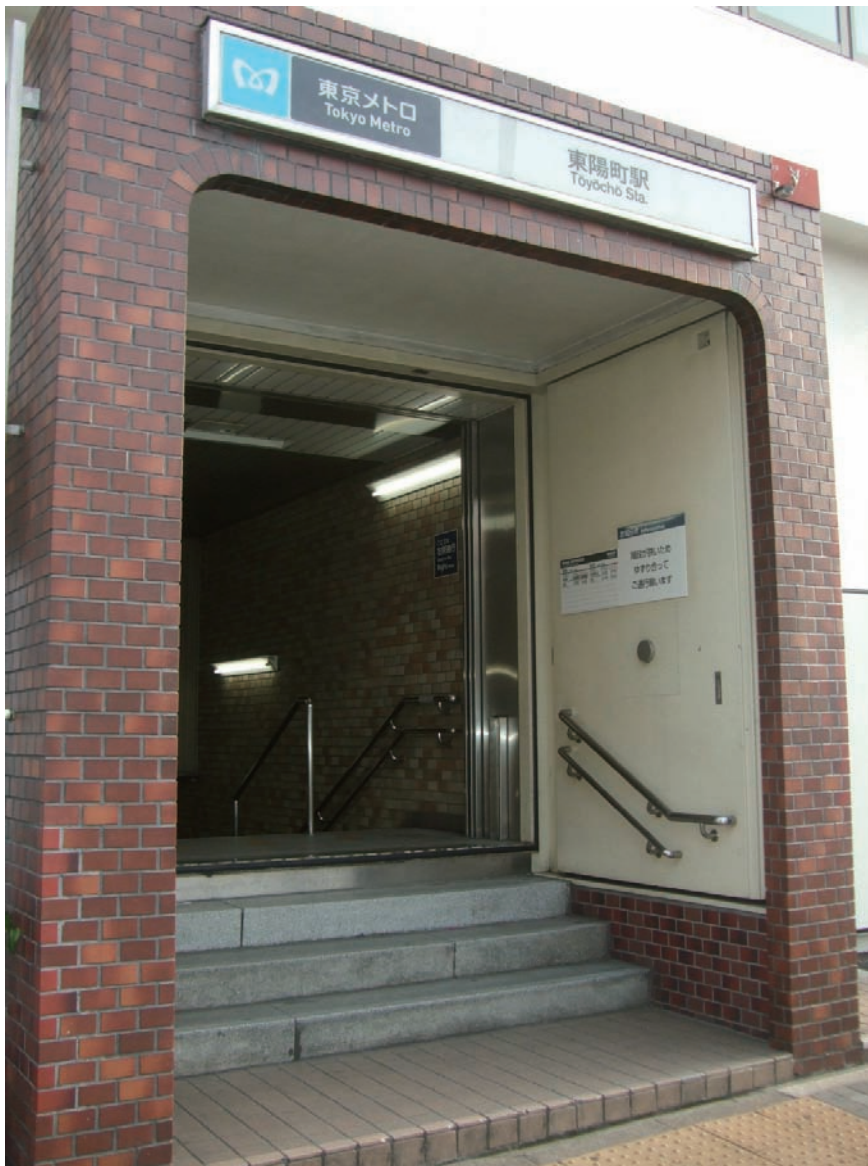
Fig. 4(b) Raised entrance of Toyochō Subway Station at 35.669469,139.816766:
The entrance has a watertight door.

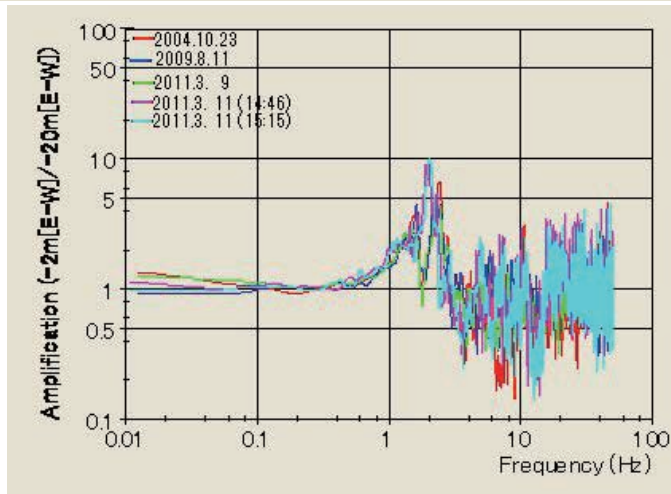
Figure 7 Frequency-domain amplifications for 6 major ground motions observed at Toyocho

Figure 5 shows the soil profile at Toyocho site and locations of seismometers. And Figure 6 shows the accelerograms at Toyocho from the main event. Note that PGAs appeared about a minute after the first arrival of S wave. The duration of the strong ground motion was very long. Figure 7 shows the frequency-domain amplifications for 6 major ground motions observed at Toyocho. The first peak appears at around 1,7Hz and 5Hz for lateral and vertical motions, respectively and there is no clear difference among 6 records including the one from the March 11th quake.

1. At Toyochō site, there was no clear difference in terms of the frequency-domain amplifications among 6 records including the one from the March 11th quake. No serious damage was reportedly found in the vicinity of the site, which area remained several meters below sea level due to the overuse of underground water and gas until 1970's and thus has been a serious concern of inhabitants of the area.
2. At Shinkiba site, frequency-domain amplifications for 6 major ground motions show the first peak appearing at around 0.8Hz and 4Hz for lateral and vertical motions, respectively. Differing from those at Toyochō, amplification curves for the March 11th quake and its aftershock at 15:15 on the

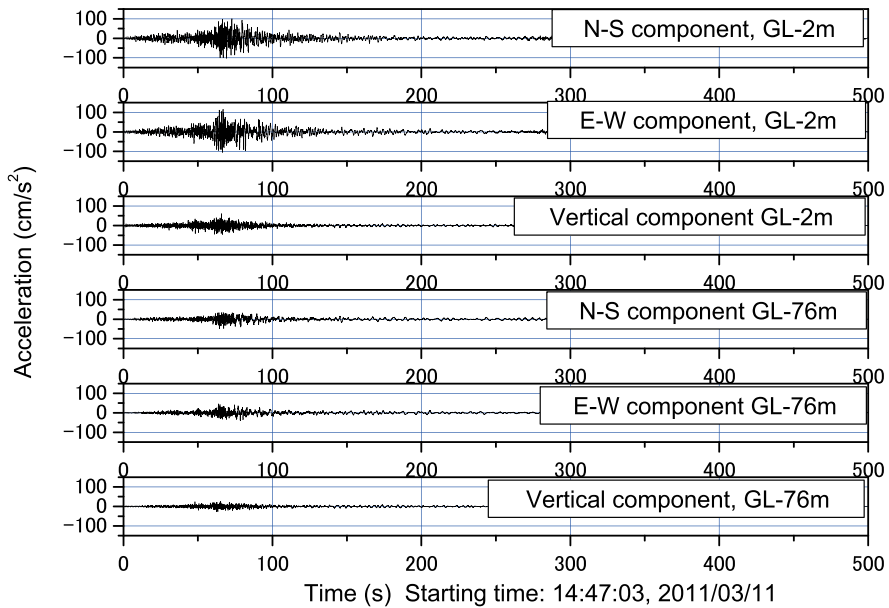
Figure 9 Accelerograms at Shinkiba from main event (Unit: cm/s^2): -76m (NS: 48.6, EW 44.8, UD: 27.3), -2m (NS: 102.7, EW 115.7, UD: 60.4), No clear sign of cyclic mobility though liquefactions were found near the station (see the photo below).

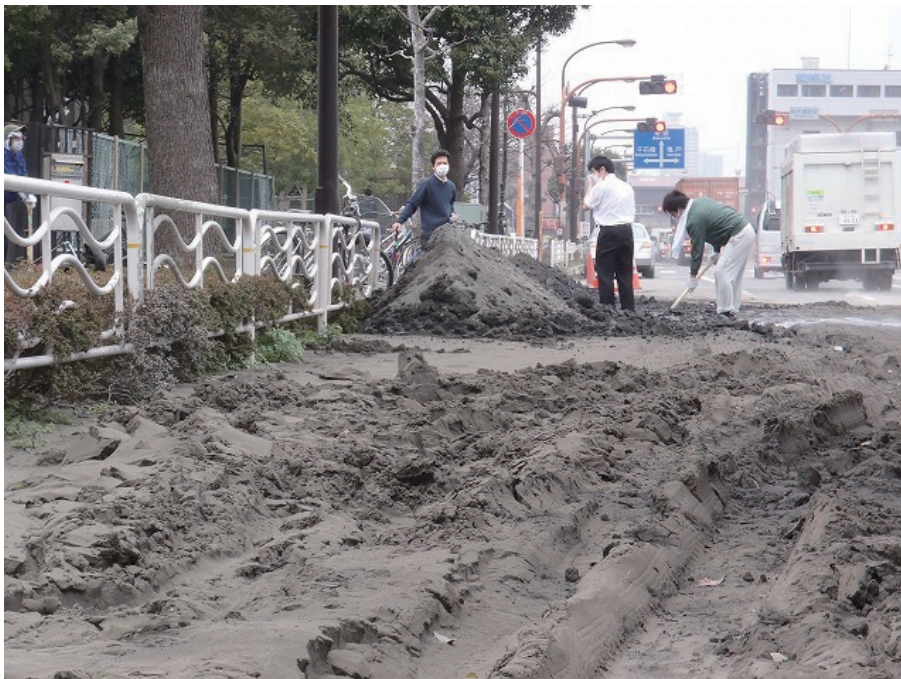
Figure 10 Liquefied sand near Shinkiba subway station (photo on 2011/03/15 by T. Kiyota. Location: 35.644812,139.828148)

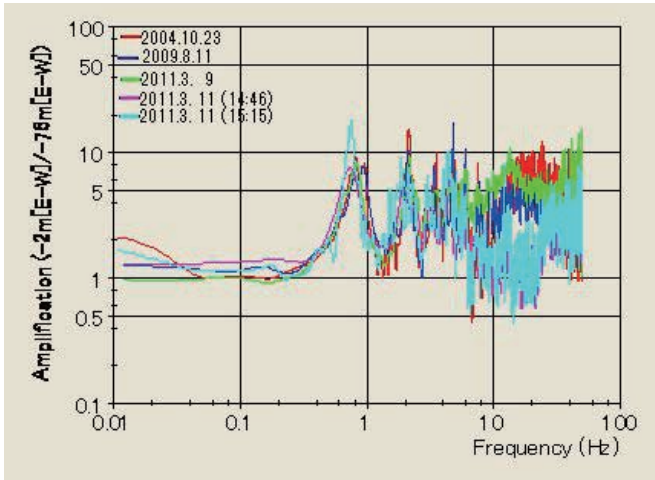
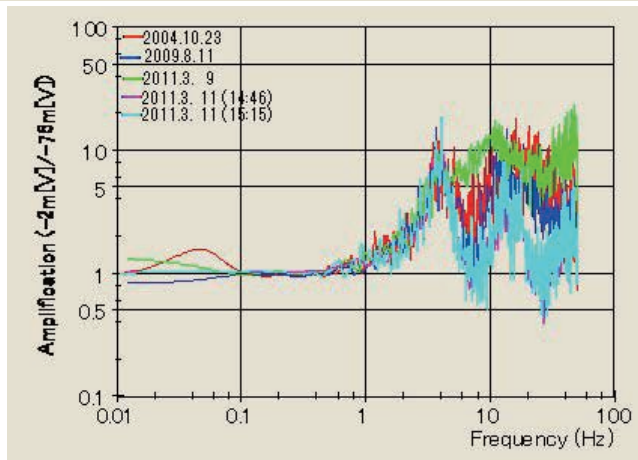
Figure 11 Frequency-domain amplifications for 6 major ground motions observed at Shinkiba: The first peak appears at around 0,8Hz and 4Hz for lateral and vertical motions, respectively. Differing from those at Toyochō (Fig. 7), amplification curves for the March 11th quake and its aftershock at 15:15 on the same day deviate from the others as the frequency increases above 4 to 5 Hz.

same day deviate from the others as the frequency increases above 4 to 5 Hz. Liquefactions were found around the observation site.

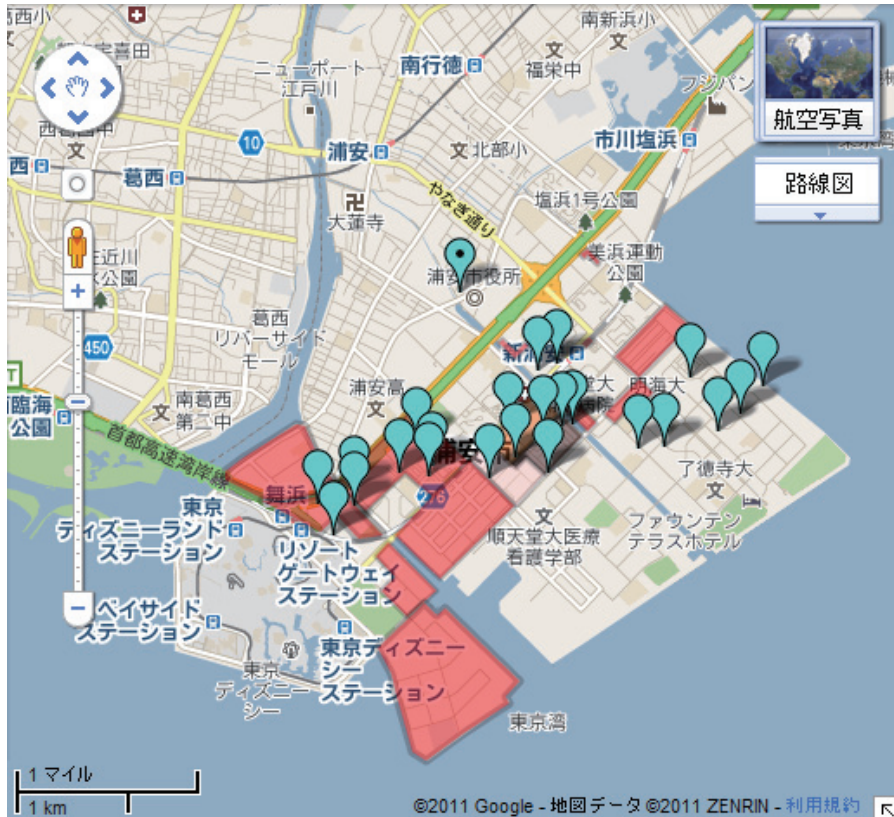
Figure 14(a) Locations of temporary water supply valves (Urayasu city)

Blue place marks: Temporary water supply valves, Colored areas: purple= it will take a long time to restore water supply systems, orange= water supply restored, red= sewage system cannot be used (as of April 10th, 2011).

Figure 13(b) shows the stepped configuration along Line-01 indicating there have been twice large landfilling activities since 1964. It may be premature, before taking many lines, to say something with confidence from this figure but some noticeable subsidence (about 0.3 to 0.4m) can be seen within an about 1km wide brush along the boundary between the first and second landfills. This wide brush may extend in east-west direction as shown in both Figures 14(a) and 14(b).
