# SHANKING TABLE TESTS ON PP-BAND RETROFITTING OF 1/4 SCALE UNREINFORCED STONE MASONRY MODELS

**ABSTRACT:** This paper introduces a technically feasible and economically affordable PP-band (polypropylene bands) retrofitting for low earthquake resistant masonry structures in developing countries. Results of the material tests and shaking table tests on building models show that the PP-band retrofitting technique can enhance safety of both existing and new masonry buildings even in worst case scenario of earthquake ground motion like JMA7 seismic intensity. Therefore, proposed method can be one of the optimum solutions for promoting safer building construction in developing countries and contribute earthquake disaster mitigation in the future.

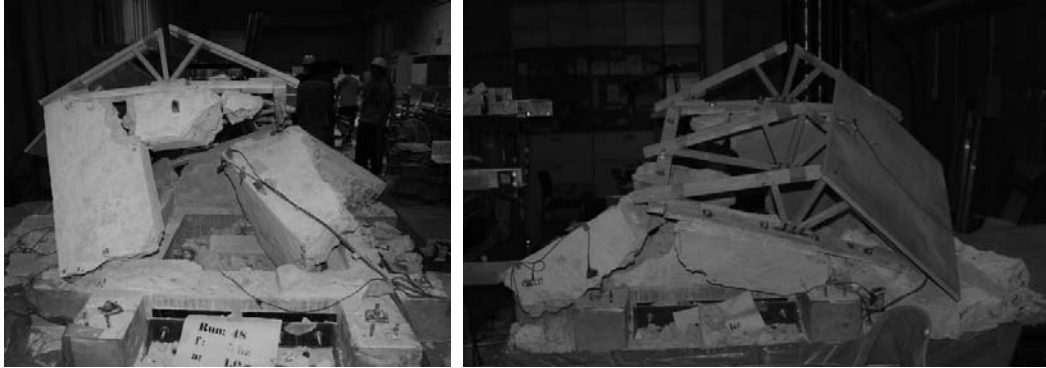
**Figure 11.** Non-retrofitted model after Run 48

At run 45, there were large amount cracks observed in walls in the direction of shaking. Exciting cracks widened and connection between adjacent walls was become weak. In case of walls perpendicular to shaking direction, top part of the east wall (part, above the door opening) was separated from the specimen. At run 47, all top part of the wall with opening was totally separated from the specimen, and some parts were fallen from a specimen. Now the all walls were separated and act independent and this finally led to the structure collapse.

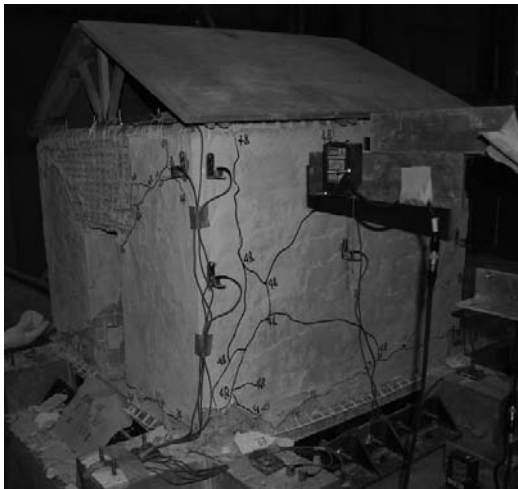
**Figure 14.** Retrofitted model after Run 48

For retrofitted specimen up to run 30, no major crack was observed in this model. Major cracks were observed closer to openings from Run 31. After those new cracks appear in each run and cracks widened with each successive run, thus, extensive cracking was observed. Although the PP-band mesh kept the structure integral during the shaking. In later stages, there was significant permanent deformation of the structure. At the final stage of the test, run 52, with 37.3mm base displacement, 4 times more than the input displacement applied in run 48 and 1.5 times more velocity, virtually the building had substantial permanent deformations. However, building did not lose the overall integrity as well as stability and collapse was prevented in such a high intensity of shaking.

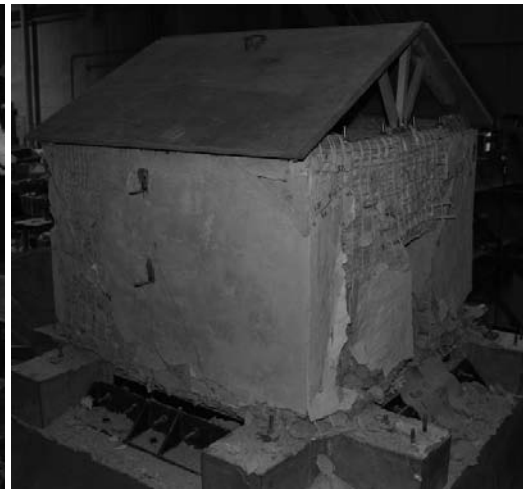
**Figure 15.** Retrofitted model after Run 51

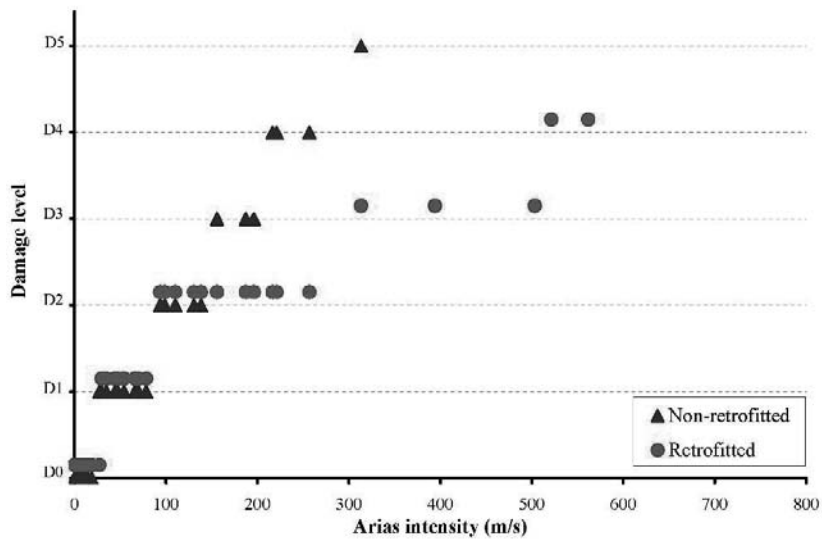
**Figure 17.** Performance evaluation based on arias intensity scale.

**Figure 17** shows the performance levels of each specimen against the dynamic motion based on Arias intensity scale. From the results, retrofitted model damage level performance was at least three times better than that of the non-retrofitted model.
