SHAKING TABLE TEST ON SEISEMIC RESPONSE BEHAVOIR OF 2-STORY MASONRY HOUSE MODEL WITH PP-BAND MESH RETROFITTING

Navaratnarajah SATHIPARAN¹, Kotaro SAKURAI², Muneyoshi NUMADA³
and Kimiro MEGURO⁴

Key Words: two-story masonry, polypropylene band, shaking table test, arias intensity

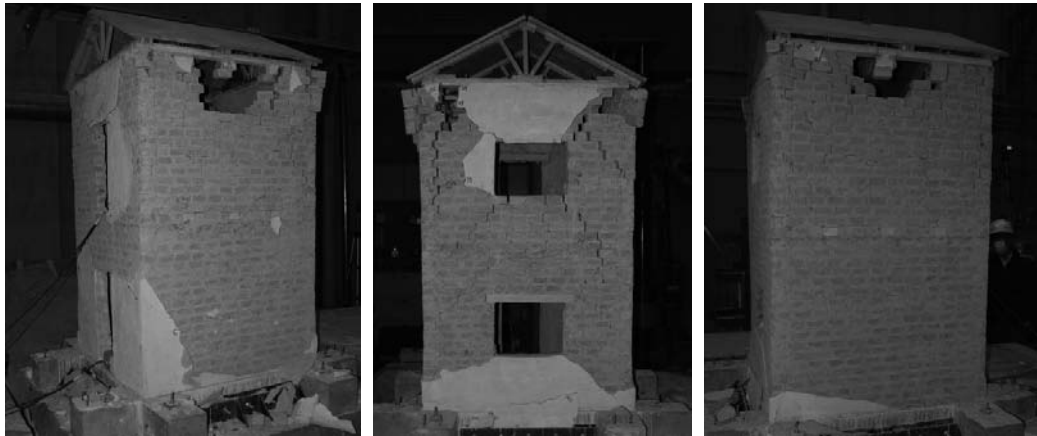
Figure 7. Non-retrofitted model after Run 43

Although in case of Non-retrofitted model, cracks widened with each successive run after Run 24, Run 43 was critical. **Figure 7** shows the non-retrofitted model after run 43. There were large amount cracks observed in walls in the direction of shaking and exciting cracks widened and connection between adjacent walls was become weak. At the end of this shake, as shown in **Figure 7**, some top portion of the north and south walls above totally separated and removed from the model before

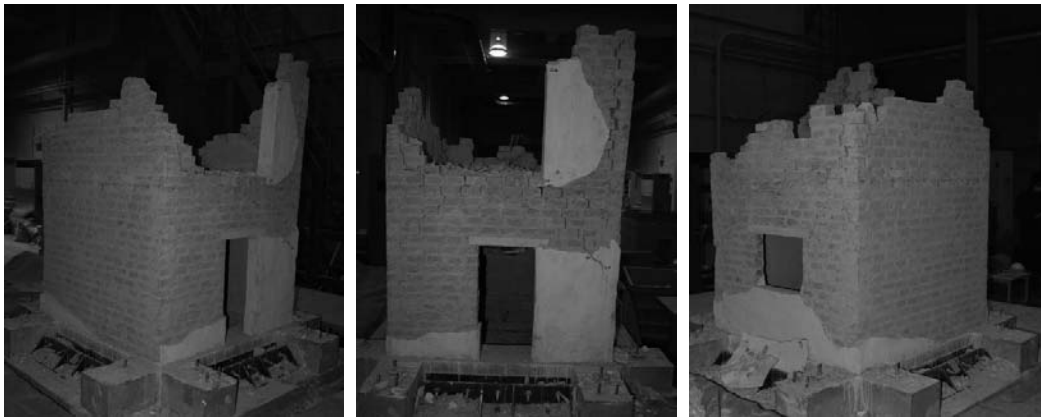
Figure 8. Non-retrofitted model after Run 44

resuming the testing program. Now the roof only supported by two walls, which were in the opposite direction of shaking. Therefore, they were bursted outwards in shaking direction. This finally led to the structure collapse. Run 44 was corresponded to base velocity and displacement equal to 125mm/s and 4mm, respectively.

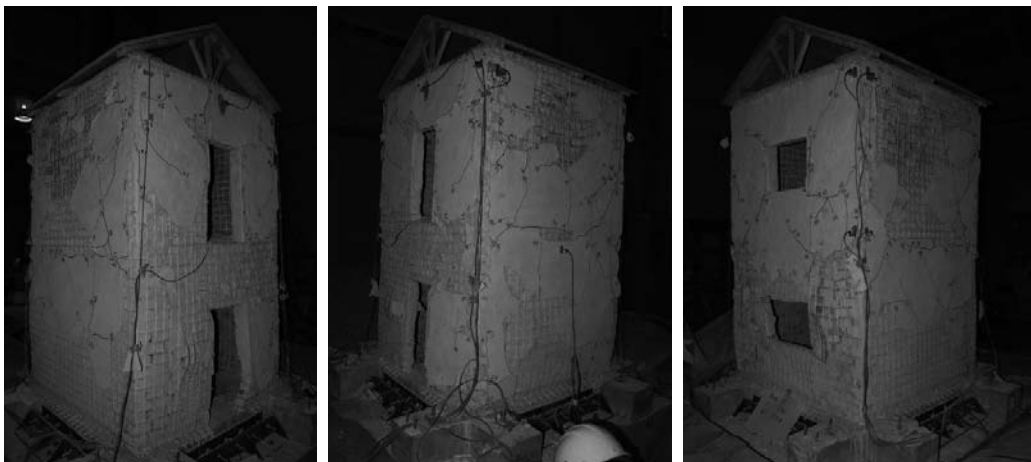
Figure 9. Non-retrofitted model after Run 52

In case of retrofitted, each successive shake caused new cracks after Run 33. In each loading, cracks widen and sliding along mortar joints could be clearly observed. At the final stage of the test, run 52 virtually, all the brick joints were cracked, and the model had substantial permanent deformations. This input motion corresponds to a velocity and displacement equal to 467.5mm/s and 37.3mm, respectively, 3.7 and 9 times larger than the motion that caused the failure of Non-retrofitted model. However, building did not lose the overall integrity as well as stability and collapse were prevented in such a high intensity of shaking.

At the final stage of the test, Run 53, with 50.6 mm base displacement, 12 times larger input displacement and 5 times larger input velocity than the Run 44 was applied. At this stage, most of the brick joints were cracked and the building had substantial permanent deformations. However, building did not loose the overall integrity as well as stability and collapse was prevented in such a high

intensity of shaking. Thus, we could say that, PP-band retrofitting technique could maintain the integrity of the structural elements. Further, the retrofitted model showed the better energy dissipation mechanism as many new cracks were propagated without losing the overall integrity and stability of the structure.

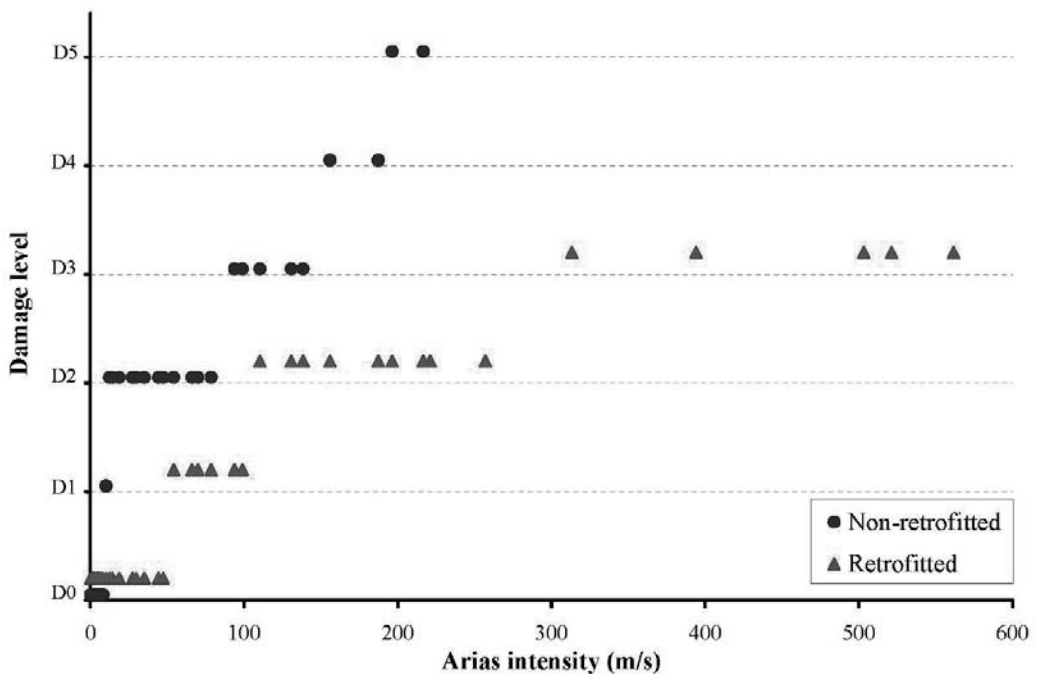
Figure 11. Performance evaluation based on arias intensity scale

Figure 11 shows the performance levels of each specimen against the dynamic motion based on arias intensity scale. Form the results, retrofitted model damage level performance was at least 4 times better than that of the non-retrofitted model.

The Arias intensity was initially defined by Arias (Arias A., 1970) as

$$I_a = \frac{\pi}{2g} \int_0^t a^2(t) dt \tag{1}$$

and was called scalar intensity. It is directly quantifiable through the acceleration record $a(t)$, integrating it over the total duration of the shaking. The arias intensity is claimed to be measure of the total seismic energy absorbed by the ground.
