DYNAMIC TESTING OF MASONRY HOUSES RETROFITTED BY BAMBOO BAND MESHES

Rajendra SOTI¹, Sathiparan NAVARATNARAJ²,
Muneyoshi NUMADA³ and Kimiro MEGURO⁴

Key Words: unreinforced masonry, bamboo-band mesh, shaking table test, JMA seismic intensity

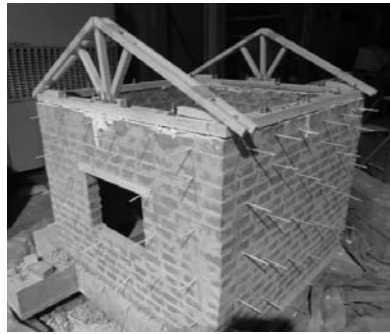
2. Securing holes using the straw during model construction

removed. Straw was placed at approximately 200 mm pitch. In case of existing structures holes can be prepared by drilling through the wall. The prepared mesh was then installed both on outside and inside of the wall and wrapped around the corner of the house. The inside and outside meshes were connected by the Polypropylene strings (PP strings) which were passed through the hole. The overlapping and wrapping of the meshes was also made around the opening and roof. Figure 2 illustrates the overall retrofitting procedure.

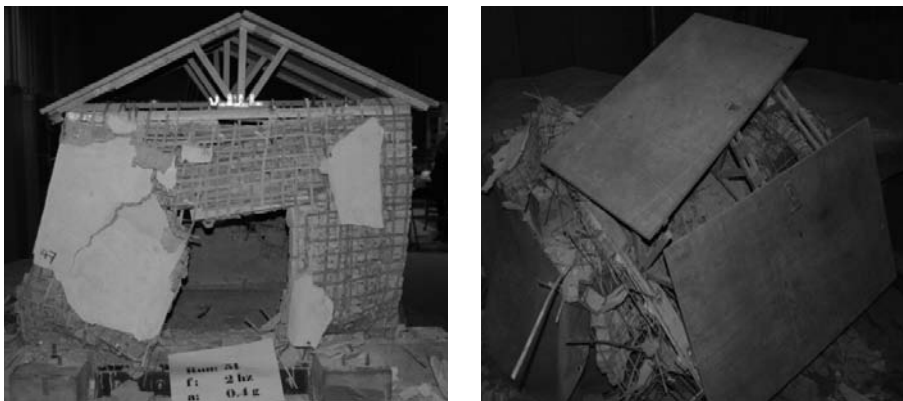
Figure 7. retrofitting building model after 51 run (left) and 52 run (right)

bottom layer of the walls. Most of the new cracks were concentrated in the bottom parts of the walls. This run caused the significant detachment of surface finishing from the specimen. Widening of existing cracks with the formation of few new cracks was continued to the run 49. At run 50, most of brick joints were cracked and few brick units fell down from the bottom part of the door opening. There was a large gap in some part of the specimen between the brick units and the mesh was broken at the corner of the wall. At run 52, the building lost the overall integrity and collapsed completely (see Figure 7).

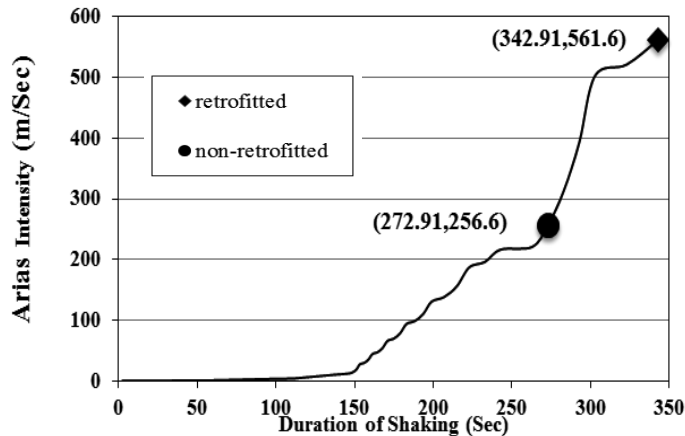
Fig 9. Seismic capacity comparison

Fig 9 shows the performance of the specimen based on arias intensity. From the results, retrofitted model could withstand more twice bigger input energy better than non-retrofitted model.
