OVERVIEW OF MASSIVE DESTRUCTION CAUSED BY THE MARCH 11TH, 2011 OFF THE PACIFIC COAST OF TOHOKU EARTHQUAKE AND IMPACT THAT THE QUAKE AND TSUNAMI HAD ON EARTHQUAKE ENGINEERING EXPERTS*

Kazuo KONAGAI¹

Key Words: Great East Japan Earthquake, tsunami, wrong messaging, role of engineers

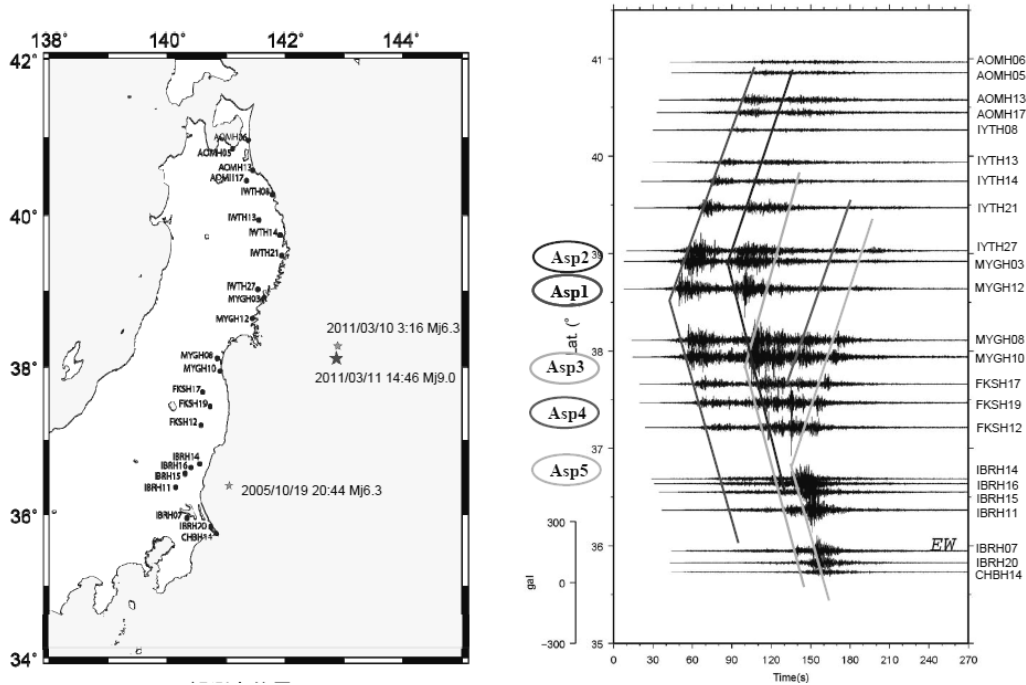
Fig. 2 0.1 to 10 Hz band-pass filtered accelerograms from a north-south trending row of 23 stations of KIK-net strong motion network along the Pacific coast of east Japan (Courtesy of Prof. Kamae K. [7]).

Fig. 2 shows 0.1 to 10 Hz band-pass filtered accelerograms from a north-south trending row of 23 stations of KIK-net strong motion network along the Pacific coast of east Japan [7]. The figure shows that the rupture front traveled away from the epicenter, triggering sub-events at several barriers and asperities, and the entire rupturing process took longer than 1 minute. As a consequence, observed seismic motions exhibited long duration times reaching several minutes. The long-continuing shakes are considered to have been responsible for buildups of soil deformations. Among many geotechnical problems, soil liquefactions along the Tokyo Bay area, a home to millions of people as well as the port/factory zone to support urban lives, emerged as one of the most serious economic and social impacts [8].

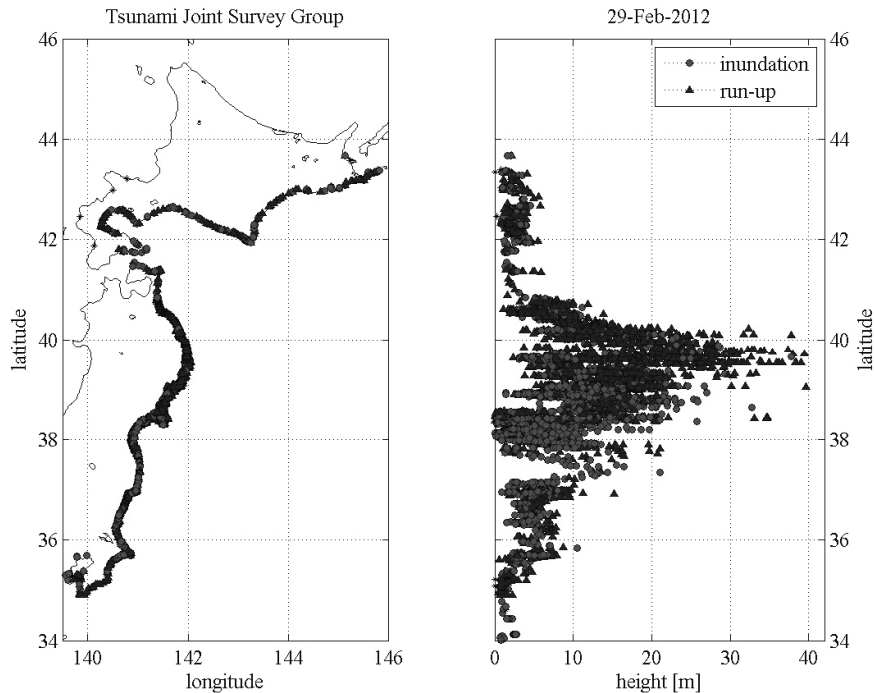
Fig. 3 Run-up and inundation heights of tsunami caused by the March 11th, 2011 Off the Coast of Tohoku Earthquake [9]

The overwhelming devastations were due to tsunami waves. According to the reports by the Coastal Engineering Committee of JSCE, (Fig.3, [9]), the Japan Weather Association (JWA) [10], and the analysis of aerial photographs by the Geospatial Information Authority of Japan (GIA) [11], indented coast line was responsible for amplifying tsunami waves such that the maximum run-up height of 40.4 m was reached near Miyako. At Rikuzen-Takada and along the Kitakami River, tsunami waves, 9 to 10 m and 5 m in average above the sea level, surged 7 km and 13 km inland, respectively. Tsunami also flooded up to 5 km inland over remarkably flat terrains of Sendai plain with the maximum inundation height of 19.5 m. Due to the tectonic subsidence observed all along the Pacific coastline, a total area of 561 km² in 64 municipalities has remained underwater.

Fig. 3, showing both tsunami run-up and inundation heights, has an about 60 km stretch of the coastline completely lacking data because the government set up a restricted area within a 30-kilometer radius of the disabled Fukushima Daiichi Nuclear Power Station (Fukushima I Station hereafter). Tower No. 27 of the Yonomori transmission line, one of the transmission lines through which the nuclear power plant receives power from Shin Fukushima Substation, was taken out by a coherent soil mass detached from an embankment of the Fukushima I station, and drawing transmission cables, the tower fell down to the ground. Since the station received no power through this line about two minutes after the quake hit the station, TEPCO reported to the Ministry of Economy, Trade and Industry its official view that the landslide took place about two minutes after the quake [13]. The other lines also malfunctioned due to short-circuit of transmission cables etc. Although all off-site power was lost, the automatic systems at Fukushima I successfully inserted all the control rods into its three operational reactors upon detection of the shakes reaching 0.52 to 0.56 g, and all available emergency diesel generator power systems were in operation as designed [14].

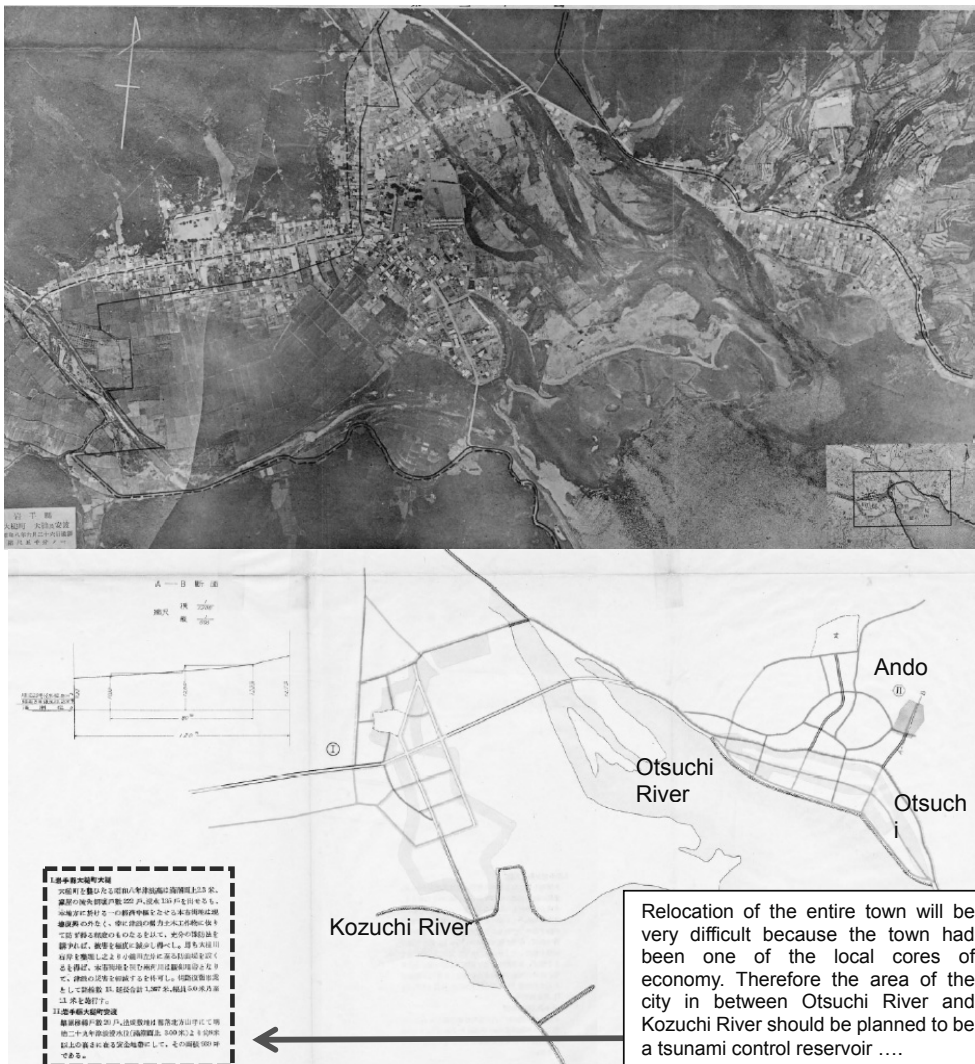
Fig. 6 Otsuchi engulfed by the tsunami caused by the 1933 Sanriku Earthquake, and its recovery plan developed by Minister's secretariat at the Ministry of Internal Affairs [27]

The above-mentioned plans for rehabilitations retain reminders of the past rehabilitation plans for the same coastal areas devastated by the tsunami waves caused by the March 2nd 1933 Sanriku Earthquake. The city planning division of the Minister’s secretariat at the Ministry of Internal Affairs mapped out strategies for rehabilitating devastated coastal cities, by tracing tsunami run-up lines and possible relocation plans on surfaces of tracing papers which are overlaid on all aerial photographs covering 29 and 9 municipalities along the Sanriku ria coast and the Sendai Bay area, respectively (Fig. 6, [27]). The drawings of its rehabilitation plans include the same three ideas that appeared in the Iwate Prefecture’s rehabilitation plan document of 2011. There is the following short mention on the sheet of tracing paper for Otsuchi Town: “The tsunami of 1933, which was 3m high in average above the sea level at Otsuchi Town, was destructive with 222 dwellings washed away and 135 inundated, and yet the relocation of the entire town will be very difficult because the town had been one of the local cores of economy. Therefore the area of the city in between Otsuchi River and Kozuchi River should be planned to be a tsunami control reservoir”. The comment goes on to the following lines: “20 dwellings on a terrace of Ando, north of Otsuchi Town, were relocated immediately after the tsunami caused by the June 15th 1896 Meiji Sanriku Earthquake. The terrace is about 3100 m² large in area and 8m high above the high tide level, and thus survived the tsunami this time”.
