# TEMPLATE MATCHING METHOD FOR SOIL SUBSIDENCE MAPS OF THE AREAS LIQUEFIED IN THE MARCH 11<sup>th</sup> OFF THE COAST OF TOHOKU EARTHQUAKE \*

**ABSTRACT:** The March 11th 2011 East-Japan Earthquake has caused sand-liquefaction over a long stretch of landfills along the coast of Tokyo Bay. An attempt was made to detect soil subsidence from airborne LiDAR (Light Detection and Ranging) images before and after the earthquake. To cancel out deep-seated tectonic displacements and systematic errors of LiDAR, the template matching technique is used for the end-bearing pile-supported buildings chosen as the template in the source image of the target area of Urayasu. The obtained subsidence map describes the spatial distribution of soil subsidence in great detail.

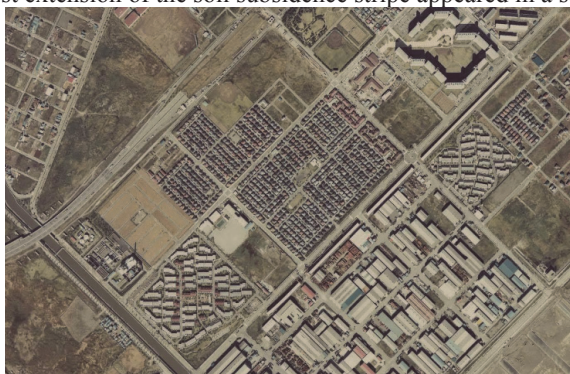
Fig. 5 Stripe of soil subsidence of across Benten residential area

(a) Location of stripe

(b) Southwest extension of the soil subsidence stripe appeared in a school-ground

(c) Benten area in 1979: The area was developed in late 1970s.  
Geospatial Information Authority of Japan (2011b)

Zooming in on one of residential areas, Benten, a clear blue brush of large soil subsidence is found running across several town blocks as indicated with arrows in Fig. 5. In these residential town blocks, where strip footings and mat foundations are the most common, houses have sunken in the soil by about 0.5m in average (Fig. 6(a)). The southwestern extension of the brush appeared as sand blows lined up in the schoolyard of Miakegawa Primary School (Fig. 6(b)). Later, on April 24, there appeared a puddle as shown in Fig. 6(c) due to a heavy rain of April 23<sup>rd</sup> 2011.

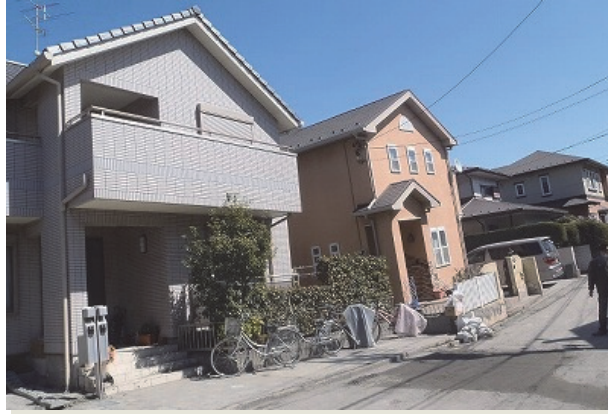
(a) Inclined and sunken houses  
Photo by Kiyota T., at 35.641895, 139.89886

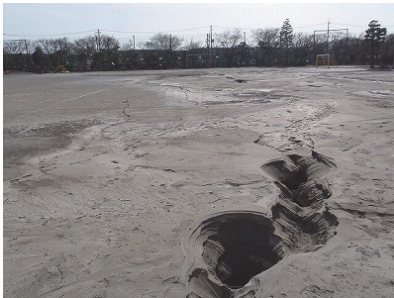
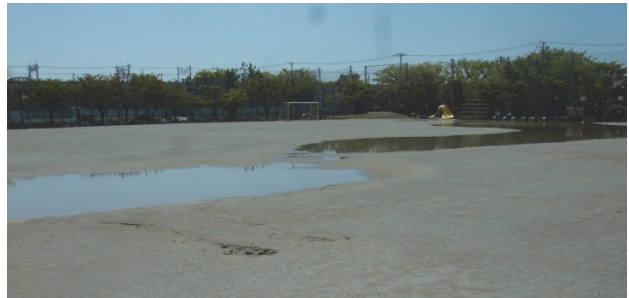
Fig. 6 Extension of the subsidence stripe appeared in a school-ground of Miake Primary School

(a) Sand blows lined up in school ground  
Photo by Konagai K., on March 19<sup>th</sup>  
at 35.638933, 139.895619

(b) Puddle appeared in school ground  
Photo by Konagai K., on April 24<sup>th</sup>  
at 35.639117, 139.895471

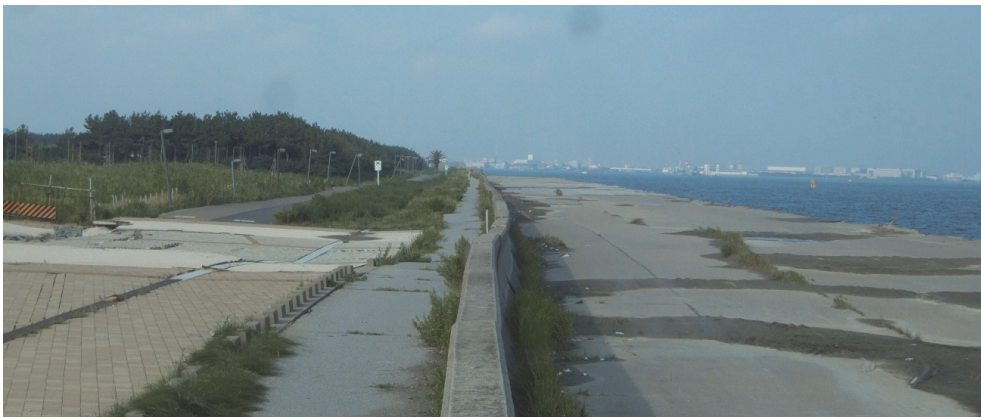
Fig. 7. Seawall pushed forward  
Photo by Konagai K. taken on Aug. 1<sup>st</sup>, 2011 at 35.63666, 139.931638

All these observed features may suggest that the surface soil has spread laterally in the normal direction with respect to the brush of soil subsidence allowing liquefied sand to force its way easily through the crack, though no clear evidence was found there. Lateral spread of the ground was more clearly found near the southeast coast of the city as shown in Fig. 7. Cross-sections AA' before and after the earthquake are compared in Fig. 8. This figure shows that the seawall was pushed about 2m forward associated with a half-meter subsidence of its backfill. A flat foot protection work, which extends over 30m distance from the seawall towards the Tokyo Bay, was also pushed toward the bay with its pavement overriding the toe of the protection work.
