# DETECTION OF LIQUEFACTION-INDUCED SAND BOILING BASED ON SATELLITE IMAGE

**ABSTRACT:** By analyzing high-resolution satellite images, attempts were made to detect liquefaction-induced sand boiling caused by the 2011 off the Pacific Coast of Tohoku earthquake, Japan. As a result, effective detection of sand boiling on road pavements in the studied region could be made by executing a masking treatment on the satellite images using information on the location of roads. In addition to classification using training data, semi-automatic classification without any training data could be successfully applied on the satellite images, while referring to the spectrum data of actual boiled sands that were measured in the field and in the laboratory. .

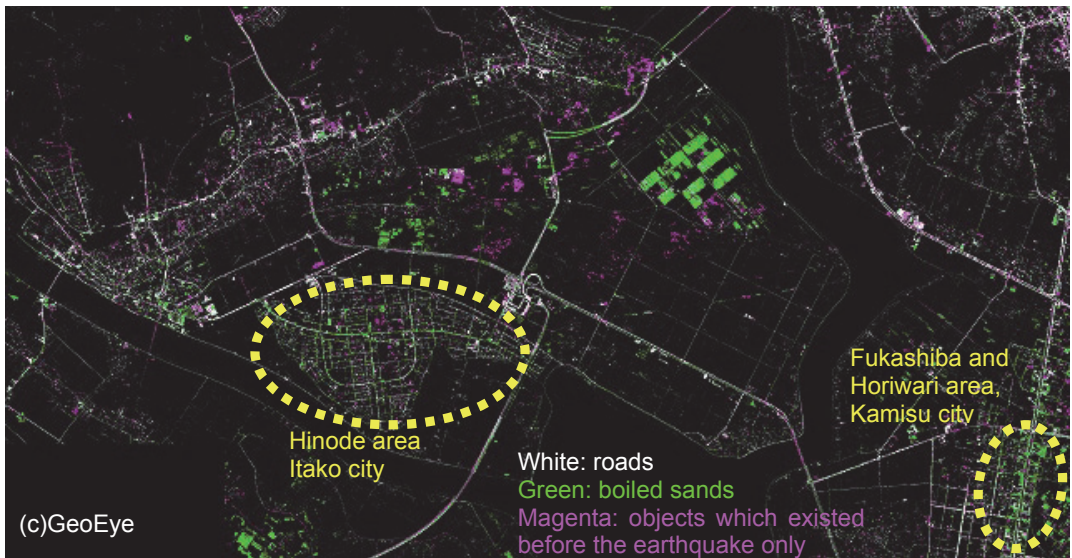
Figure 2 Result from preliminary analysis (Ishikawa and Sawada, 2012)

Figure 2 shows the results of preliminary analysis of satellite images conducted by Ishikawa and Sawada (2012) using the training data that corresponds to typical sand boiling. In the figure, the sites detected as boiled sand were colored in green. In general, the green colors concentrated into two areas,

which correspond to Hinode area in Itako city, and Fukashiba and Horiwari area in Kamisu city. These results are consistent with the results from relevant field surveys (MLIT 2011; Tsukamoto et al., 2012, among others). Photo 1 shows typical sand boiling observed in these areas.

On the other hand, it could be also seen from Figure 2 that the results from the above analysis overestimated the occurrence of sand boiling. Though some structures and farms are colored in green, it has been confirmed by field investigation that no sand boiling was observed in-situ. Such overestimation was possibly caused by their spectral characteristics that were similar to those of boiled sands.

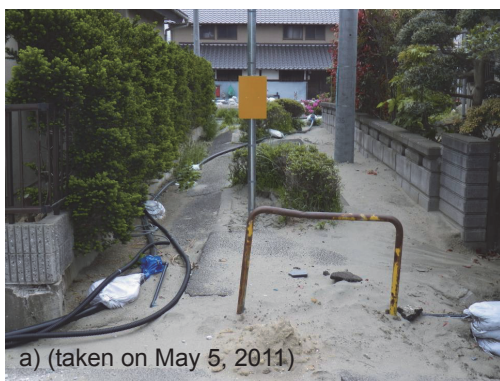
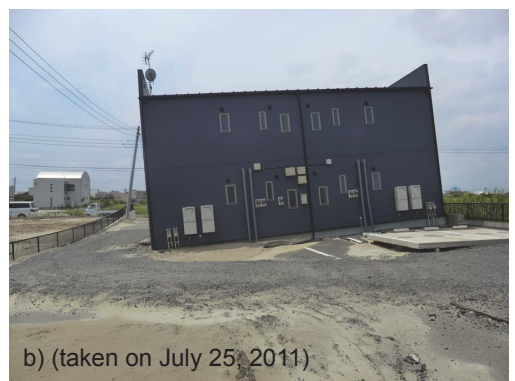
Photo 1 Sand boiling observed in a) Hinode area, Itako city and b) Fukashiba area, Kamisu city

a) (taken on May 5, 2011)

b) (taken on July 25, 2011)

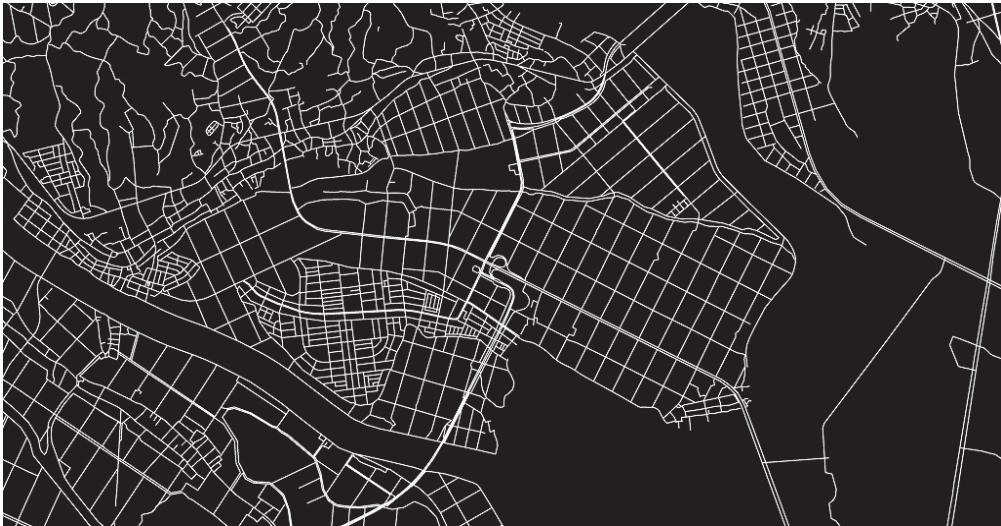
**Figure 3** Location of roads in the studied area (based on OpenStreetMap)

In order to reduce such overestimation, in the current study, a masking treatment on the satellite images was executed by using the information on the location of roads, as shown in Figure 3, which is provided through the service of "OpenStreetMap Japan" (OSMJP 2013). It was expected that the sand boiling on road pavements would have caused similar changes in the spectral characteristics of their satellite images. It should be noted that the information on the location of roads is not complete in the Fukashiba area, as can be seen in Figure 3, and thus this area could not be analyzed with sufficient accuracy in the subsequent analyses.

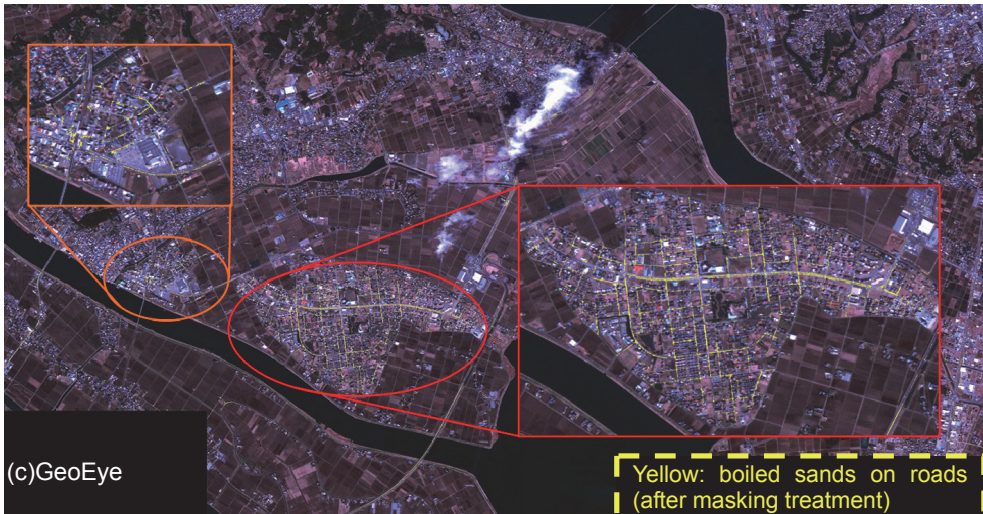
**Figure 4** Result from analysis using training data of typical sand boiling for classification

After the above masking treatment, as shown in Figure 4, the extensive sand boiling on the roads in Hinode area could be effectively detected. In addition, partial occurrence of sand boiling on the roads near JR Itako station could be also detected.

As the results from the above semi-automatic classification, successful detection of boiled sands in Hinode area and around JR Itako station could be made. The areas of boiled sands as shown in Figures 4 and 6 by using the two different kinds of classification matched to each other with a correspondence ratio of about 80 %.

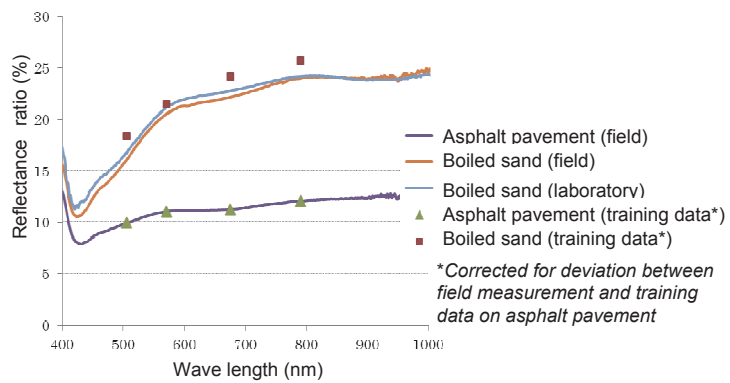
**Figure 5** Spectrum data of boiled sand and asphalt pavement

Figure 5 summarizes the spectrum data of boiled sands and asphalt pavements measured in the field investigations and laboratory experiments in terms of the relationships between the reflectance ratio and the wave length. For comparison, the data derived from the training data that corresponds to typical sand boiling on the satellite image are also shown. A reasonable agreement could be seen among the results from three different kinds of evaluations.

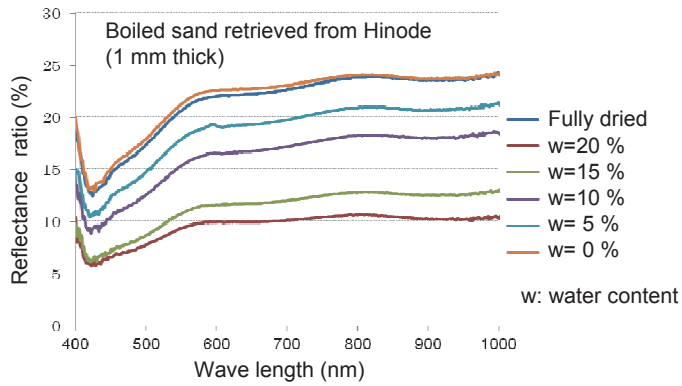
**Figure 6** Spectrum data of boiled sands at different water contents

It was also verified in the laboratory experiments that the thickness of boiled sands did not affect their spectrum data, when they were under dry condition. When they were thicker than 1 mm, the pavement material beneath the boiled sands did not affect their spectrum data, either. On the other hand, as typically shown in Figure 6, it was revealed that the reflectance ratio was reduced with the increase in the water content of boiled sands, while the general shapes of the spectrum data were unchanged.
