# OUT OF PLANE BEHAVIOR OF COMPOSITE RETROFITTED MASONRY WALL SYSTEMS

Saleem M. UMAIR<sup>1</sup>, Muneyoshi NUMADA<sup>2</sup> and Kimiro MEGURO<sup>3</sup>

**ABSTRACT:** The present study deals with the earthquake disaster reduction by the development of new composite material to mitigate the collapse of unreinforced masonry structures (URM) in urban and rural areas in developing countries. Collapse of unreinforced masonry walls causes a large number of human casualties due to a strong ground motion. Masonry walls are relatively strong for in-plane shear and much weaker in out of plane direction resulting collapse of masonry structure. Being highly expensive, FRP is a strong material and can significantly increase the out of plane bending strength of masonry walls. Being an expensive material, FRP exhibits a highly catastrophic brittle failure under extreme loading leaving no warning and evacuation time for residents. On the contrary, polypropylene band (PP-band) is a cheap material with much larger ductility and holding capacity to avoid sudden failure, caused by the breaking of wall into small fragments which has been found as a major cause of casualties. In this study, an at

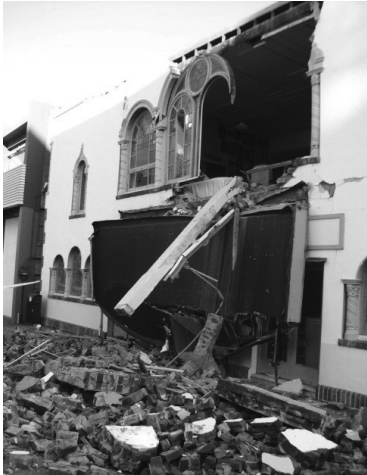
(a): Canterbury, New Zealand

**Figure 1.** Typical out-of-plane failure of an unreinforced masonry

Figure 1(a) shows typical out-of-plane failure of an unreinforced masonry wall on the second level of 146 Kilmore Street in Canterbury New Zealand [EERI, 2012]. The light blue concrete column, hanging from the second floor, has no reinforcement. Figure 1(b) shows the out of failure of masonry house during Van, Turkey Earthquake of October 23, 2011 [EERI, 2012].

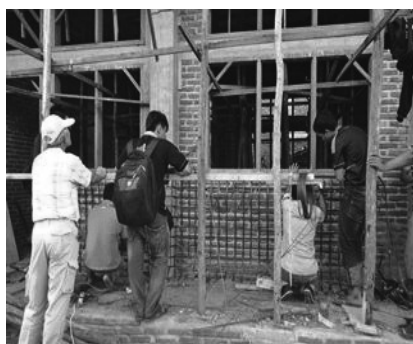
(a) PP-band retrofitting of a masonry house in Indonesia

**Figure 2.** Retrofitting of masonry wall using PP-band in the field and laboratory

Meguro and Mayorca [Meguro and Mayorca, 2003] have developed polypropylene band (PP-band) retrofitting method considering economic affordability, local acceptability, material availability and technological applicability required for retrofitting. PP-band is a very cheap material with fairly large deformation capacity. Main objective of PP-band retrofitting is to hold the masonry components into a single unit and to prevent the collapse of masonry structure. After carrying out a series of experiments ranging from small-scale model to full-scale masonry house, it was found that PP-band retrofitted walls can withstand much stronger input ground motion without collapse [Meguro et al, 2005].

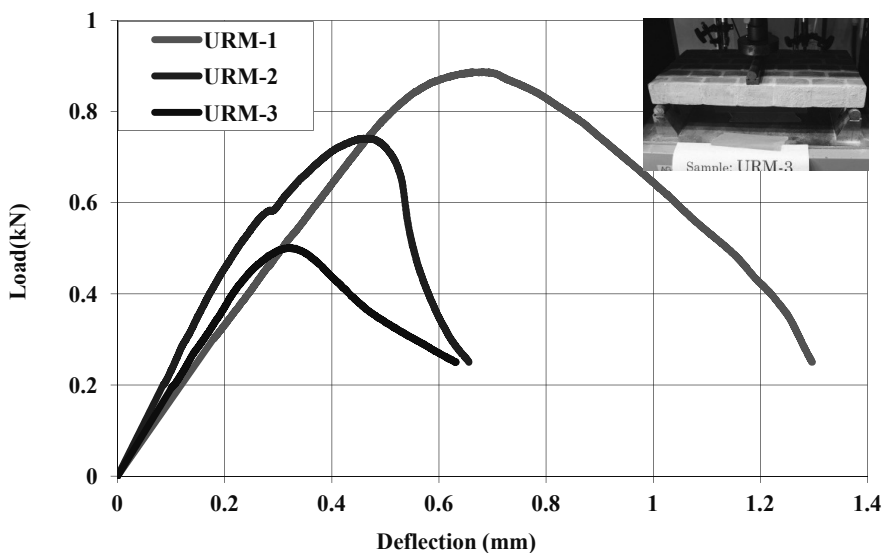
One of the main focuses of experimental results was load-displacement curves of masonry wallets. Figure 5 shows the load displacement curve of non-retrofitted masonry wallets. All URM specimens are tested using same loading rate of 0.1mm/min. Although preparation, curing and testing conditions of masonry wallets were similar still the non-retrofitted wallets show a variety of peak strength with an average value of 0.7 kN with almost similar initial stiffness. Behaviour of wallets was almost linear up to the peak value. Sliding type of failure has been observed exhibiting a weak brick mortar joint at vertical displacement range from 0.6mm to 1.2mm as shown in Fig.5 (a).

Figure 5. Load-displacement curves of non-retrofitted masonry wallets

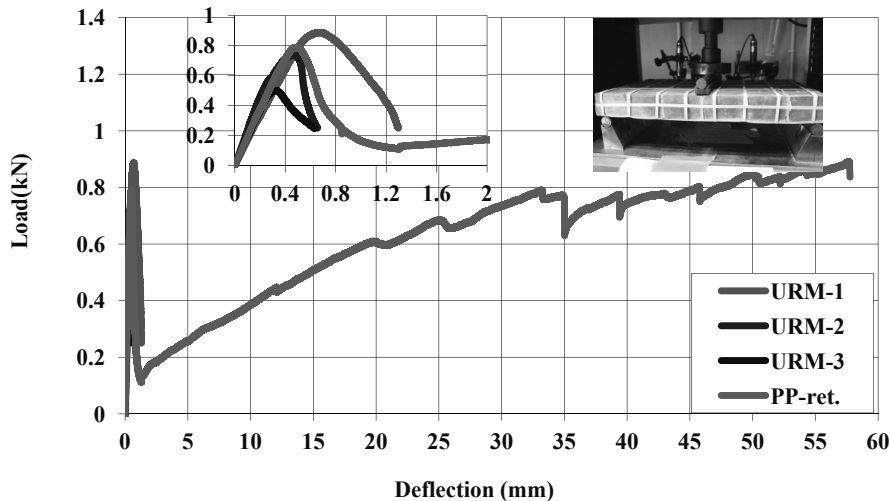
Figure 6 shows the load displacement curve of PP-band retrofitted masonry wallet. It has shown almost similar initial stiffness and peak strength of 0.79 kN which is almost same as that of non-retrofitted masonry wallet. Up to initial peak loading rate of 0.1mm/min is used and after that the test was continued at a loading rate of 2.0 mm/min. In case of PP-band retrofitted masonry wallet after the displacement of 1.2 mm/min the sample again started taking load with some reduced stiffness, even it has gone up to a displacement of 57.7 mm with a load value of 0.88 kN. PP-band retrofitted masonry wallet has shown a fairly long deflection and deformation as compared to URM masonry wallets

**Figure 6.** Load-displacement curves of non- retrofitted masonry wallets and PP-band retrofitted masonry wallet

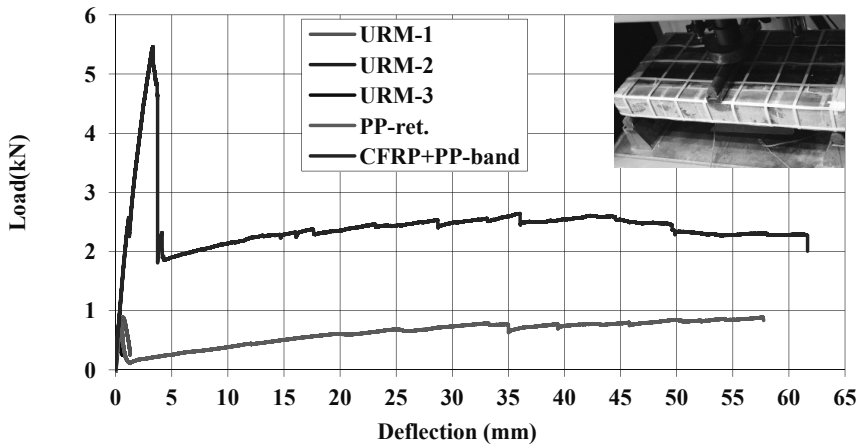
Figure 8 shows the load-displacement curve for URM, PP-band retrofitted and CFRP+PP-band retrofitted. In case of CFRP+PP-band retrofitted masonry wallet initial strength of URM is increase from 0.8kN to 5.5kN and displacement carrying capacity is also increased from 1.2mm to 62mm. After the peak strength of 5.5kN, there is a sudden drop but still CFRP+PP-band retrofitted masonry wallet has shown a good residual strength up to the final failure of wallet. Proposed composite material has increased initial strength, deformation capacity, and residual strength of non-retrofitted masonry wallet.

**Figure 8.** Load-displacement curves of non-retrofitted masonry wallets, PP-band retrofitted and CFRP+PP-band retrofitted masonry wallet

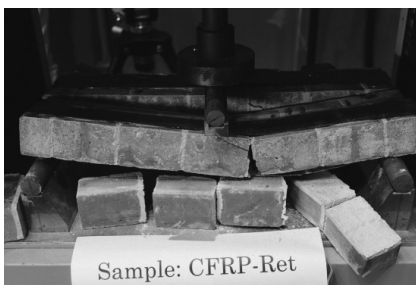
Figure 9 shows that failure pattern of different type of masonry wallets under out of plane loading. Figure 9 (a) shows a pure bending type of failure with major central cracking with spalling of bricks in the central part of masonry wallets. There were no signs of shear failure near supports. Figure 9 (b) shows that PP-band retrofitted masonry wallet failure. It is almost same type of failure as that of URM but PP-band kept holds the masonry units. As PP-band is attached with the out of plane connectors, so it has not provided any increase in bending strength but after the peak, it kept the brick unit as single mass to further take load up to a displacement of 58 mm as shown in Fig 6. Figure 9 (c) shows the failure of CFRP- retrofitted masonry wallet. CFRP- retrofitted masonry wallet has shown a step wise failure initiated with the fall of inner and outer brick layers. Failure of wallet was mainly due to detachment and debonding of CFRP from brick surface. CFRP+PP-band retrofired masonry wallet failure has shown in the Fig 9 (d). Use of PP-band along with the CFRP has changed the failure mode of only CFRP retrofitted masonry wallet as the step was failure is vanished. In CFRP retrofitted case the wallet was disintegrated into longitudinal strips but CFRP+PP-band retrofitted masonry wallet has avoided the delamination of brick layers form the wallet. It kept hold the entire brick mas into a single system even up to the final failure of masonry wallet.

(c) Failure pattern of CFRP-retrofitted masonry wallet
