MONOTONIC AND CYCLIC UNDRAINED TORSIONAL SIMPLE SHEAR BEHAVIOR OF ASO KUMAMOTO PUMICE SOIL

Muhammad UMAR¹, Gabriele CHIARO² and Takashi KIYOTA³

ABSTRACT: The 2016 Kumamoto Earthquake Sequence caused a number of geodisasters in the Mount Aso Caldera, including a large-scale flow-type slope failure known as the Takanodai landslide. Between April and October 2016, the authors conducted a series of geotechnical damage surveys and field investigations in the landslide area, and retrieved samples of volcanic soils to be characterized in the laboratory. In an attempt to provide insights into the failure mechanism of the Takanodai landslide, this paper reports on preliminary results of monotonic and cyclic undrained torsional simple shear tests carried out on reconstituted specimens of Aso pumice soil. The test results revealed that Aso pumice soil has the tendency to show a flow-type failure behavior characterized by an abrupt develop of large shear strains exceeding 50% when subjected to monotonic torsional shear loadings. On the contrary, under cyclic shear stress condition, a progressive build-up of excess pore water pressure was observed until the stress state reached the failure en

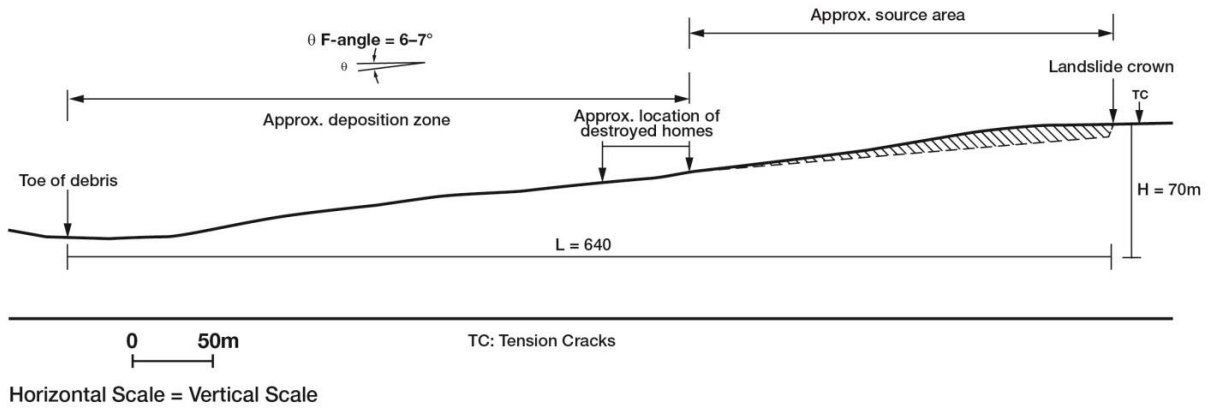
Figure 2. Cross-section A-A' through the Takanodai landslide (Chiaro et al., 2017)

Field observations indicated that the Takanodai landslide was a mobile earth slide that developed into a flow-type slide on a low angle slope (around 10-15°), with a travel angle from landslide crown to debris toe of approximately 6°. As shown in Figure 1, the landslide travelled in three different directions from a common source. The landslide was about 100m in width, 300-600m in length and 5-10m in depth. Relatively large intact blocks of soil, grass and trees (Photos 1 and 2) travelled towards the toe of the slope suggesting a translational movement of the soil. Tension cracks and scarps above the head scarp adjacent the Aso Volcanological Laboratory were widely observed, indicating the potential for head scarp retrogression and/or new incipient landslides to occur. As shown in Photo 3, the slip surface was identified and traces of orange-colored pumice soil were clearly noted on it.

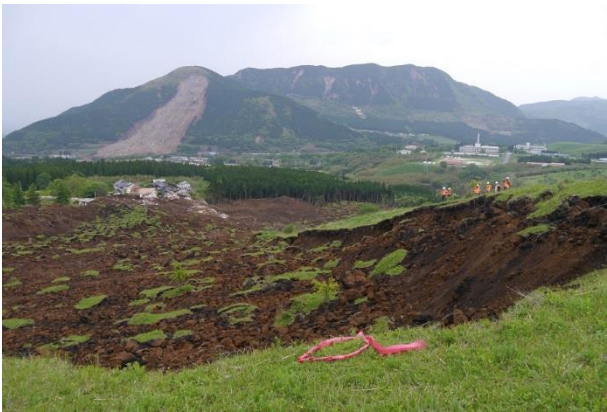
Photo 1: View of the Takanodai landslide (looking downhill), with damaged houses and the large debris avalanche at Aso Ohashi Bridge visible in the distance

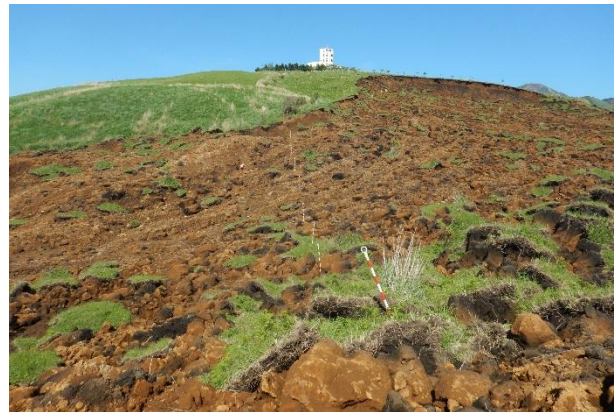
Photo 2: View of the Takanodai landslide (looking uphill), with the Aso Volcanological Laboratory visible in the distance

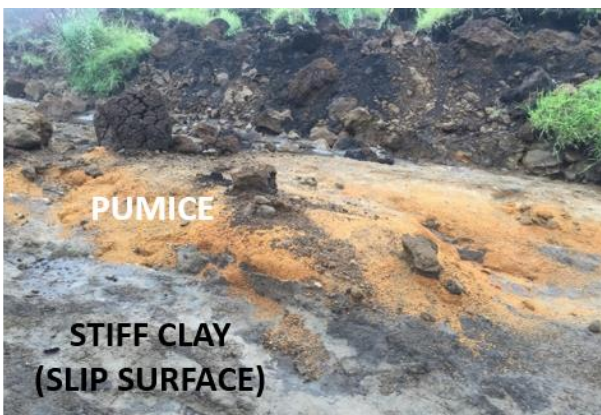
Photo 3. Traces of pumice soil on the slip surface

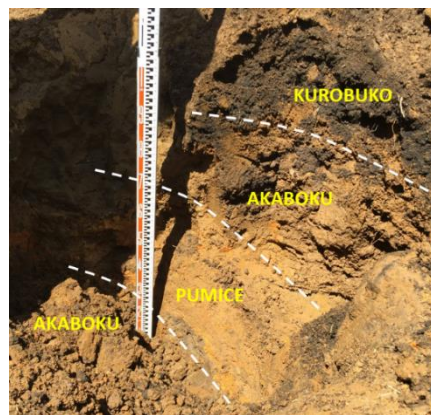
Photo 4. Soils exposed in wall of a trial pit excavated in the northern flank of the landslide

Two small trial pits were excavated across the assumed slide surface. Soil exposed in the trial pit is shown in Photo 4, and a borehole describing a typical soil profile up to the depth of 14m is reported in Figure 4. The soil consists of (1) Kuroboku volcanic ash with organic contents (black color); (2) volcanic ash Akaboku (red/brown color); (3) pumice soil; and (4) soft/weathered rock. It is worth to mention that water seepage within the pumice soil layer was clearly observed, indicating that the Akaboku ash soil (clay-like soil) is much less permeable than the pumice soil.

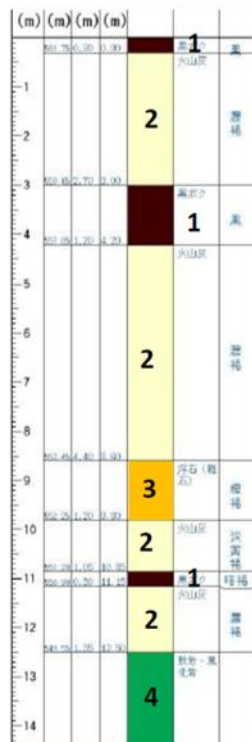
- 1) Kuroboku soil;
- 2) Akaboku soil;
- 3) Pumice soil;
- 4) Soft/weathered rock

Figure 3. Typical borehole data around Aso Volcanological Laboratory

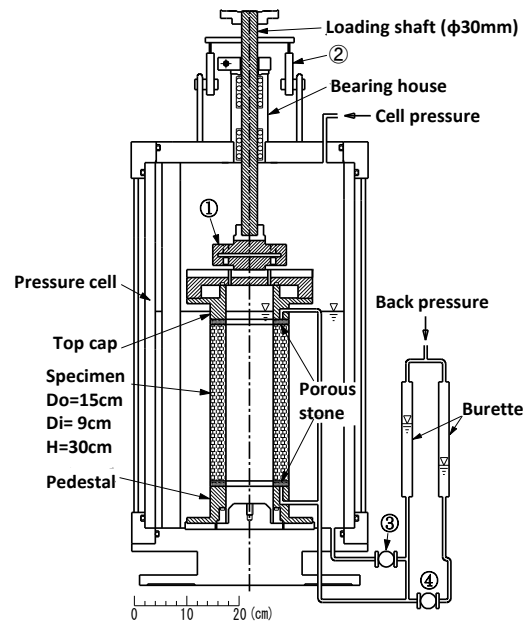
- ① Two-component load cell
- ② Large vertical displacement transducer
- ③ High capacity differential pressure transducer (confining pressure)
- ④ Low capacity differential pressure transducer (volume change)

Figure 4. Torsional shear apparatus employed in this study (after Kiyota et al., 2008)

Laboratory testing was carried out using the fully automated torsional apparatus shown in Figure 4, which has been developed in the Institute of Industrial Science, University of Tokyo (Kiyota et al., 2008). Such a device is capable of achieving double amplitude shear strain levels exceeding 100% by using a belt-driven torsional loading system that is connected to an AC servo motor through electromagnetic clutches and a series of reduction gears. Torque moment and axial load are measured by a two-component load cell, which is installed inside the pressure cell. The axial load and torque moment capacities are 8kN and 0.15kNm, respectively. Difference in pressure levels between the cell pressure and the pore water pressure are measured by a high-capacity differential pressure transducer (HCDPT) with a capacity of over 600kPa. On the other hand, volume change during the consolidation process is measured by low-capacity differential pressure transducer (LCDPT). A potentiometer with a wire and a pulley is employed to measure the rotation angle of the top cap and, thus, the large torsional deformation. Shear stress amplitude is controlled by a computer, which monitors the outputs from the load cell, computes the corresponding stress value and controls the device accordingly. It should be noted that the measured shear stress is corrected for the effects of the membrane force by using the hyperbolic equation proposed by Chiaro et al. (2015).

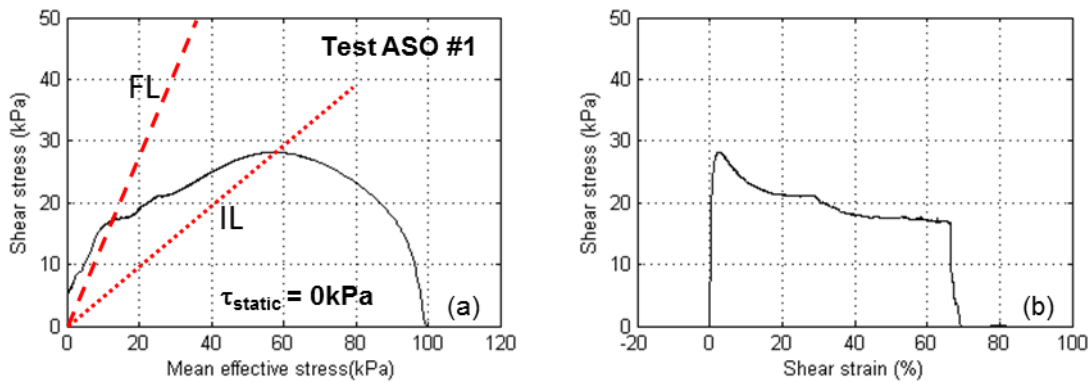
Figure 5. Test ASO #1: a) effective stress path; and b) stress strain relationship

Figures 5 and 6 show the results of monotonic undrained torsional simple shear tests, in terms of effective stress paths and stress-strain relationships. For the sake of comparison, typical monotonic torsional shear behavior of Toyoura sand is illustrated in Figure 7.

As shown by Figs. 5a and 6a, under the stress conditions used in this study, Aso pumice soil exhibited a purely contractive behavior, during which the mean effective stress (p') decreases while shear stress (τ) progressively increases up to a transient peak stress (in correspondence of the instability line or IL line). The peak stress state is accompanied by an unstable behavior (Lade, 1993) with a sudden loss of strength and a large development of pore water pressure and shear strains.

In addition, by looking at the stress-strain responses (Figs. 5b and 6b), strain-softening behavior (i.e. decrease in shear strength owing to shear strain increase) can be observed after the transient peak stress. Moreover, Aso pumice soil showed a tendency to deform under a nearly constant stress (residual shear strength).

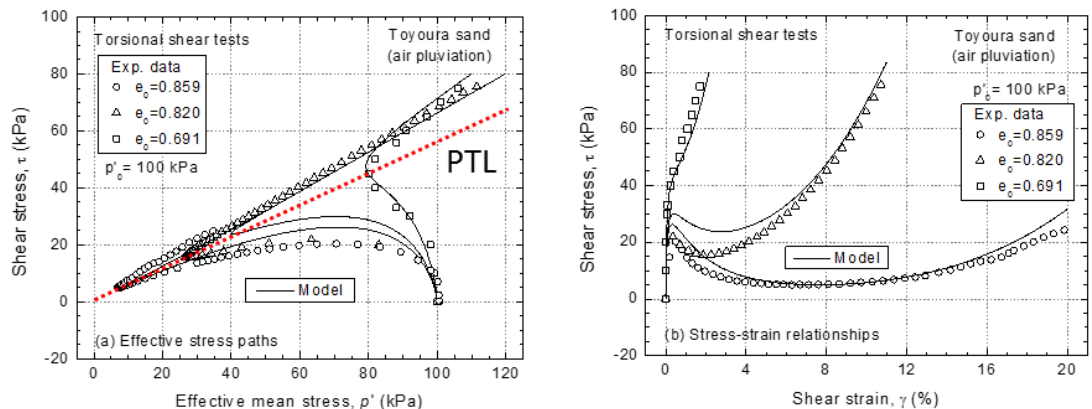
Figure 7. Monotonic undrained torsional shear behavior of Toyoura sand (Chiaro et al., 2013)

When compared with the response of Toyoura sand shown in Fig. 7, it seems that Aso pumice soil behaves similarly to a medium-dense sand specimen. However, some difference can be seen. For example, while a medium-dense sand specimen usually behaves first contractive and then dilative (p' increases after reaching the phase transformation line), Aso pumice soil behaves purely contractive and the shear stress suddenly drops after reaching the failure envelop line (FL). Therefore a clear PTL line cannot be established for Aso pumice soil. Moreover, while after the quasi-steady stage medium-dense sand experiences a limited strain development, Aso pumice soil undergoes large strain development. This different behavior may be attributed to: 1) the low crushability of sand particles (hard grained material) as compared to that of Aso pumice (crushable volcanic soil); and 2) different soil structure.

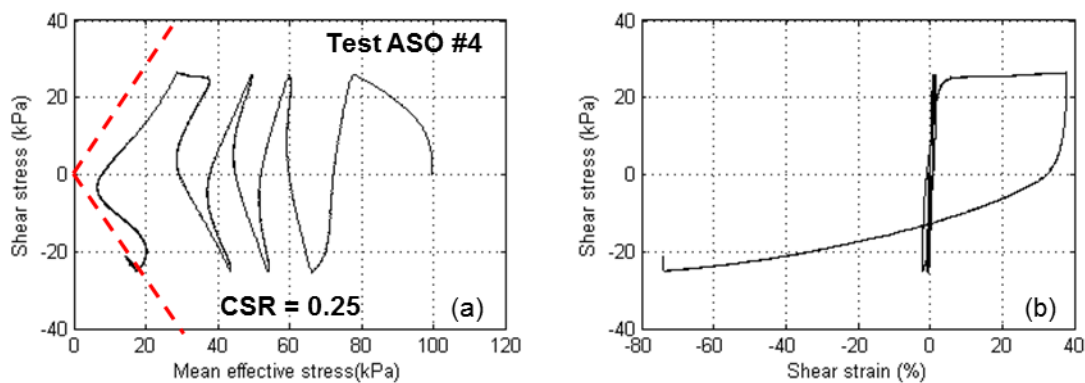
Figure 9. Test ASO #4: a) effective stress path; and b) stress strain relationship

Undrained shear tests were performed using two level of cyclic stress ratio ($CSR = \tau_{cyclic}/p_0'$) of 0.20 and 0.25. Figures 8 and 9 show typical effective stress paths with their associate stress-strain plots. In both tests, Aso pumice soil showed a cyclic mobility failure type where the effective stress path progressively moves toward the zero- p' conditions but the cyclic shear strain increases up to large values. In particular, initially the shear strain were very small and then suddenly exceed values of double amplitude shear strain (γ_{DA}) of 50% or more during the last few cycles of loading as p' approached zero. Hyodo et al. (1998) presented similar behavior for the crushable Shirasu soil (a volcanic soil from southern Kyushu) subjected to cyclic triaxial shearing.

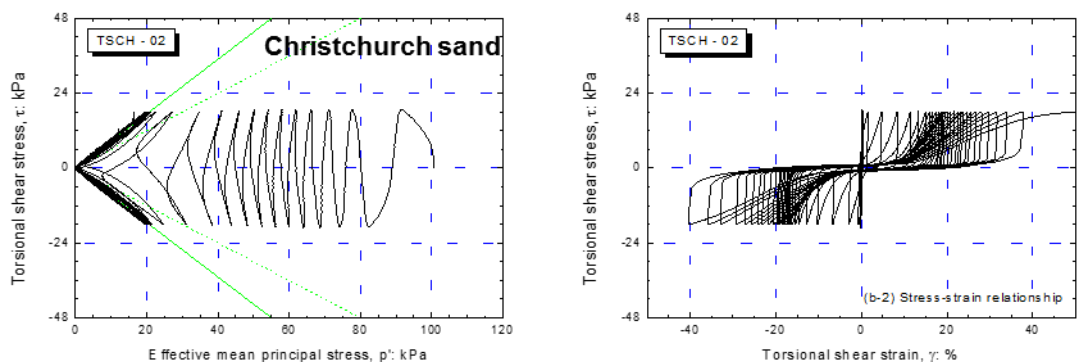
Figure 10. Cyclic undrained torsional shear behavior of Christchurch sand (Chiaro et al., 2015)

It is noted that, the undrained cyclic behavior observed in this study for Aso pumice soil is quite different from that of a liquefied sandy soil for which large strain are developed under stress condition of zero- p' and zero shear stress (Fig. 10).

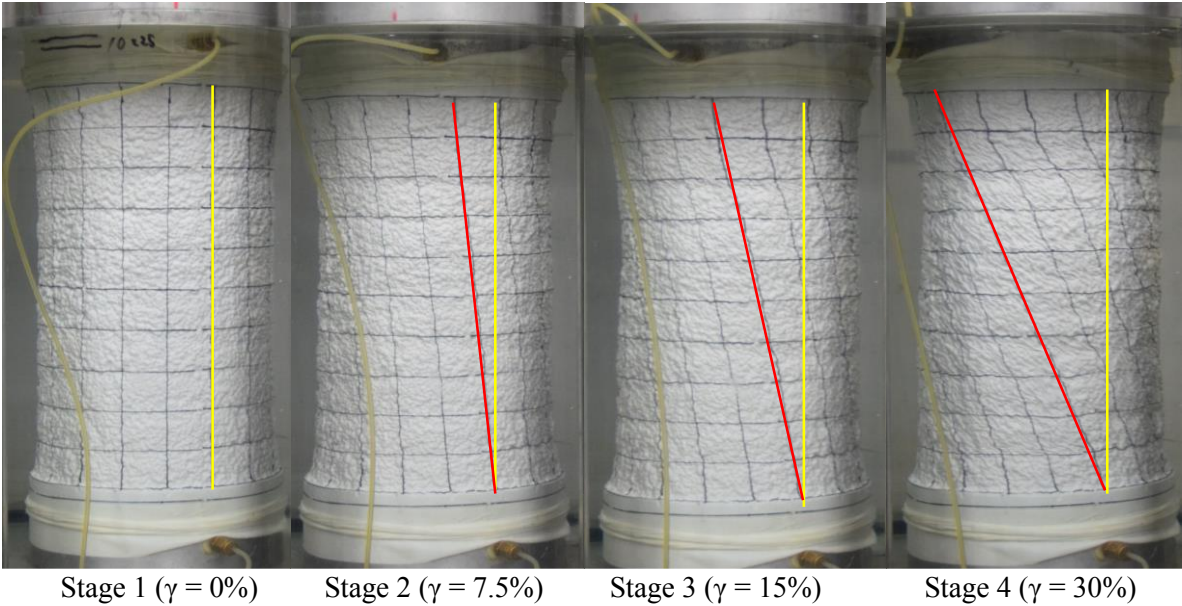
Photo 5. Typical deformation of Aso pumice specimens in cyclic undrained torsional shear tests

For completeness, the deformation characteristics of Aso pumice specimen at various states of shearing during Test ASO #3 are shown in Photo 5. At state 2, corresponding to a shear strain (γ) of about 7.5 %, the deformation was uniform throughout the specimen height. At state 3 ($\gamma = 15 %$), the deformation was still rather uniform. However, at stage 4 ($\gamma = 30 %$), it appears that strain localization started to develop in the upper part of the specimen.

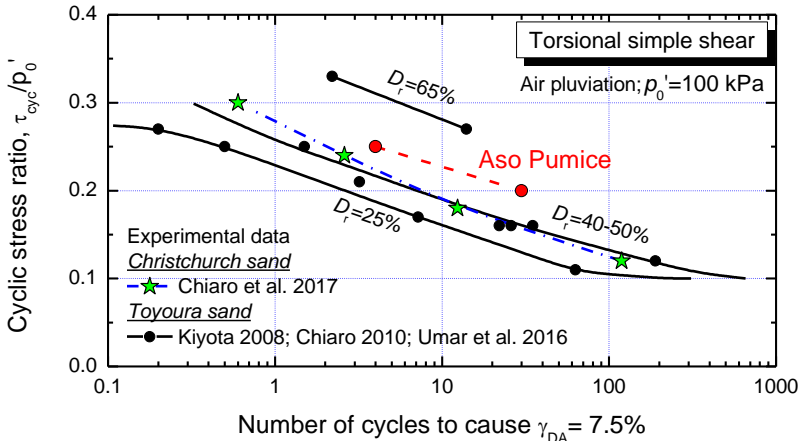
Figure 11. Cyclic strength curves for double strain amplitude 7.5%

Conventionally, the resistance to liquefaction or to cyclic strain accumulation of soils is evaluated as the number of cycles to develop a specific amount of double amplitude shear strain (γ_{DA}) during cyclic loading. Accordingly, Fig. 11 reports the liquefaction resistance of Aso pumice soil corresponding to a at double amplitude shear strain (γ_{DA}) of 7.5%, which is equivalent a double amplitude shear strain of 5% in triaxial tests. In the same figure, liquefaction resistances of Toyoura sand and Christchurch sand (both hard grained soils) are reported for comparison.

Despite the differences in cyclic behavior previously described, it appears that the liquefaction resistance of crushable Aso Pumice soil can be closely related to that of less-crushable medium-dense sandy soils.
