SOIL LIQUEFACTION AND DAMAGE TO SOIL STRUCTURE
DURING THE EARTHQUAKE OFF MIYAGI PREFECTURE ON
JUNE 12TH, 1978

SYNOPSIS

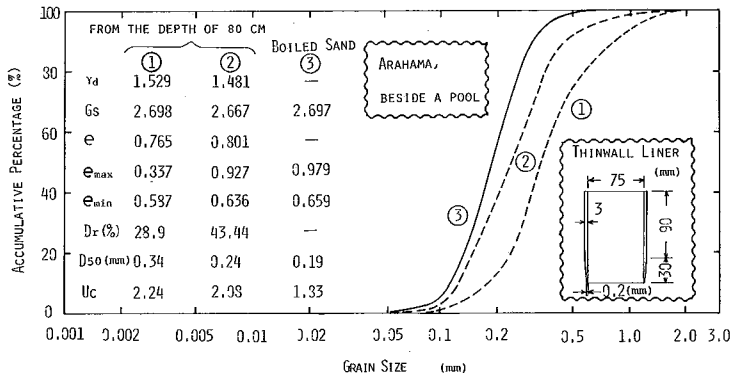
Fig. 4. Gradings and Physical Properties of Sands from Arahama

ARAHAMA: At a National Recreational Area which is located behind a sand dune on the right bank at the mouth of Abukuma River, several cracks opened during the earthquake from which water spouted (see Photo. 1). The bottom face of a swimming pool was cracked by upward flow of excessive porepressure generated during the earthquake (see Photo. 2). Also, one side of a septic tank floated up 40 cm above the ground surface as shown in Photo. 3 and Fig. 2. Sand boils were observed only on the displaced side. Cone penetration tests were conducted at five points using a double tube cone penetrometer as illustrated in Fig. 2. At three locations, resistances

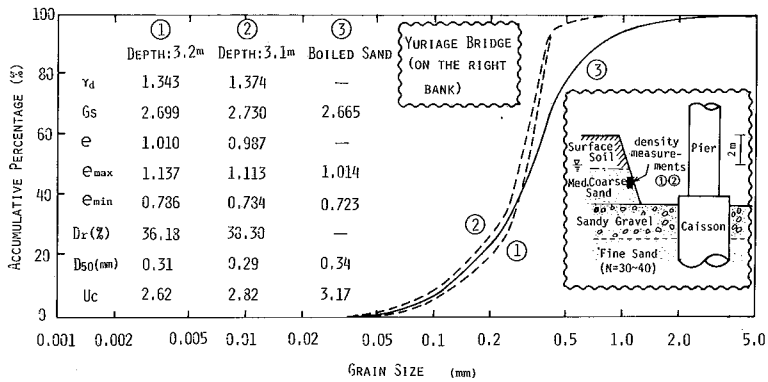
Fig. 5. Gradings and Physical Properties of Sands from the High Water Channel of Natori River at Yuriage Bridge

A deep trench was subsequently dug using the well-point method around the pier which is placed nearest to the embankment on the right bank (see Fig. 5 and Photo. 6). This trench was dug to check whether the underground part of the pier was damaged or not. Any crack was not observed. In the trench, loose coarse sand layer of about 2 m thick was found. By the same method as done at Arahama, in situ density of the sand layer was measured in the trench as shown in Fig. 5. As shown in Fig. 5, measured relative densities was 36% and 38% which show a loosely packed state of the sand layer. By the results of the geotechnical survey which was conducted beforehand for the design of the bridge, this loose coarse

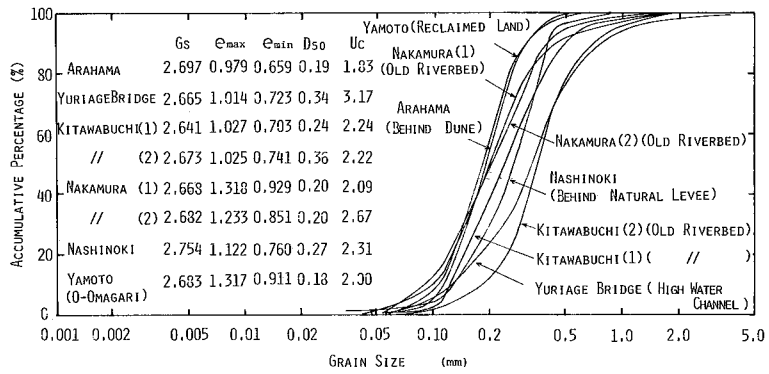
Fig.6. Gradings and Physical Properties of Boiled Sands

Fig. 6 shows the grain size distributions of boiled sands several sites in Miyagi Prefecture. These sites are indicated in Fig. 1. The mean diameter D_{50} for these sands ranges from 0.2 to 0.4 mm and the coefficient of uniformity U_c is small. These grading characteristics are similar to sands in Niigata City liquefied during the Niigata Earthquake of 1964.

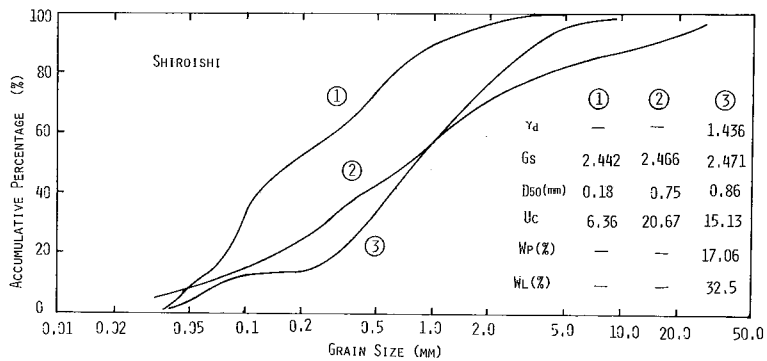
Fig.8. Gradings and Physical Properties of Materials Sampled from Slipped Embankment at Shiroishi

MIDORIGAOKA AT SHIROISHI: At this place, a fill made for residential houses slid fluidly. This fill was made in a small valley using volcanic loam and scoria. The gradings of soils sampled from the slid fill were shown in Fig. 8. It is reported that there used to be a small pond at the bottom of the existing fill. And it was observed at the site that the saturated soil of the fill becomes fluidy one when remolded.
