SEISMIC PERFORMANCE OF MEDIUM- AND HIGH-RISE REINFORCED
CONCRETE BUILDINGS TO TANGSHAN EARTHQUAKE 1976

Kaishun WANG I) and Tsuneo OKADA II)

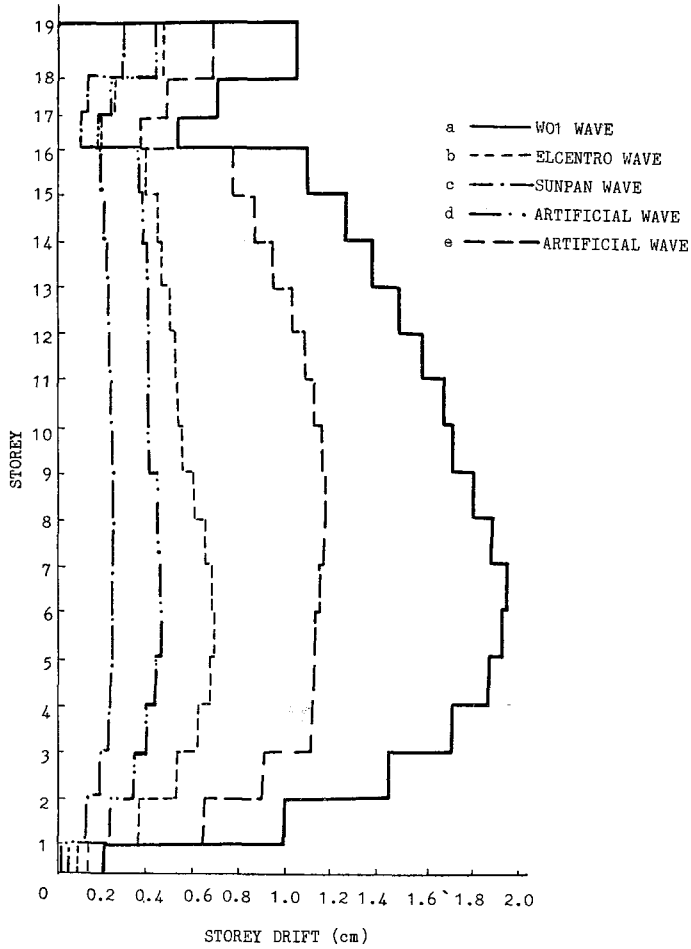
Fig.1 Response Displacements of Apartment Building #10

Further analyses were done using several earthquake waves as input ground accelerations. Their maximum acceleration values were all adjusted to 200 gals. The calculated envelopes of storey drift are shown in Fig.1. The input earthquake waves are as follows: a) earthquake W01, b) El Centro earthquake of May 18th, 1940 (NS components), c) Sunpan earthquake of Aug. 16th, 1976 in China (S60°E components), M=7.2, d) artificial stochastic seismic wave conformed to the standard spectrum of Type II site soil (medium soils) according to Chinese Code, and e) artificial stochastic seismic wave conformed to the response spectrum of apartment No.10 site soil of which the thickness is 104 meters.

Fig.1 shows that the response value calculated by observed W01 is about 4-5 times of that obtained from standard spectrum. The response to the waves b) and c) are quite small. Only the value obtained from the waves e) approaches the observed one. The response obtained from standard spectrum appears to be quite small because the criterion in classifying soil condi-

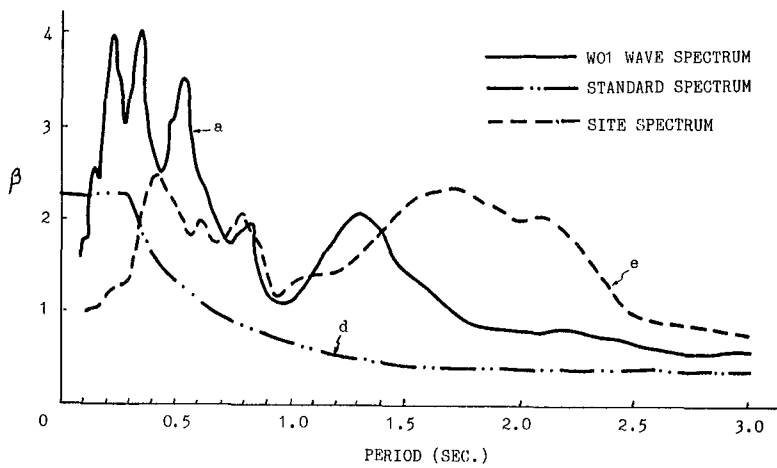
Fig.2 Response Spectra

The comparison of three response spectra is shown in Fig.2: curve d) is standard spectrum of Type II site soil, and curves e) and a) are response spectra of seismic waves e) and a) mentioned above, respectively. It appears that spectrum d) can not express the site properties of the apartment.

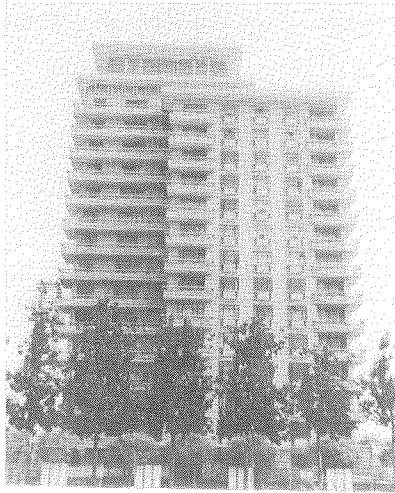
Photo 1 Apartment Building #10, Beijing
Photo 2 Tianjin Friendship Hotel
Photo 3 Expansion Joint of
Tianjin Friendship Hotel
Photo 4 Railing of Tianjin Friendship Hotel
Photo 5 Tianjin Alkali Factory
