## URGENT REPORT ON THE CHIBAKEN-TOHHO-OKI EARTHQUAKE OF 1987\*

Choshiro TAMURA<sup>1)</sup> and Kazuo KONAGAI<sup>2)</sup>

## 1. PREFACE

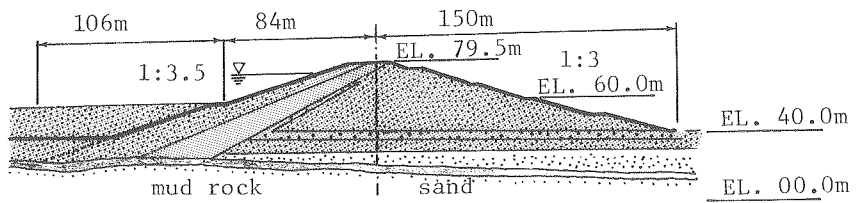
Fig. 3 Standard cross-section of Nagara Dam

On Dec. 27, we inspected the Nagara Dam ( $\Delta=35$ km, earth dam, 52m in height) near the Inunari Village where some severe damages on houses and graves were seen. The schematic view of this dam was shown in Fig.3. We found some cracks on the pavement on the top of the dam, and a long and narrow soiled portion with width of about 10cm on the concrete wall of the spillway. This shows clearly that the embankment settled more than 10cm. The Moroichi Bridge crossing this spillway are pinned to abutments on both sides, and street drains on the abutments were crushed. However, there was no damage which brought the functional disorder into the dam.

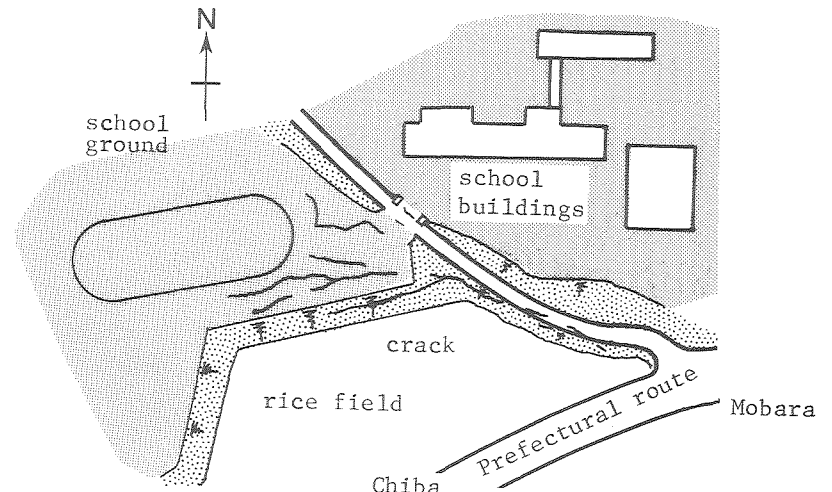
Fig. 4 Nagara junior high school

Damages to school grounds of sand banked up on soft soil deposits stood out clearly. The schematic map of the Nagara Junior-High School is shown in Fig.4. In this school, we could see a long cracks running across the school ground and reaching the access road. The half side of the ground which faces a rice field subsided to an extent of 7cm, and the thin steel tape inserted in the opened crack reached at the depth of 1.75m.

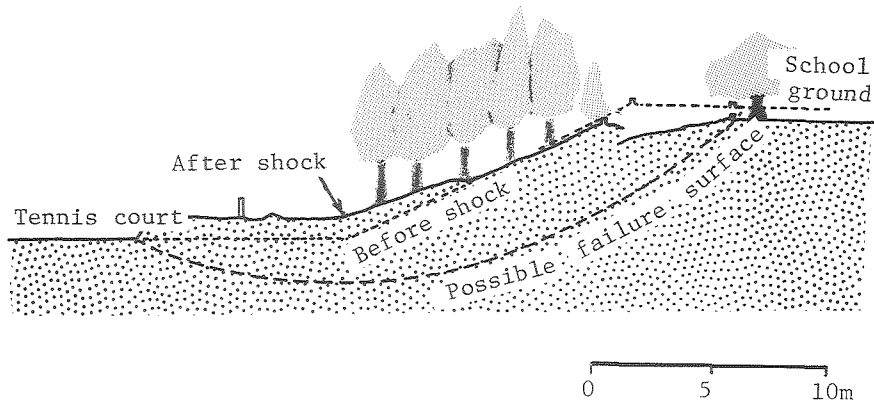
Fig. 5 Schematic cross section of damaged slope

In the Chonan Junior-High School, the school ground constructed on a sandy banking with the height of about 5m was settled over the whole surface, and some evidences of liquefaction were seen in places. North part of this ground and the access road to school buildings were severely damaged by a slide of slopes(Fig.5). The slid area is about 25m in width and 30m in length. This slide resulted in an upheave of the tennis court
