**DAMAGE REPORT OF THE BIHAR NEPAL EARTHQUAKE
OF AUGUST 21, 1988**

Rajiv DUGGAL (I)
and
Nobuhiko SATO (II)

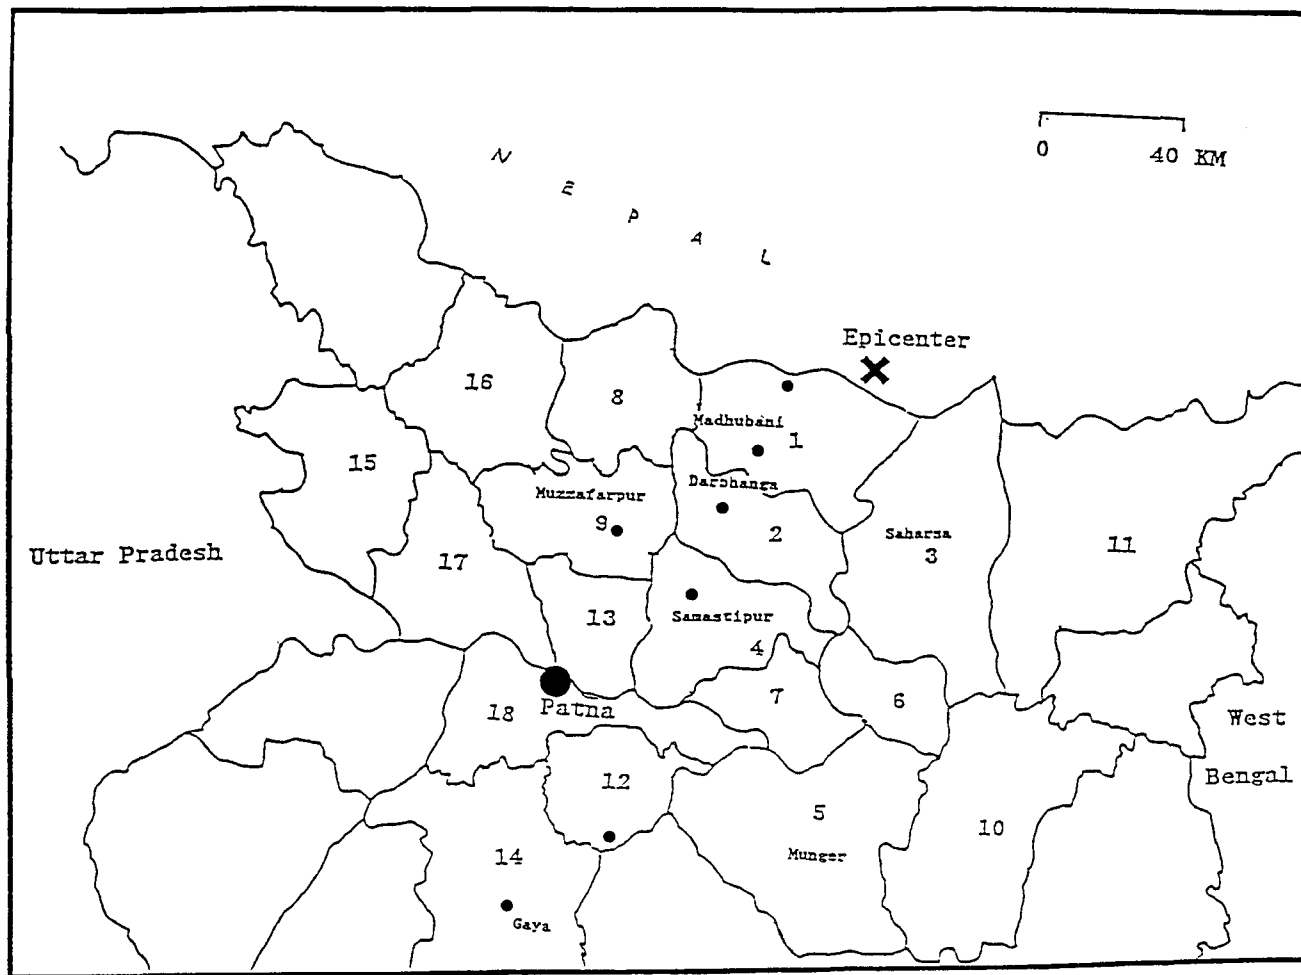
Fig. 2 Earthquake Affected Districts in Bihar State

and Khagaria (see Figure 2 and Table 2; note that the districts are numbered in Figure 2 in the order of their appearance in Table 2). The damage in India was light to moderate, with most modern reinforced structures including bridges, water tanks etc. remaining unscathed. The quake affected mainly old and poorly built houses and masonry buildings already weakened by the previous 1934 strong tremor.

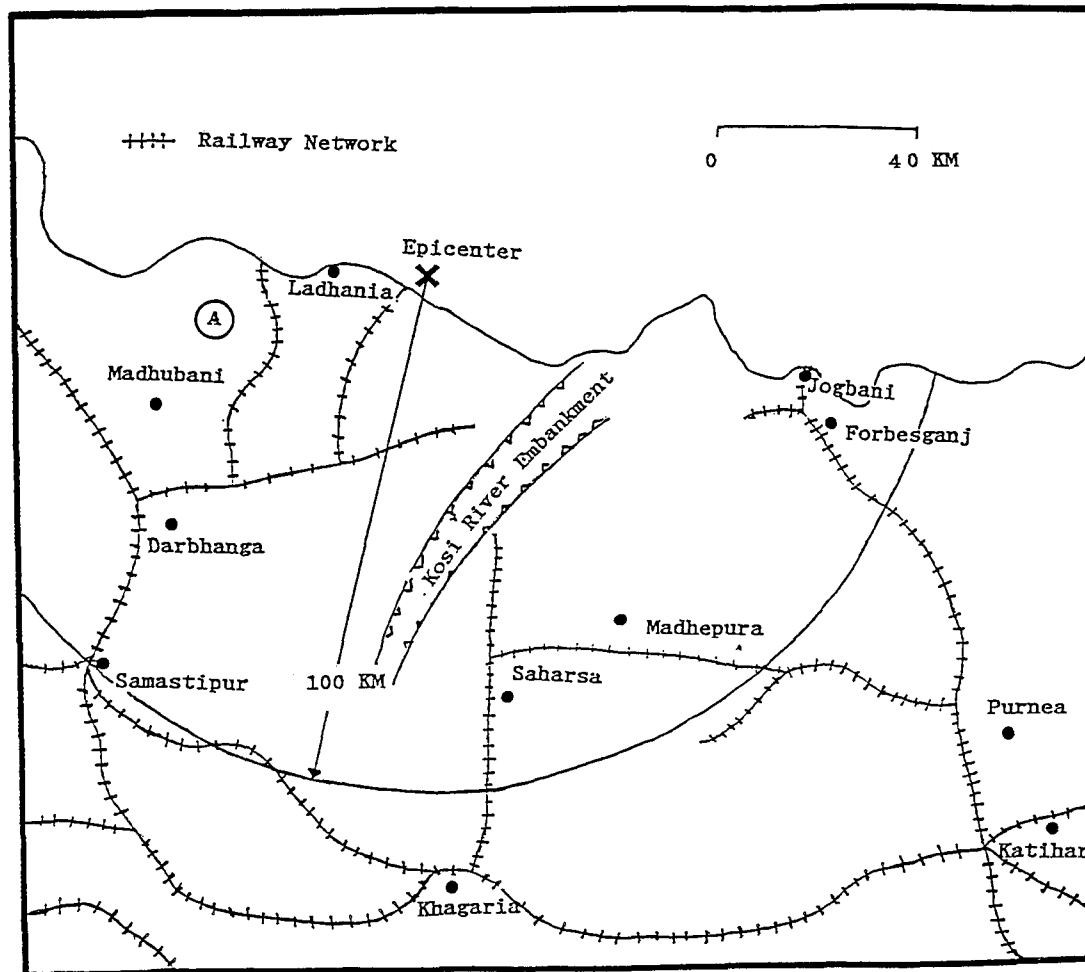
Fig. 8 Railway network and River embankments
in the affected area in India

Railway facilities: Figure 8 shows the railway network in the earthquake affected region. The girder bridge over river Gandhak,

Embankments: The river embankment over Butahi Balan in Madhubani district (marked (A) in Figure 8) and the western and eastern embankments of river Kosi developed longitudinal cracks.
