## **RECONNAISSANCE REPORT ON STRUCTURAL DAMAGE IN BAGUIO BY THE JULY 16, 1990 LUZON EARTHQUAKE**

by :  
Gilbert L. MOLAS\* and Fumio YAMAZAKI\*\*

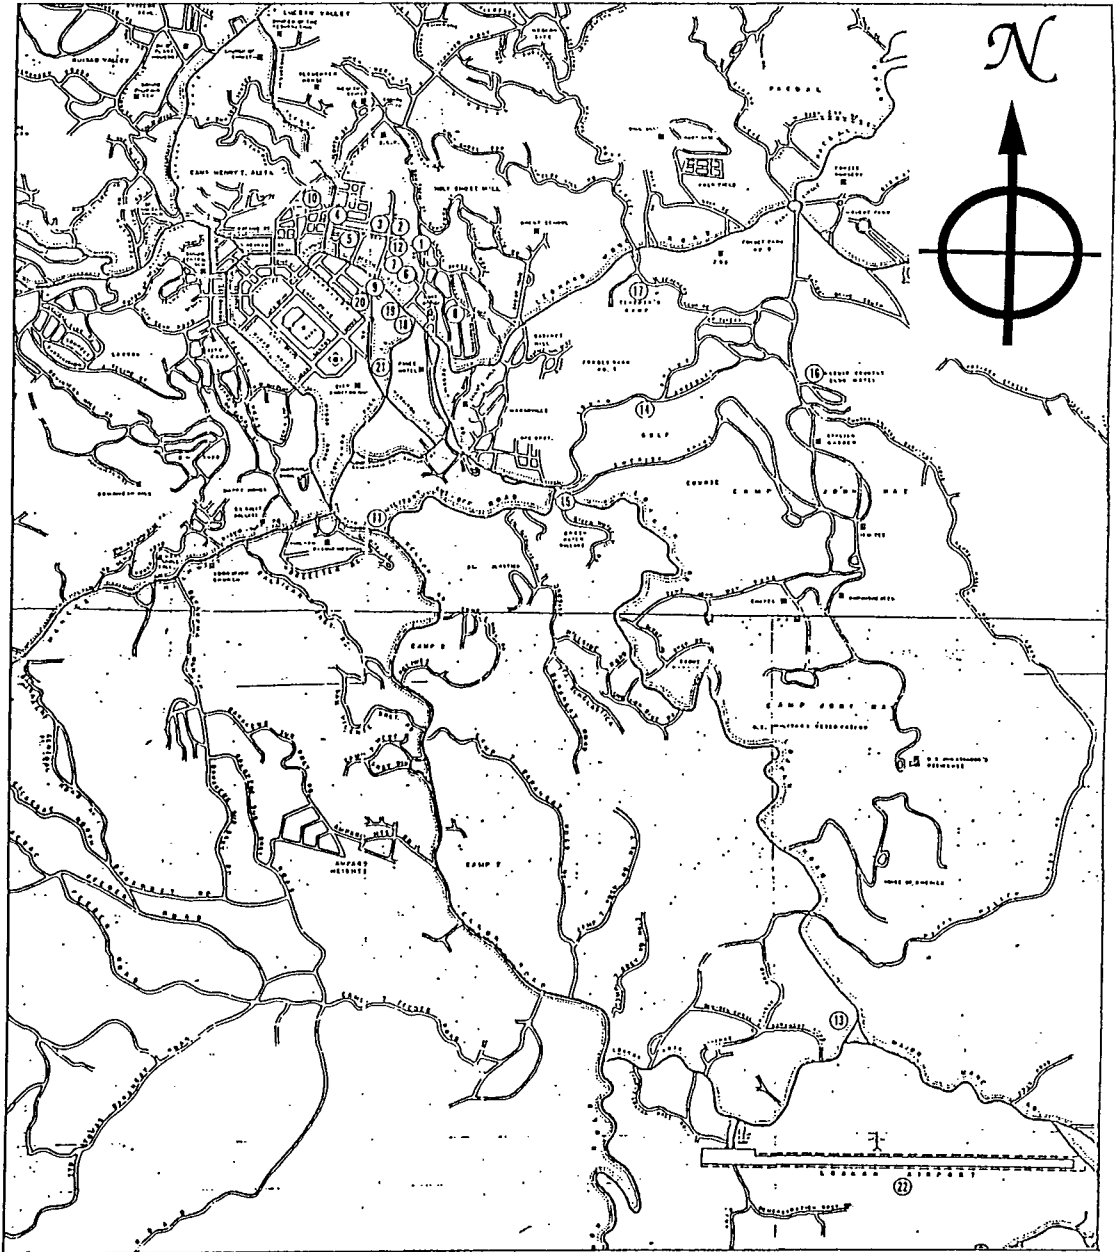
Figure 3 Location of surveyed buildings in Baguio  
(numbers correspond to buildings in Table 1)

The city was generally orderly and peaceful just three weeks after the tremor. Although the city was not completely destroyed, it was the most affected city of the whole country. There were spectacular collapse of buildings but these are not widespread in the city. Figure 3 shows the locations of damaged buildings in Baguio which we have surveyed.

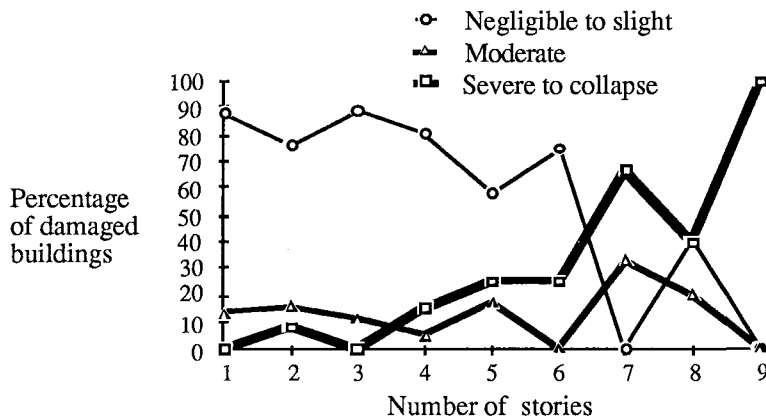
Figure 4 Relation of number of stories to percentage of damage

Table 2 Percentage of damage with respect to number of stories (data from Nomura, Ref. 2)

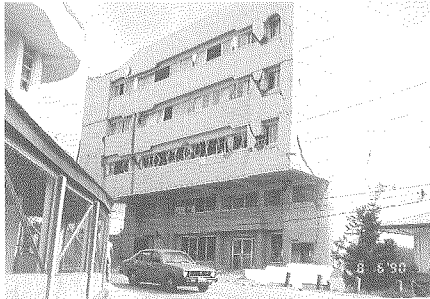
This is a 5-storey reinforced concrete building with one basement. The building is of new construction with interior finishing left to be done. The plan of this building is unique in the sense that the width at the front is longer than the width at the back. This gives the building a trapezoidal shape. Also, the top three floors are cantilevered by about 2 to 3 meters in front (Photo 3).

Photo 3 Facade of Golden Bake Shop showing large overhang

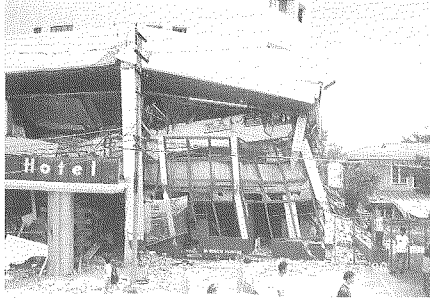
This is a 5-storey, reinforced concrete frame structure. The first 2 stories have a regular rectangular shape while the top 3 floors have a circular shape. The building uses both circular columns and rectangular tied columns. The first two floors were being used by commercial establishments (Photo 5).

Photo 5 View of FRB Hotel from Luna road

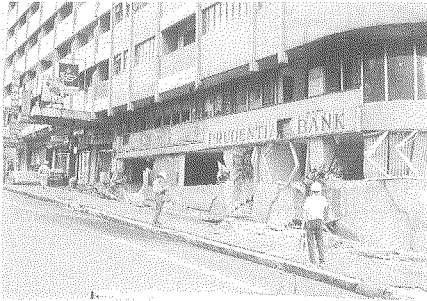
This is a nine storey reinforced concrete building with one basement located at the most crowded area of Baguio City. The first two stories were used by commercial establishments while the rest were used as condominium type residences. This building is one of the tallest building in Baguio. The building's plan is unique because it is triangular shaped. The building is also located in sloping ground (Photo 23).

Photo 23 View from Session road of Skyworld building

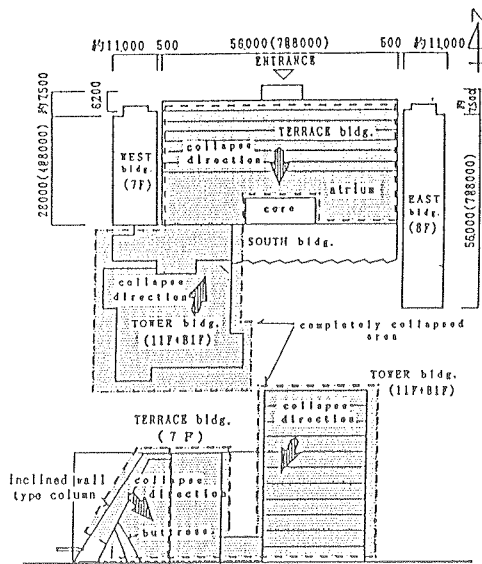
Figure 10 Outline of Hyatt Terraces Hotel (after Nomura)

The Hyatt Terraces is the biggest hotel in Baguio. It is composed of five buildings constructed close together. These are the Terrace building, West building, East building, South building and the Tower building (Figure 10).

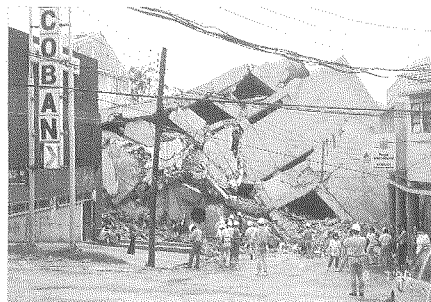
Baguio Park Hotel is a reinforced concrete frame structure with nine stories. This building completely collapsed in a pancake type while buildings next to it did not suffer serious structural damage. Photo 48 shows view from Harrison road. The damage to the building on the left was probably caused by the debris from the hotel. Due to the collapse of the building, the configuration cannot be determined during the field investigation. Photo 49 shows the view from the back.

Photo 49 View of Baguio Park Hotel from the back
