**Seismic Capacity of Reinforced Concrete Apartment Buildings  
Damaged due to 1992 Erzincan Earthquake, Turkey**

by  
Yoshiaki Nakano\*

This paper describes the seismic capacity of reinforced concrete apartment buildings which were damaged due to 1992 Erzincan Earthquake, Turkey. The seismic capacity was evaluated according to the Japanese Standard and the correlation between the seismic capacity and damage levels observed in the field survey was discussed.

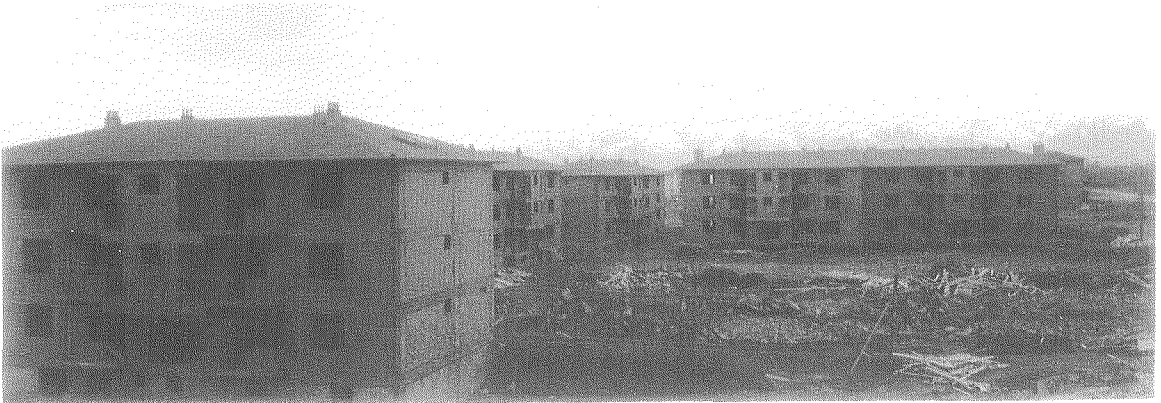
The structure investigated herein is three-story reinforced concrete apartment building, located in the central area of Yavuz Selim District in Erzincan City (*Fig. 1* and *Photo 1*). In this area, approximately 40 buildings were under construction at the time of the quake.

*Photo 1: Three-story apartment building under construction in central Yavuz Selim District*
