Report on Spatial Structures Damaged by the 1995 Great Hanshin Earthquake

K. Kawaguchi ¹ and Y. Hangai ²

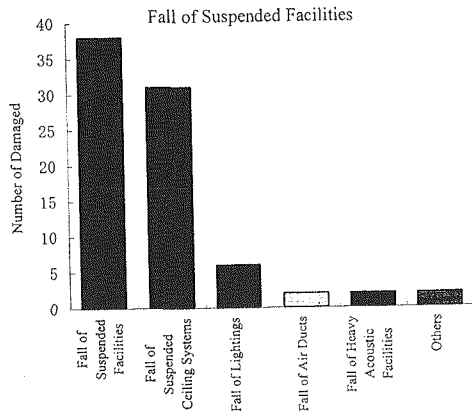
Fig. 1: Fall of suspended facilities
(Total number of investigated = 117)

In many halls suspended ceiling panels or other facilities suspended from the roofs fell off while the roof structures themselves remained undamaged (see Photo 24). In Photo 27, one can see a huge speaker frame fell on the floor of the arena. So far, 117 damaged spatial structures, such as public halls or gymnasiums, were reported to us. From the view point of structural engineering, most of the damage to them were minor. Among the damage to spatial structures, the rate of damage to suspended facilities, especially damage to suspended ceiling systems, is very high. Fig.1 shows items in fall of suspended facilities. Fall of suspended facilities is reported in 38 cases among 117 investigated spatial structures. Above all, the major failure is fall of suspended ceiling systems, which is reported in 31 cases. Fig. 2 and 3 show distribution of damaged spatial structures. Fig. 3 shows JMA intensity 7 area and distribution of damage to spatial structures. Most of the spatial structures damaged to structural elements are around the intensity 7 area while spatial structures damaged to suspended facilities are found in broader area.
