DAMAGE REPORT ON THE 1994 HOKKAIDO-TOHO-OKI EARTHQUAKE

Kimiro MEGURO¹, Fumitoshi KUMAZAWA² and Atsushi MIKAMI²

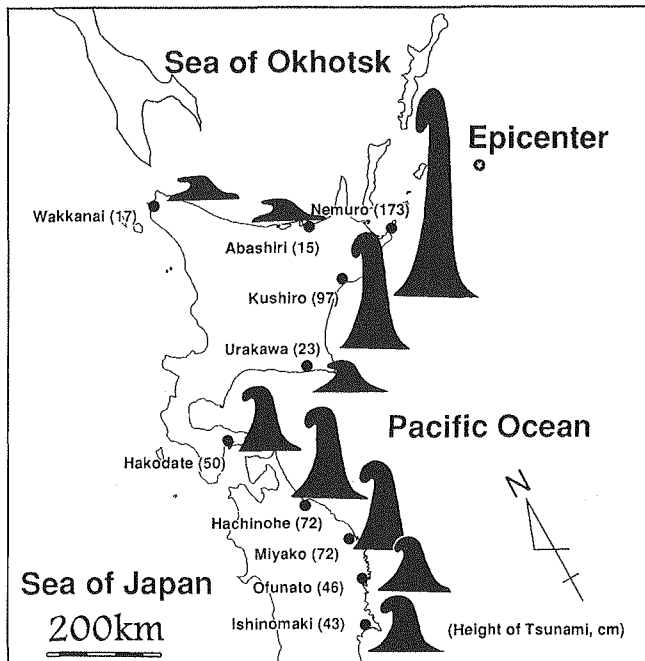
The first high waves reached Kushiro and Nemuro, both in eastern Hokkaido, at around 11 p.m. Tsunamis as high as 173 cm were reported at Hanasaki Port in Nemuro at 11:04 p.m. and 60 cm in Kushiro at 11:13 p.m. Tsunamis 72 cm high were observed in Miyako, Iwate Prefecture, Honshu. The highest 97-cm waves in Kushiro were recorded at 3:02 a.m., Wednesday, about four and a half hours after the earthquake (*Figure 9*).

Figure 9 Tsunamis as high as 173 cm were reported in Nemuro (From Asahi Shimbun News)

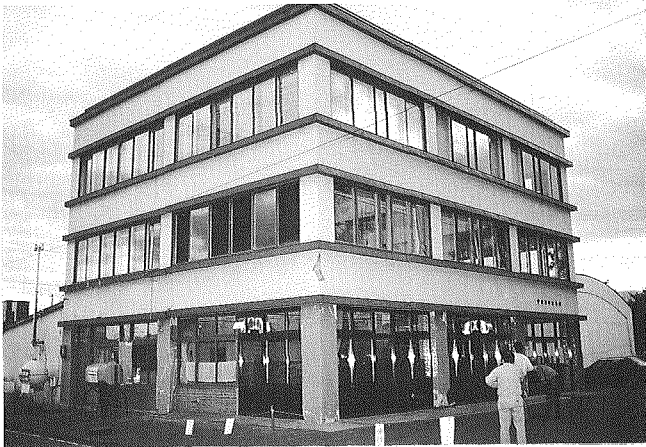
Photo 6 Overview of Nakashibetsu Citizen's Hall

Photo 7 Shear failure of column with wall and shear failure of beam (Nakashibetsu Citizen's Hall)

Nakashibetsu Citizen's Hall and Nemuro Hospital, which were constructed in 1962 and 1958, respectively, were severely damaged by shear failure of the columns on the first story (**Photos 6-10**). Many shear cracks on columns were also observed at Nakashibetsu Hospital that was constructed in 1968 (**Photos 11 and 12**). Many wooden houses on reclaimed land were damaged due to

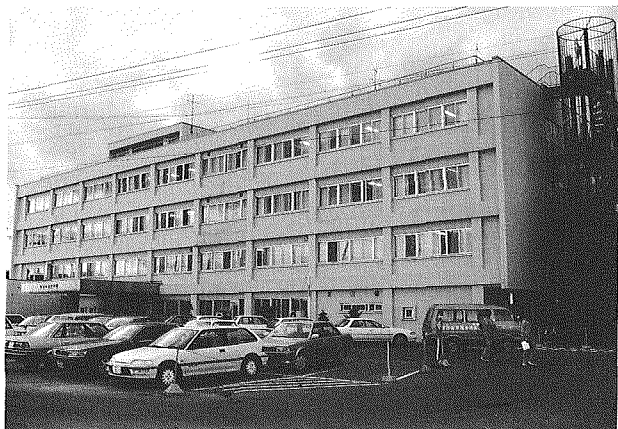
Photo 11 Overview of Nakashibetsu Hospital

*Photo 12 Shear crack of column
(Nakashibetsu Hospital)*

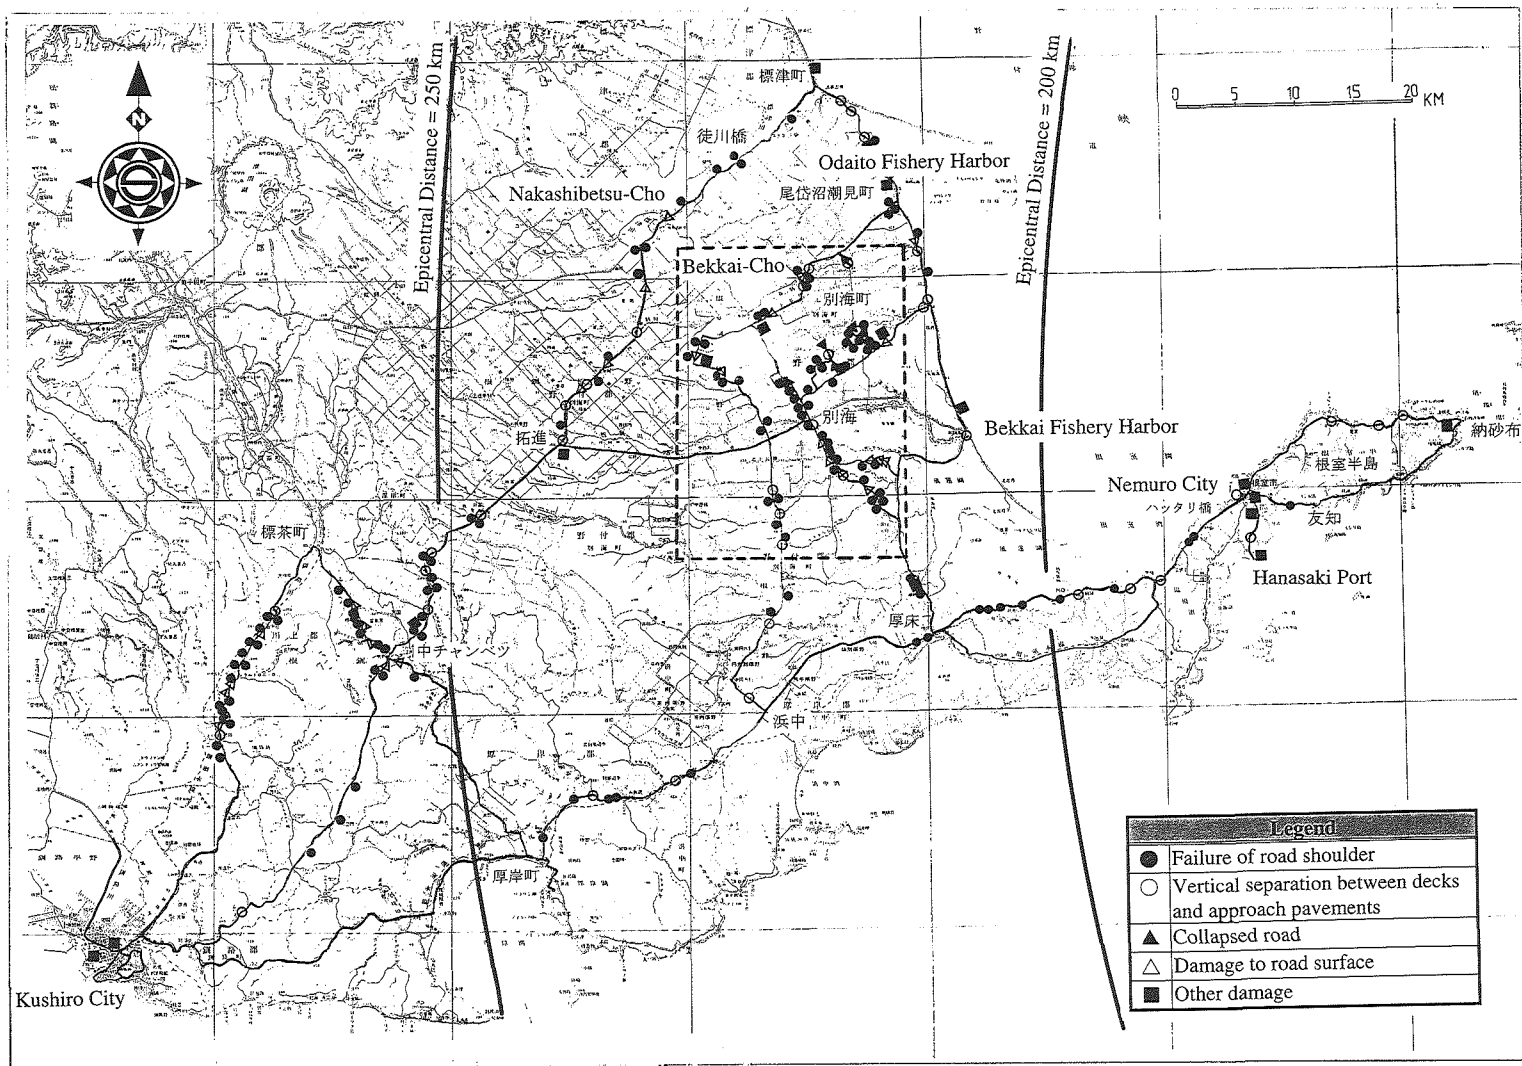
Figure 10 Distribution of damage to roads in eastern Hokkaido

Figure 10 shows the distribution of damage to roads in eastern Hokkaido. Representative damage to roads can be classified as follows:

- 1) Vertical separation between bridge deck and approach pavement: The most common disruption at bridge sites was settlement of approach fills due to compaction of embankment materials. These settlements produced vertical separations between the approach pavements and the bridge decks as shown in *Photo 21*.
- 2) Damage at the section between hills: Significant road damage was observed at the valley section between hills or mountains, often with a river flowing through the valley or with high underwater level (*Photo 22*).
- 3) Damage at fill section beside the cut: Fill sections beside the cut were often damaged due to the different motions between these sections (*Photo 23*).

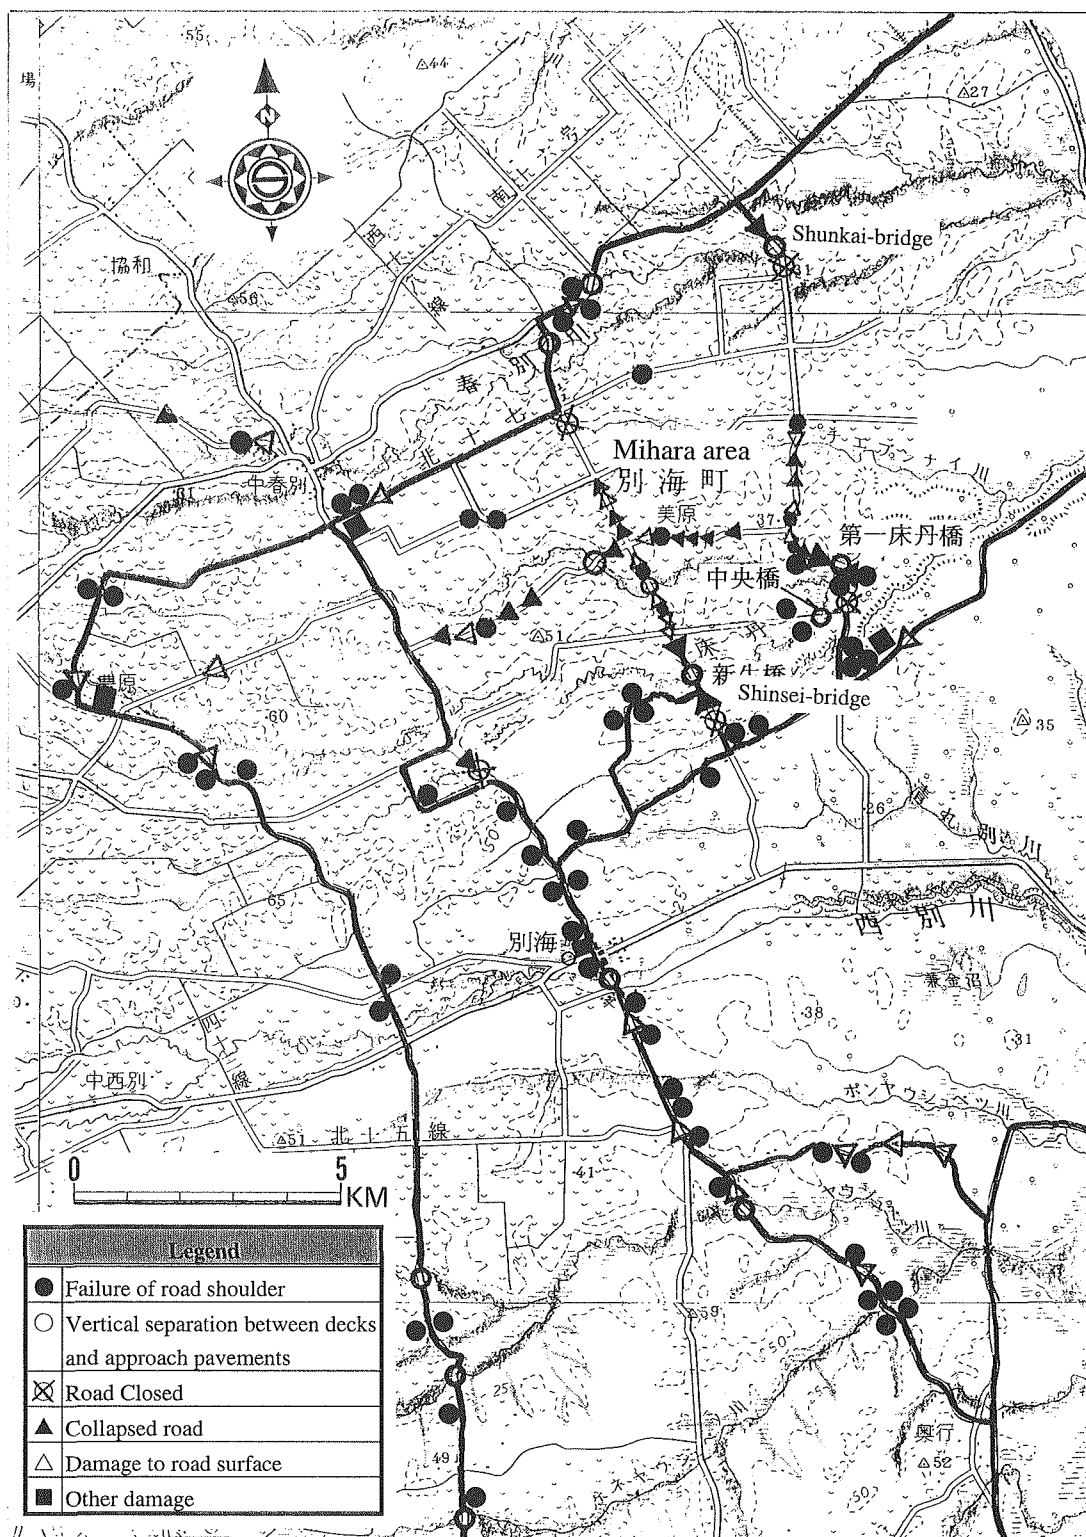
Figure 11 *Damaged roads in Bekkai Town*
(Enlarged figure of the dashed line area of the previous figure)

Bekkai Town is famous for its large-scale dairy farming. Therefore, damage to roads greatly inconvenienced the farmers. *Figure 11* shows Bekkai Town and the damage to roads in Bekkai Town investigated by the Konagai Laboratory. As shown in the figure, the Mihara area suffered the heaviest damage to roads from the earthquake. Many rivers flowing in this area,

like the Tokotan and Syunbetsu, cross the trunk line between Bekkai Town and its northern neighboring town. Significant road damage was found at these crossings as shown in **Photos 24-25**. The most common disruption at bridges was the collapse of approach fills due to sliding or compaction of the embankment materials. The bridges themselves had almost no damage.

The topography of this area called Konsen plateau might be one reason for the heavy damage. The Konsen plateau is less than 200m-high, and is poorly drained. Peat and bog are widespread and the lack of sunshine and the balmy temperatures help maintain the saturated state year-round.

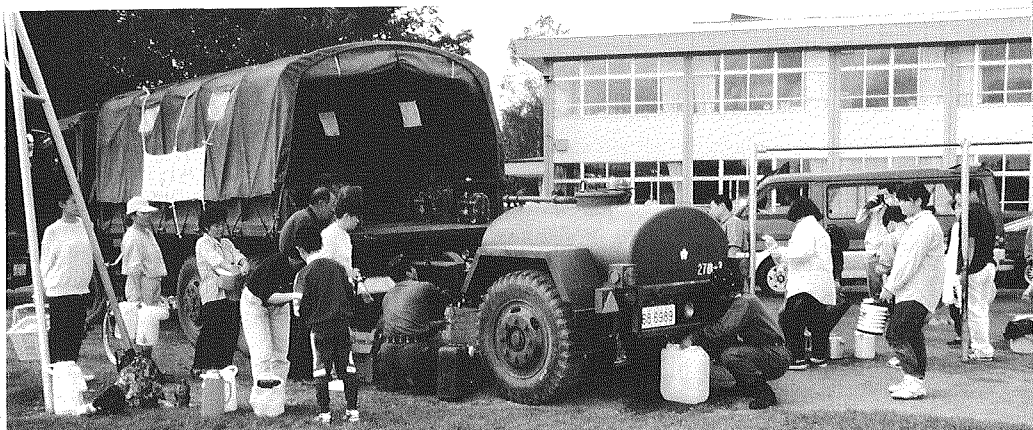
The most heavily affected were the water supply systems of cities and towns in eastern Hokkaido. Early Wednesday morning, about 15,000 households were without water, mostly in Nemuro (6,000), Bekkai (5,000), Nakashibetsu (2,000) and Hamanaka (1,800). On Thursday morning, about 11,000 were still without water. In Nemuro, the number increased to 6,450, about half of all households in the city. The number of households without water had decreased to about 2,600 by Saturday morning,

Photo 32 Self-Defense Forces supply potable water to the citizens of Nakashibetsu

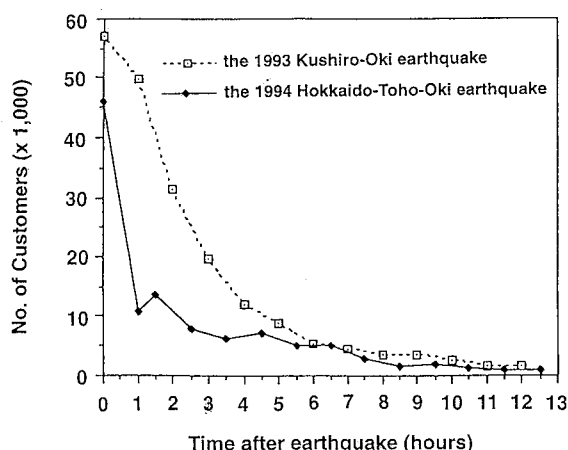
Power failure affected about 46,000 households in Hokkaido, but power was restored to most areas by midnight Tuesday. The number was reduced to about 1,200 at 9:00 a.m. of the next day (*Figure 12*). However, its effect was serious on some dairy farms remotely located from towns because the blackout hindered the milking of cows.

Figure 12 Restoration of power after the earthquake
(after the *Denki Shimbun News*, October 13)
