Damage Report on 1994 Sanriku-harukaoki Earthquake

Kenji Kabayama ¹⁾, Atsushi Mikami ²⁾, Yoshiaki Nakano ³⁾ and Choshiro Tamura ⁴⁾

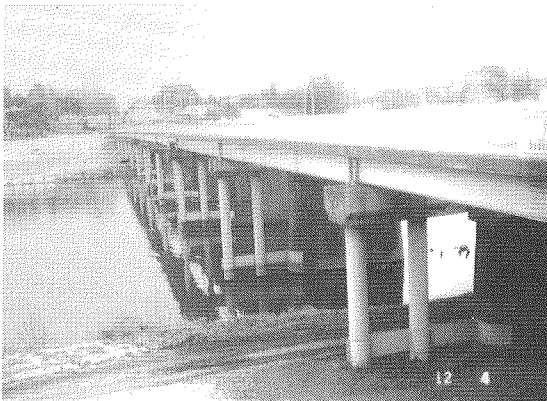
The Ohashi bridge is about 230 m long with 10 piers crossing the Mabuchi river. This bridge is composed of two structurally different bridges; a main bridge and a pedestrian bridge as shown in Photo 21. The main bridge is supported by concrete piers and the pedestrian bridge by steel piers. The bridges were connected with concrete and steel bars at the edges of their piers. Those connections were damaged as shown in Photo 22 due to the difference of response motions between these component bridges. Pier 3 of the main bridge sank and tilted into the Mabuchi river on the upstream side (Photo 23).

Photo.21 A complete view of the Ohashi bridge

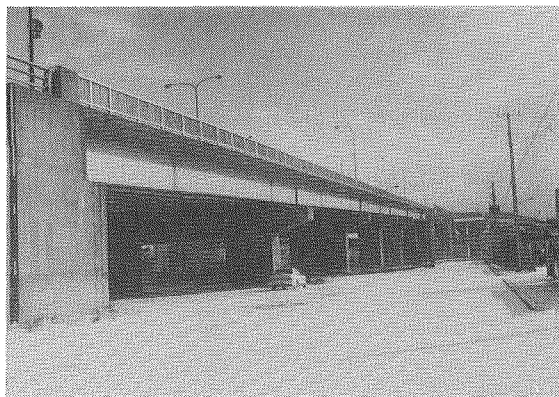
The Hachinohe-Ohashi is a bridge of over 1300 m in length (Photo 24). Damage to the steel deck plate of the bridge was found at the joint of the decks above pier 12 (Photo 25). It is suspected that the decks temporarily moved to separate, then the decks came to collision when these deck plates returned to their original positions. Pier 12 supports two different types of girders; an I-type girder and a box-type girder of longer span as shown in Photo 26. It is suspected that the damage occurred due to the different motions of the different types of structures. A handrail of the bridge was expanded about 17 cm in length as shown in Photo 27. A guardrail of the bridge was suspected to be fractured by the large transverse displacements of the bridge (Photo 28).

Photo.24 A view of the Hachinohe-Ohashi bridge

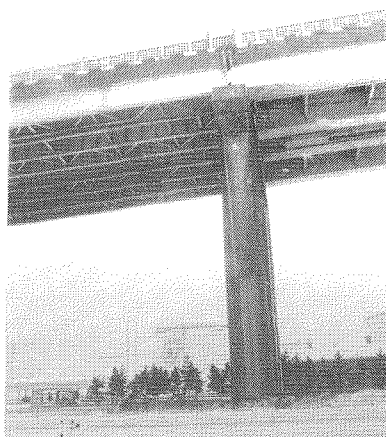
Photo.26 Two different types of girders supported by the pier 12
