Report of the Damage caused by the Mid-North Iwate Earthquake of September 3, 1998

Kazuo KONAGAI, Atsushi MIKAMI, Toshihiko KATAGIRI, Raquib AHSAN
and Daisuke MARUYAMA

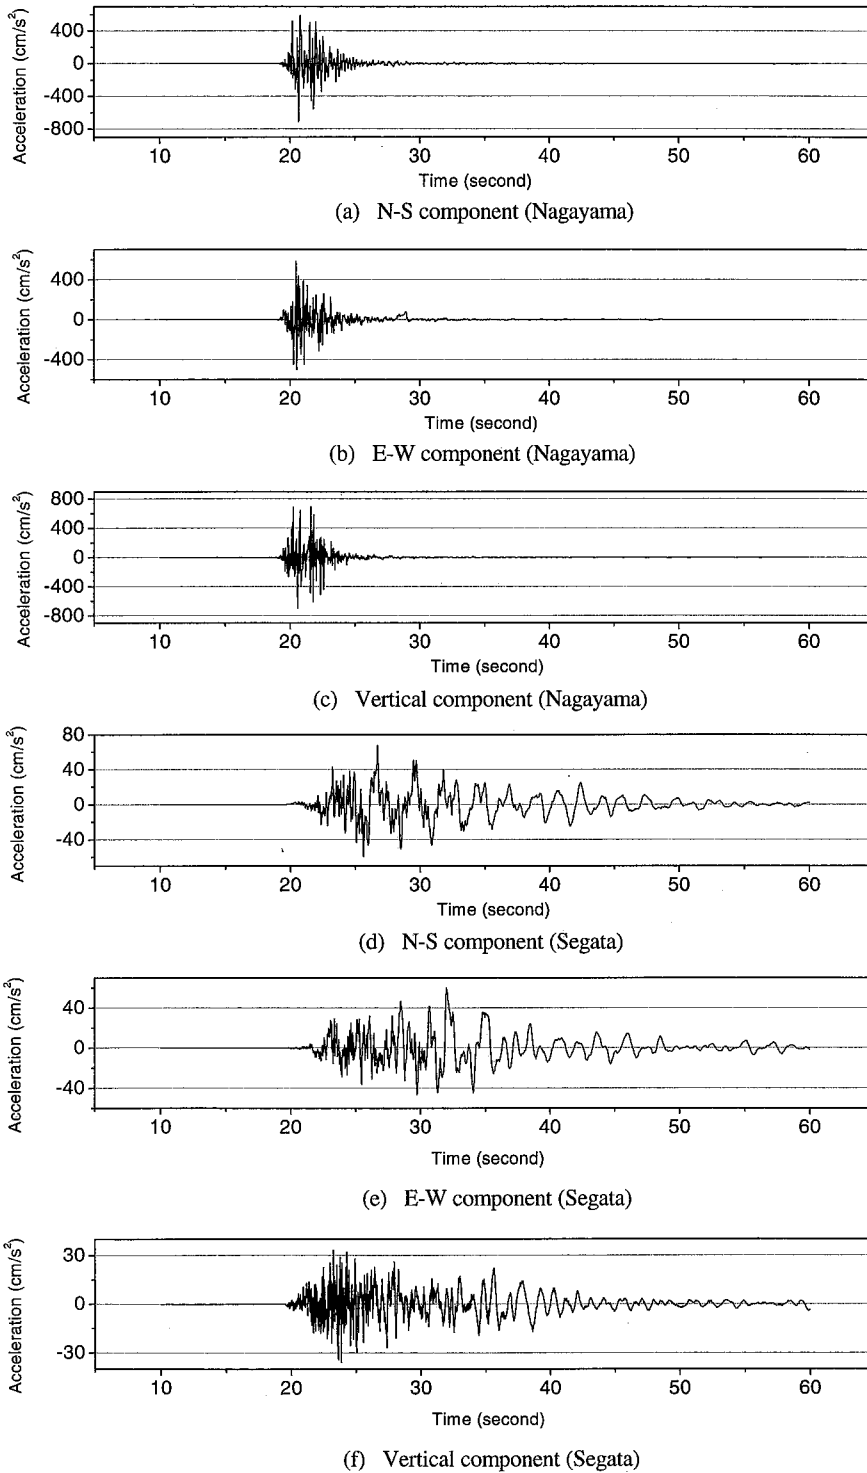
Fig.3 Acceleration-time histories in Shizukuishi (16:58, Sept. 3, 1998)

Figs 3(a)-(c) and **Figs. 3(d)-(f)** show the recorded strong ground motions at Amihari spa and the municipal office of Shizukuishi town, respectively. Peak acceleration of 714 cm/s^2 was reached at Amihari spa about 3 km north-east of the epicenter, whereas the peak acceleration reached at Segata in Shizukuishi town, 10-15 km south of the epicenter, was 68 cm/s^2 . This remarkable attenuation is seemingly consistent with the fact that no serious damage was reportedly found in downtown Shizukuishi.
