## Deformation Build Up in Soils and Damage to Viaduct Foundations

### 1. INTRODUCTION

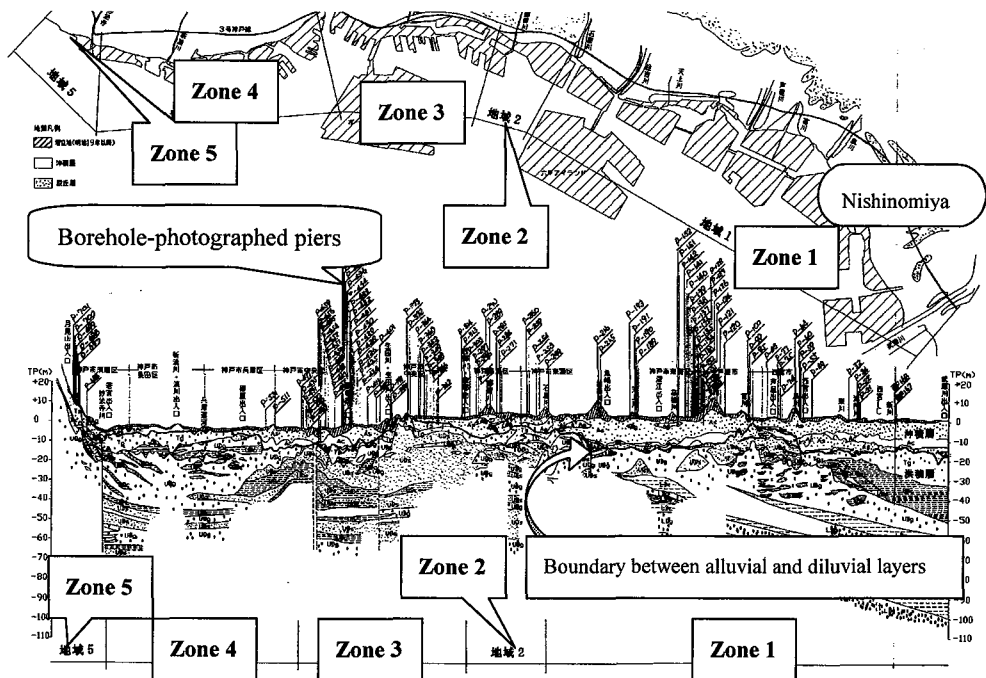
Figure 2 Zones along Route 3, Hanshin Expressway

distribution of the displacements can retain some certain components of bedrock movements that were directly caused by the fault dislocation. Cancellation of these components is essentially impossible as far as no reliable indication of bedrock movements is available. Nevertheless some thick and stiff caisson foundations of the Route 5 running roughly parallel to the Route 3 were considered to reflect the motions of bedrocks as their bottom ends touched firmly the bedrocks. The displacements of these foundations and triangulation points on stiff soils were used for the cancellation of the bedrock displacements, though the cancellation yielded only slight change in the overall pattern of the displacement distribution as shown in **Figure 1**. The entire extent of the Route 3 was divided into 5 zones (**Figure 2**) based on a rough categorization of subsoil conditions. Zone 1 extends from Nishinomiya to Ishiyagawa over a widely spread alluvial soil deposit of about 10 to 15 m thick. The soils and other suspended matters that rivers have carried over centuries from the Rokko mountains are mostly from weathered granite. In Zone 2 (from Ishiyagawa to Maya), the Route 3 runs along the boundaries between alluvial fans and the terraces at the base of the Rokko Mountains, whereas in Zone 3 (from Maya to Naka-Futo), it runs along an old coast of the Stone and Earthenware Age of Japan (Jomon Age). Zone 4 extends over a deposit of coarse sandy and gravelly soils with some isolated clayey soil layers sandwiched. The Route 3, like the other major routes in Kobe, goes from east to west through the long-spread city. It however changes its direction towards north in Zone 5 (from Wakamiya to Tsukimiyama) where diluvial terraces feature some undulating configuration.

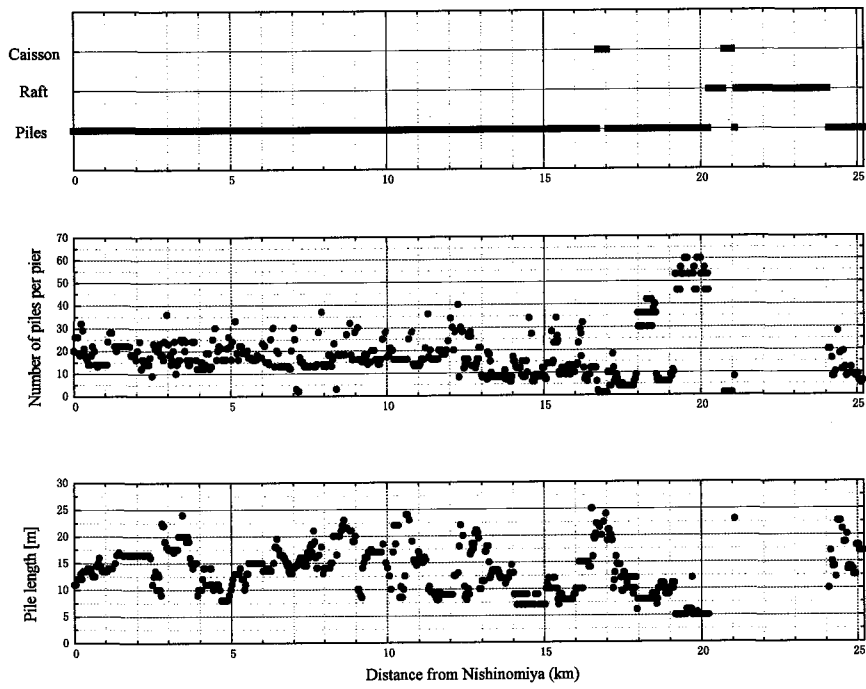
**Figure 3** Types of foundation, number of grouped piles and pile lengths

The Route 3 of the Hanshin expressway, a long viaduct with the entire extent of about 25 km through Kobe, has total 718 piers, and 84% of the piers are pile-supported. Among them, 91% are bored cast-in-place piles. Three plots in **Figure 3** show, from the top respectively, types of foundations, numbers of grouped piles and pile lengths with respect to the distance along Route 3. The lengths of the piles vary in accordance with the thickness of the alluvial soil deposit (**Figure 4**). Borehole pictures of cracks on the piles were taken at 122 piers. The piers investigated are shown in **Figure 2**. Average crack openings per pier were then categorized into 10 ranks (**Figure 5a**), and were compared with the embedment depths of the piles (**Figure 5b**) and the absolute values of ground surface displacements as well (**Figure 5c**). In **Figure 5b**, hatched bars show the locations of the clayey layers that exhibit some flexible natures. The extent of damage indicated with the crack openings seems to be consistent with the spatial distribution of the displacements remaining on the ground surfaces. This tendency becomes
