## **Buildup of Soil Deformations and Damage to Subway Tunnels \***

## 2. DAMAGE TO YAMATE LINE

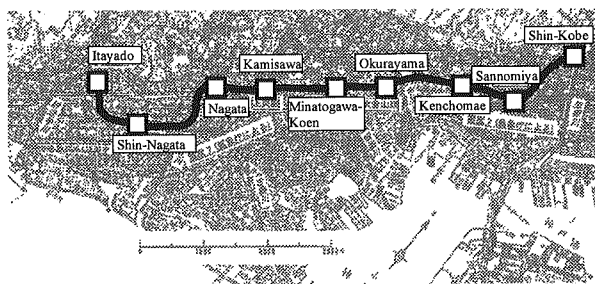
**Figure 3.** Yamate line of the Kobe City Rapid Transit Bureau

Walls and columns of this line, however, seem to bear clearer marks showing that the tunnel has experienced alternate shear in its transverse direction all the better for the fact that the cracked walls and columns remained barely standing there. This subway line, like the other railways in Kobe, goes from east to west through the long-spread city over narrow alluvial fans lined up along the Rokko mountains (**Figure 3**). The tunnel is box-shaped throughout the entire extent of the underground stretch from Itayado to Shin-Kobe. The west half of the line (Itayado—Okurayama) is double-tracked on the same level, whereas the east part for the two-level tracks extends from Okurayama to Sannomiya. Cracking of columns supporting the tunnel ceilings is a noticeable feature of the extensive structural damage to this tunnel. Seriously cracked columns were mostly found at three places, Shin-Nagata station and its eastern approach (about 400 m), Kamisawa station and its east and west approaches (about 720 m), and Sannomiya station (about 310 m). In these sections longitudinal cracks were found on walls, ceilings and floors. Transverse cracks were found over the entire extent of the line.
