Provisional Report of the June 23, 2001 Atico Earthquake, Peru¹

Kazuo KONAGAI², Kimiro MEGURO¹, Junichi KOSEKI¹, Kenichi OHI¹, Hiroshi SATO³, Junichi KOSHIMURA², Miguel ESTRADA¹, Jorgen JOHANSSON¹, Paola MAYORCA¹, Ruben GUZMAN¹ and Tomihiro KIMURA⁴

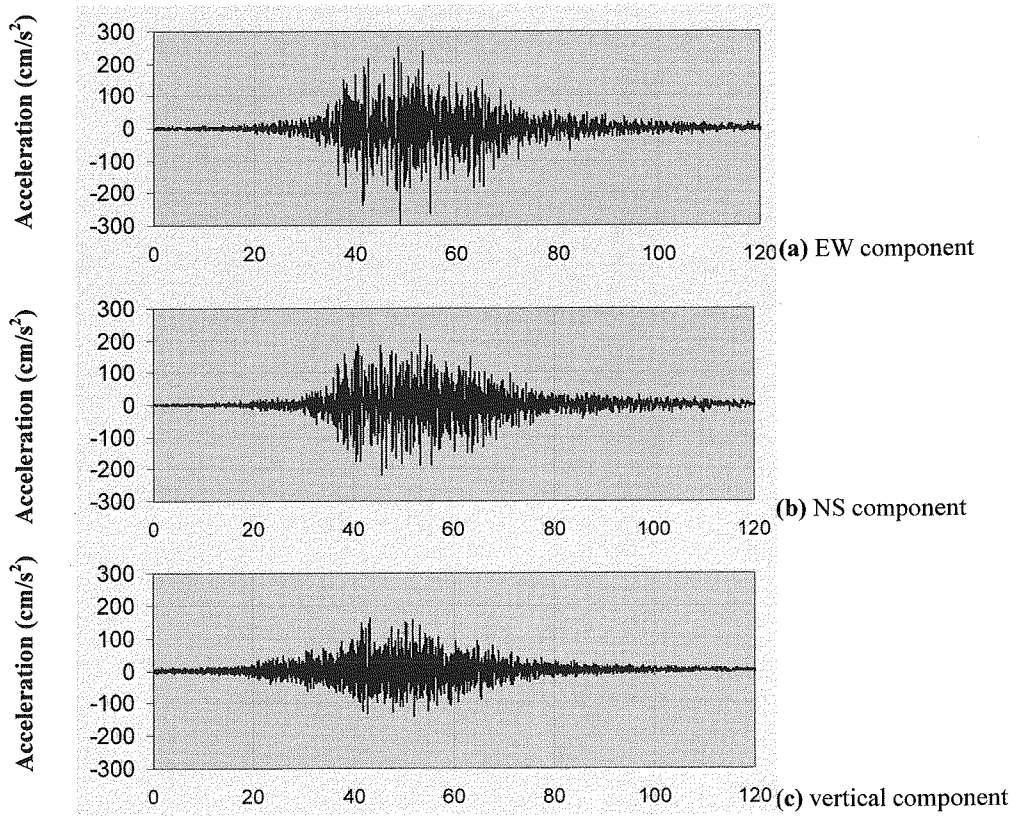
Figure 2. Acceleration time histories at Moquegua

CISMID (Japan-Peru Center for Earthquake Engineering and Disaster Mitigation) has recovered and processed the information from only one instrument that triggered in Peru, the one in the city of Moquegua. Two other instruments in the epicentral area apparently malfunctioned. **Figures 2 and 3** show the corrected ground acceleration time histories and the corresponding acceleration response spectra obtained from that instrument recording in East-West, North-South, and Vertical directions.

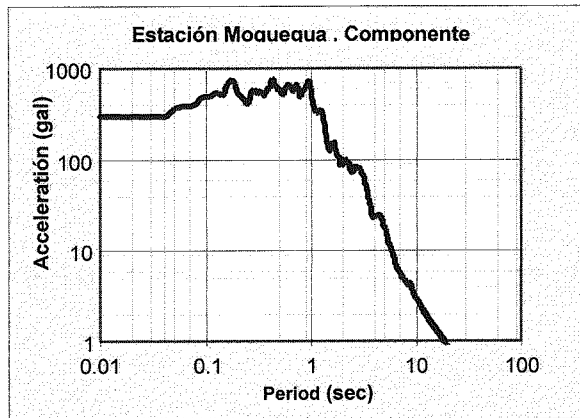
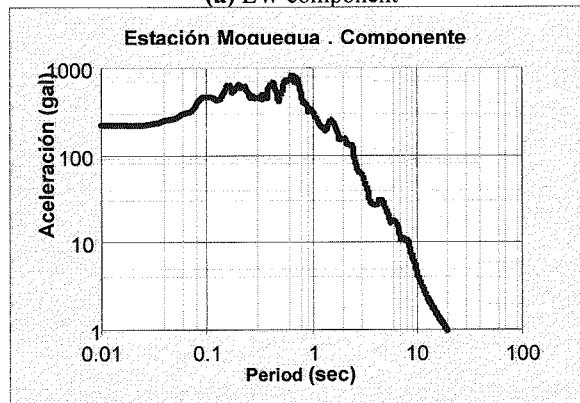
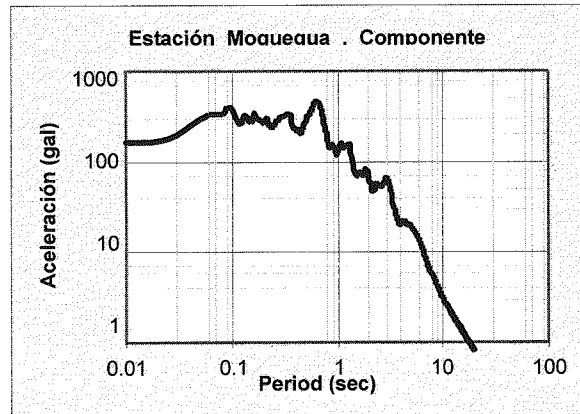
Figure 3. Acceleration time histories at Moquegua

(a) EW component

(b) NS component

(c) UD component

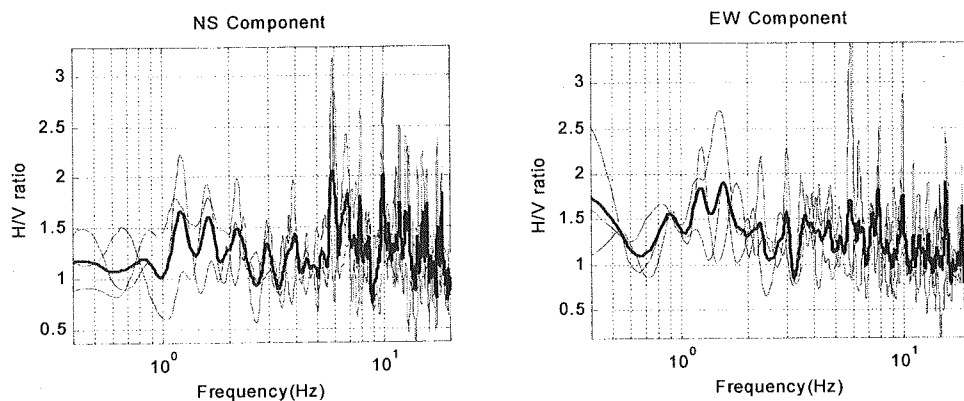
In order to evaluate the topographical effect in a different way, microtremors at the top and toe of the ridge were measured, and at each site, the ratio of the horizontal component spectra to the vertical one (H/V ratio) was calculated in order to get the predominant period of the site [Nakamura, Y., 1989]. The H/V ratio is fairly flat at the toe, which might indicate the stiff soil nature of the site (**Figure 6**). On the other hand, at the top of the ridge, a peak can be identified at around 4-5Hz, the fact indicating the topographical effect. EW component at around this peak is about twice as large as the NS component in **Figure 7**. Since EW direction is about normal to the ridge, this fact is consistent with the finding from the investigation of cracked utility poles.

Figure 6. H/V ratio at the toe

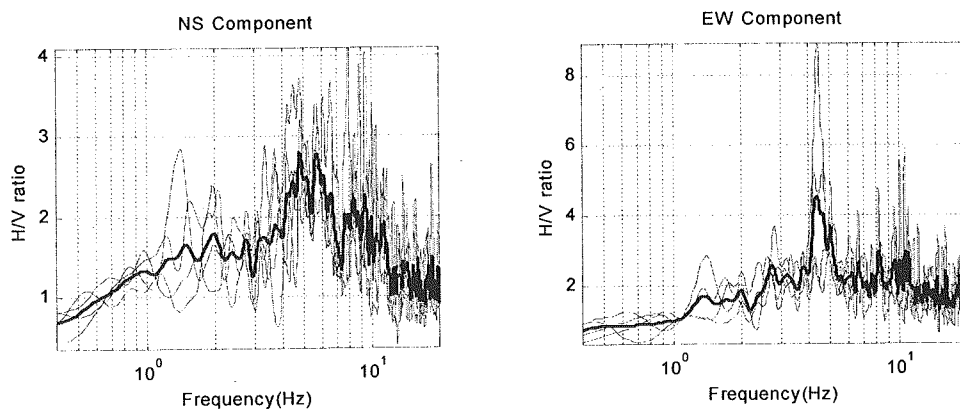
Figure 7. H/V ratio at the top

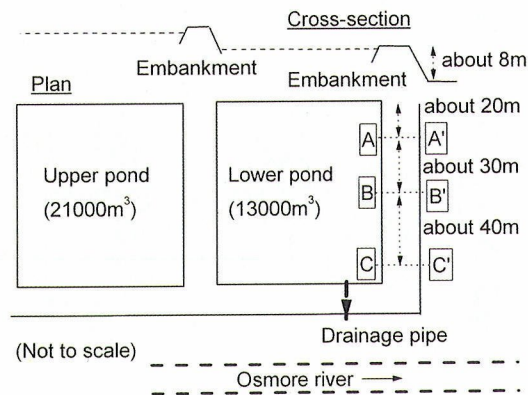
Figure 13. Plan of two oxidation ponds for sewage treatment

Figure 13 shows a plan of two oxidation ponds for sewage treatment in Moquegua. The upper and lower ponds have a capacity of 21000 and 13000 m³, respectively, and have been cleaned every ten years. Their bottom is sealed with clay layer.

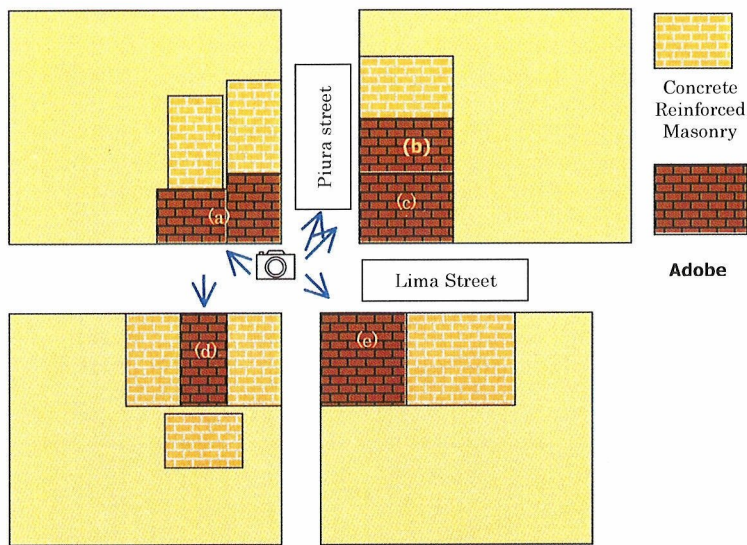
Structures of adobe performed in general badly as observed in many other earthquakes. Below follows a sketch and some figures showing collapsed adobe structures whereas neighboring reinforced masonry structures suffered on only minor damage (**Figure 20**). **Points (b) and (c)** show that a corner of an adobe structure is a weak point.

Figure 20. Sketch showing location of **Points (a)-(e)**.

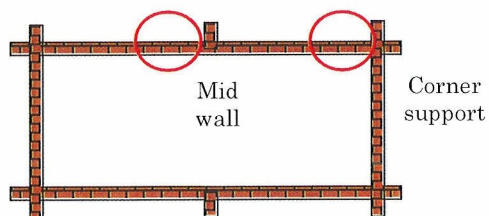
In **Figure 21** and **22** an adobe wall with side support still stands after the shake while the brick wall next to it fell over. This type of side support could be a simple but effective strengthening technique for adobe houses (**Figure 23**).

Figure 23: Plan view of overlapping adobe walls with mid wall side support.

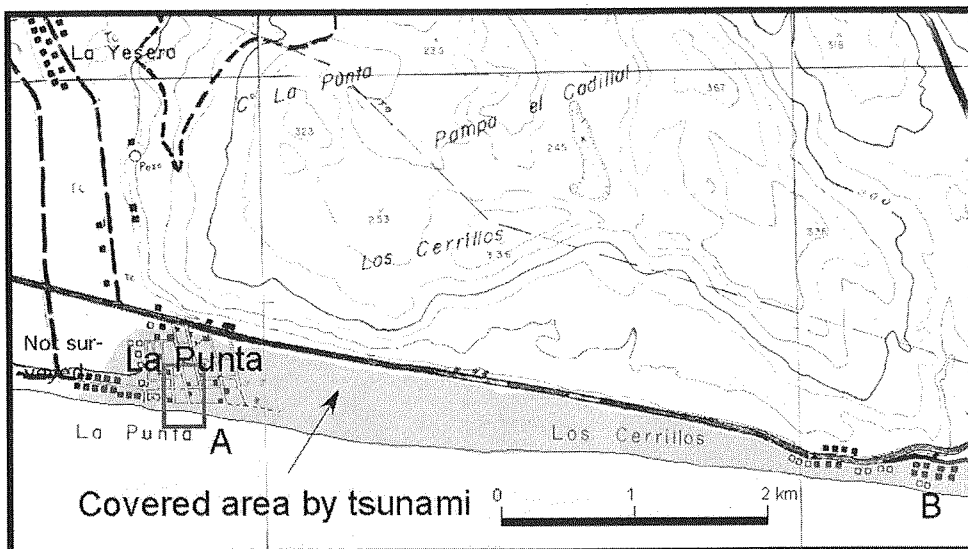
The dark colored zone in **Figure 24** is considered to have been inundated with water. The surges destroyed a great number of dwellings, hotels and restaurants there (**Figures 25** and **26**). The inundated zone was covered thin with wet fine silty soils suggesting that the water surged over the zone was stopped there for a while as is shown in **Figure 27(c)**. From a number of RC columns pushed down (**Figure 27(a)**), possible directions of tsunami surges were estimated (**Figure 27 (b)**).

Figure 24. Inundated zone, La Punta:
