## PROVISIONAL REPORT OF THE DECEMBER 26, 2003 BAM EARTHQUAKE, IRAN

**ABSTRACT:** The Bam earthquake of December 26, 2003 (Mw6.5) occurred around the city of Bam in the southeast of Iran. Since the earthquake happened early in the morning at 01:56:56 (GMT, 05:26:26 local time), most of the reported victims of 43,100 were killed in their dwellings. A joint team covering both social and engineering aspects of this killer earthquake was organized among the Japan Association for Earthquake Engineering, Japan Society of Civil Engineers (JSCE) and the Ministry of Education, Culture, Sports, Science and Technology (MEXT), with the International Institute of Earthquake Engineering and Seismology (IIEES) as the major Iranian counterpart. This is a quick report prepared by the ERS members covering physical features of the earthquake and damage to dwellings.

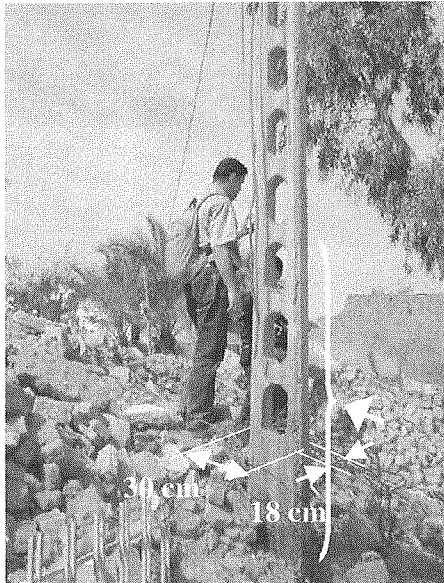
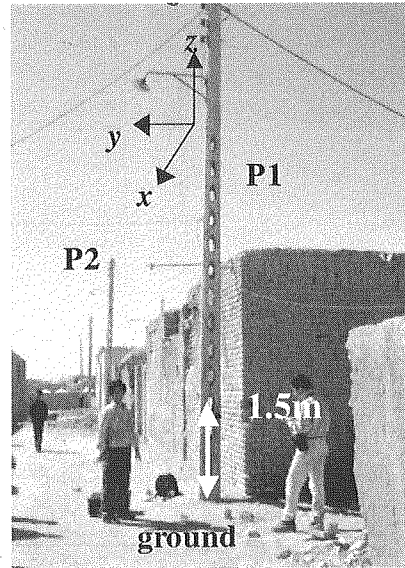
Fig. 4 Poles taken in Bam

(a) 8m pole with holes and embedment depth of 2 m

(b) Poles P-1 and P-2

In order to examine the dynamic features of this pole type, microtremors were measured at two poles (Fig. 4(b)). Their characteristics are summarized in Table 1. Bottom holes on P-2 pole were filled in to prevent theft.

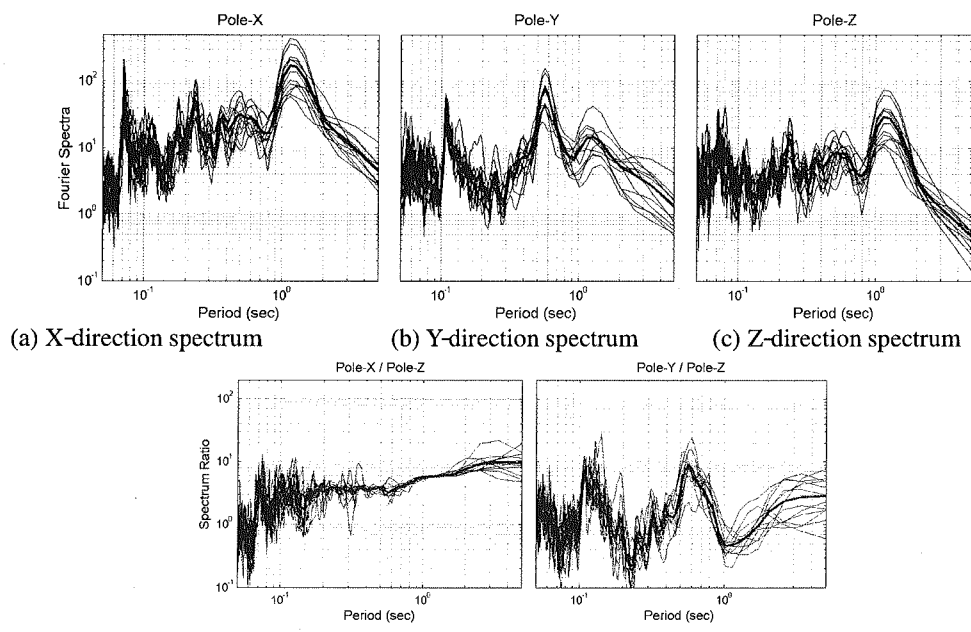
Fig. 7. Comparison of P-1 spectra in three directions

Fig. 6 shows the transfer functions for P-2 pole. The functions have similar shapes as those for P-1 pole in all cases, suggesting that mortar filled in holes had little effect on the dynamic behavior of the pole. Fig. 7(a), (b) and (c) show X, Y and Z components of the pole vibration spectra. It is noted that the spectra for X and Z components are similar with each other, while Y component exhibits some different shape. Fig. 7(d) shows X/Z and Y/Z spectra ratios to highlight this feature. Assuming that the vertical vibrations of the pole were mainly induced by cable oscillations, it may be concluded that a cable has an important effect on the pole's motion along the cable.

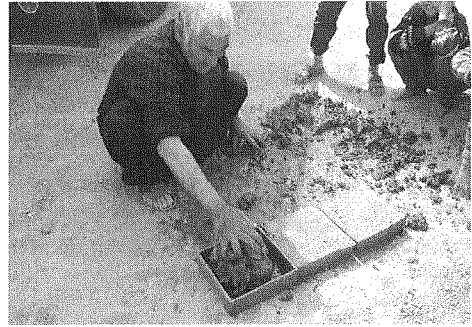
Figure 10. Adobe preparation

Although the Iranian Code of Practice for Seismic Resistant Design of Buildings, Standard No. 2800 [4] prohibits the use of adobe buildings, this is by far, the predominant construction material in the region, especially in the older part of Bam city. Typical houses are one story height with thick walls, up to 900mm, and heavy roofs, which serve as insulation for both hot and cold weather. Adobes are prepared manually as shown in Fig.10 and its typical measures are 250mm×250mm×65mm. Natural fibers are sometimes included in the mud mix. Multi-wythe walls are the most common.

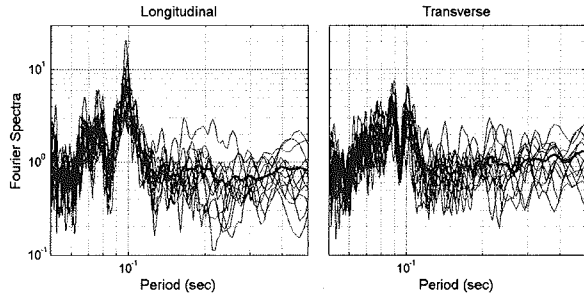
Figure 14. Heavily damaged partially confined masonry house

Figure 13 shows one of the surveyed adobe houses in Darzin City. The structure height is approximately 3.8m and the average wall thickness 800mm. The sensor was placed on top of the roof coinciding with a wall alignment. Figure 14 illustrates the analysis results. The blue lines show the spectra of different measurement windows whereas the red line represents the average. The fundamental periods in the longitudinal and transverse directions are 0.1 and 0.09sec, respectively. It is clear that the structure is slightly stiffer in the transverse direction along which several walls were aligned. The transverse direction spectrum shows a peak at 0.1sec, which coincides with the vibration period in the longitudinal direction. This may suggest some torsional vibrations in the structure.
