# GEOTECHNICAL HAZARD FOR CIVIL INFRA-STRUCTURES IN THE OCTOBER 23, 2004 NIIGATA CHUETSU EARTHQUAKE, JAPAN

**Key Words:** Chuetsu earthquake, landslides, active folding, tunnels

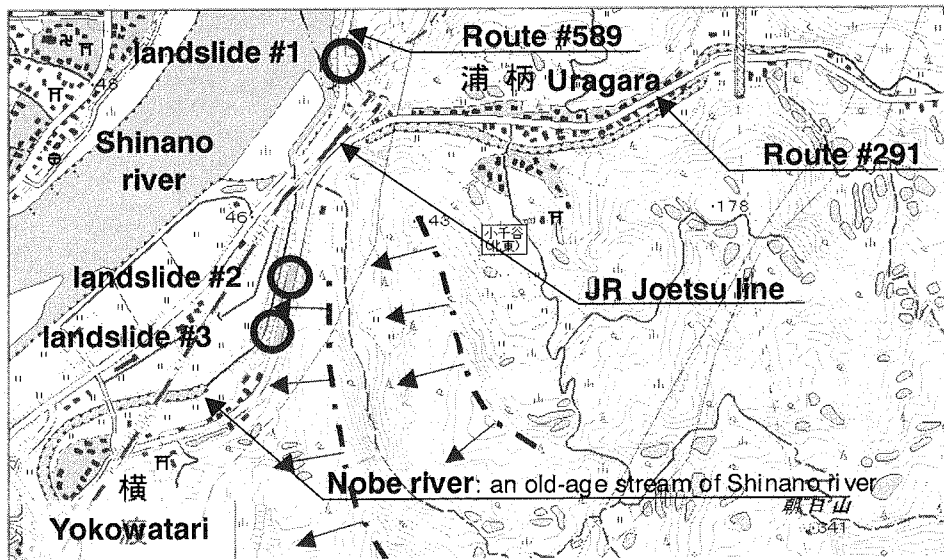
Fig. 3. Locations of surveyed landslides near Uragara and Yokowatari localities, Ojiya city: Arrows show gentle dip slopes of cuestas.

Similar landslides are found at Yokowatari region, about 300-400 m south of the Myoken slide (Fig. 5, landslides #2 and #3 in Fig. 3). A poorly consolidated sandy mud rock plane slipped along its joint leading to Nobe River, and buckled upward as shown in Fig. 5(b). Nobe River at this location is an old-age stream of the Shinano River, and is considered to have eroded the toe of this dip slope. The landslide mass stopped the flow of Nobe river, and consequently, rice fields along the river were all flooded.

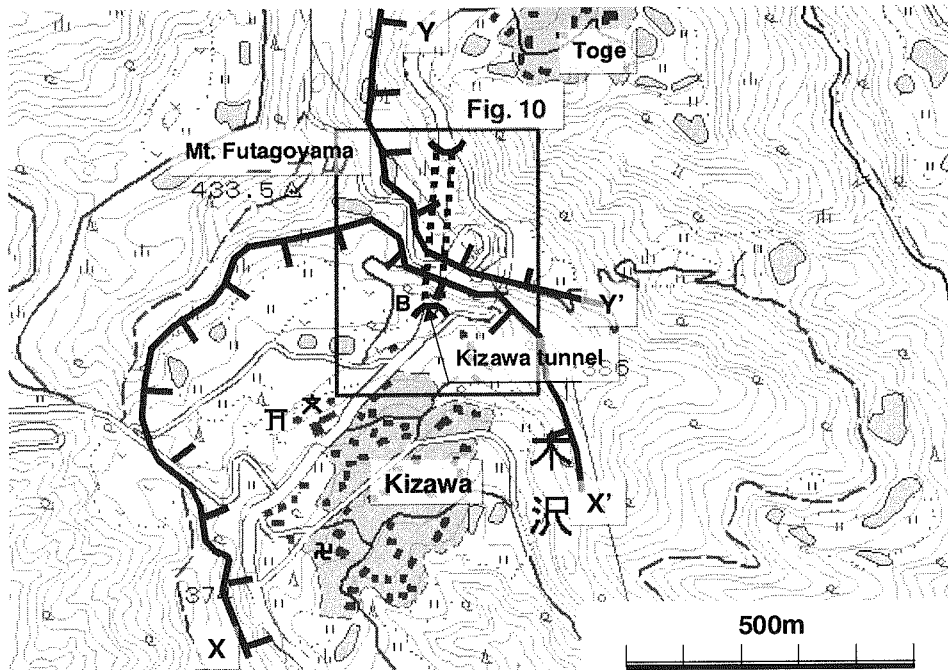
Fig. 9. Surface configuration in the vicinity of Kizawa tunnel

Kizawa tunnel skims the NW-SE trending branch of Futagoyama mountain ridge (Fig. 9). The area is covered thick with Ushigakubi formation of Pliocene age. The surface configuration shown in Figs. 9 and 10 indicates that Kizawa locality about 300 to 800m south of Mt. Futagoyama lies on an old landslide mass with its escarpment shown by line XX'. The south mouth of the tunnel is located a little below this escarpment. A depressed configuration is also found east to northeastern side along the Futagoyama ridge suggesting the presence of another landslide escarpment (line YY'). The North tunnel mouth is closer to this configuration.

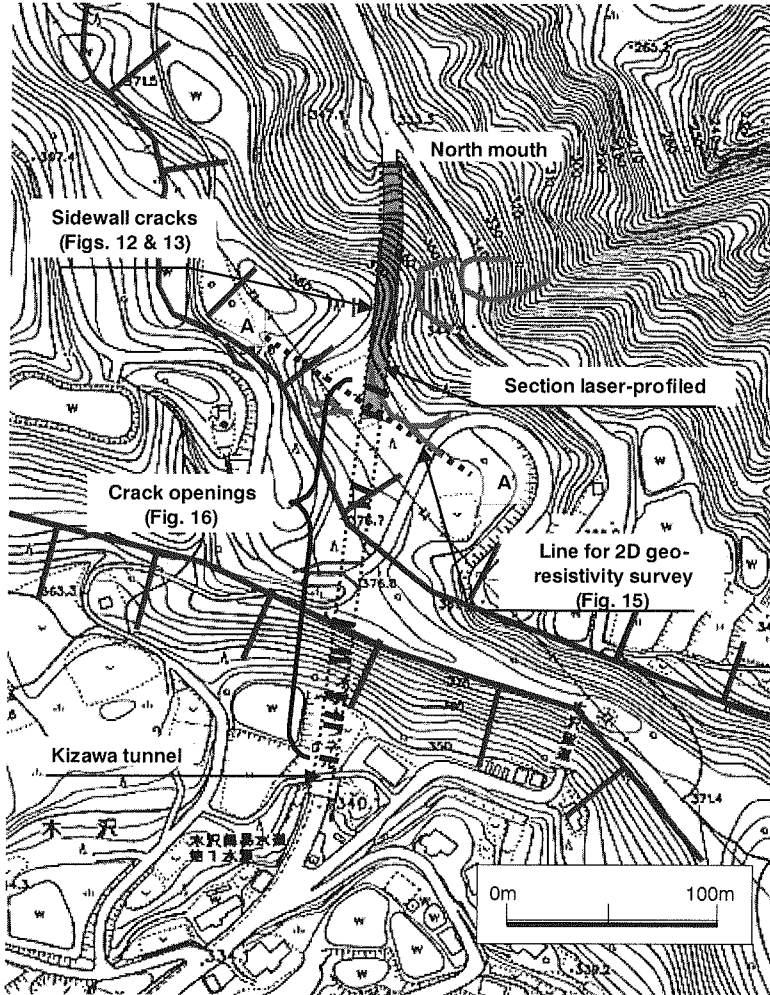
Fig. 10. Kizawa tunnel

The Northern 120m segment of Kizawa tunnel (Fig. 10) was laser-profiled. Fig. 12 shows that two pairs of major cracks, E1, E2, and W1, W2, go diagonally up through the tunnel (see Fig. 13). The cracks, E1 and E2 on the east wall (Figs. 12(a) and 13(a)), extend over the 45 to 83m distance from the north tunnel mouth, while W1 and W2 (Figs. 12(b) and 13(b)) over 38m to 88m distance on the west wall. Fig. 14 shows three cross-sections at 51, 55 and 59m points together with an intact cross section measured at 100m point. It is clear from this figure that the pairs of cracks on the wall became hinges for the upper half of the tunnel cross-section that was pushed 40 to 50 cm east and about 10 cm down.

This part of the tunnel passes 20 to 30 m to a mountainside sloping to the east, and the damage is considered to have been caused by the motion of the soil/rock surrounding the tunnel, which motion was not clear in appearance from outside. Some minor cracks found on the ground surface were mapped on Fig. 10. As we find more cracks hidden there, a clearer image of the landslide mass will emerge.

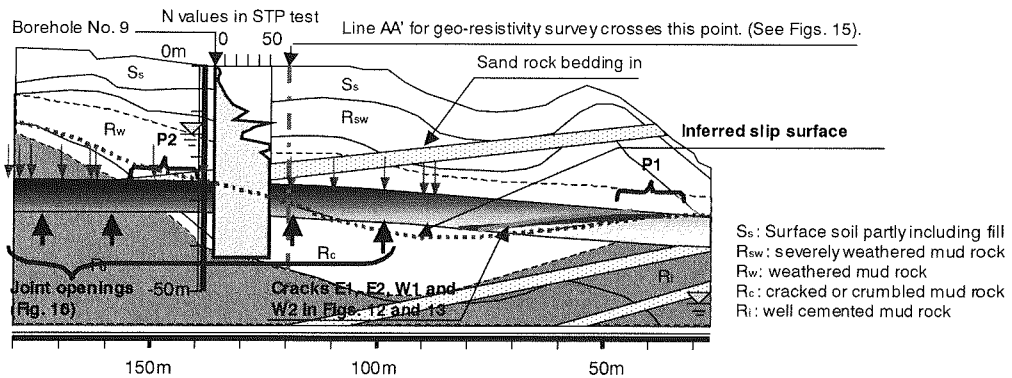
As has been mentioned, the northern part of the tunnel crosses at two locations, P1 and P2, a severely cracked and/or weakened mud rock layer (Fig. 11). The cracks E1, E2, W1 and W2 shown in Fig. 12 seem to have appeared in this weakened mud rock zone P1 near the north tunnel mouth. On the other hand, Cracks that appeared on the concrete lining (downward thin line arrows in Fig. 11) over some longer distance (100-180m) covering P2 zone, cut the tunnel axis upright and diagonally crosswise. This pattern of cracking seems to suggest that the tunnel was slightly bent towards the east-sloping mountainside. A lot of water reportedly came out of boreholes through the rock zones P1 and P2 before the tunnel construction. The soil profile along borehole #9 in Fig. 11 indicates that the underground water level is about identical to the upper surface of this weakened rock zone.

Fig. 11. Soil/rock profile along Kizawa tunnel: Downward thin arrows on the tunnel crown show locations of cracks cutting the tunnel axis upright and diagonally crosswise, while upward thick arrows show locations of joint openings (see Fig. 16).

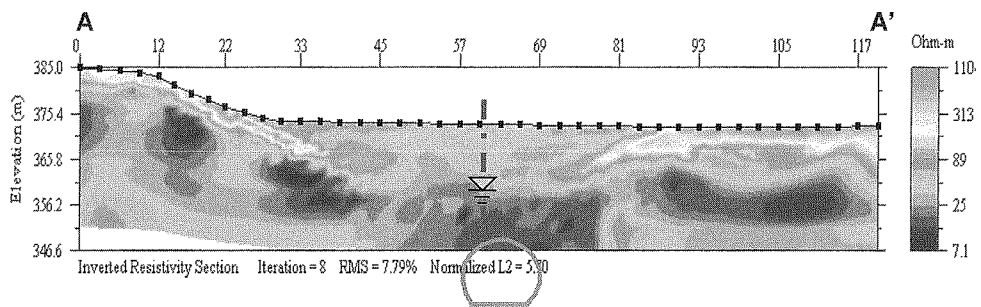
Fig. 15. Spatial distribution of geo-resistivity across Kizawa tunnel

Near this borehole, a 123m-long line, A-A', was taken along a depressed ground surface for geo-resistivity measurement (see the broken line A-A' in Fig. 11). This line crosses in its middle over the tunnel at an angle of 60 degrees. The possible pattern of geo-resistivity distribution, obtained from an inverse analysis (Fig. 15), shows a shallow zone with high resistivity of about 300-2000 Ohm-m suggesting the presence of the original ground surface (0-36m and 72-123m). Low resistivity zones underlie this zone. In the middle of Line A-A' over the most depressed and flat configuration (26-90m), the surface soil deposit of about 15m-thickness is underlain by a lower resistivity zone (about 7-20 Ohm-m) whose upper surface is about identical to the underground water level in Borehole #9. This zone with an inclusion of the tunnel near the deepest bound of the geo-resistivity measurement (red circle in Fig. 15) is a little asymmetric. The presence of the tunnel may be affecting the underground water flow.

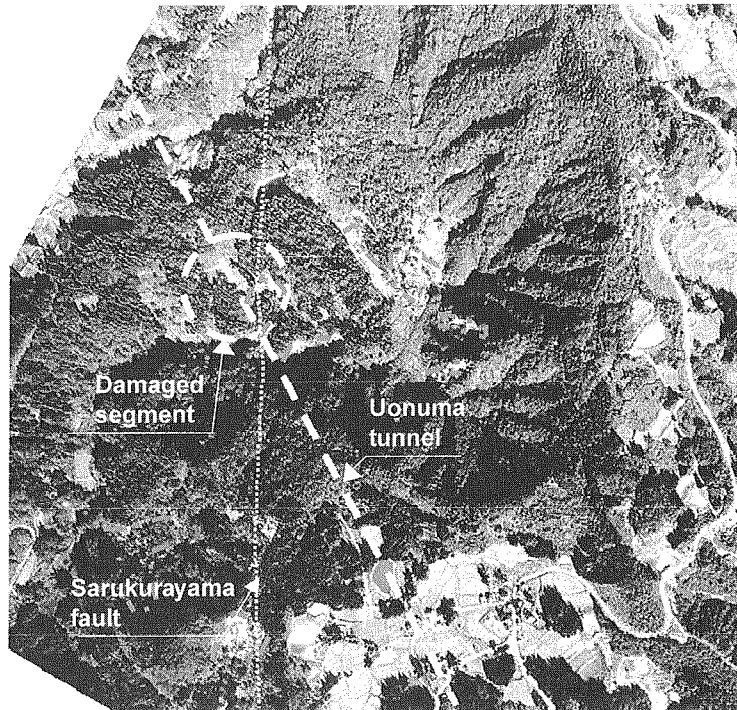
As seen in Fig. 19, some landslides occurred above the tunnel damage location. Other researchers and also the authors research group have made field trips to different areas along the Sarukurayama fault, but no direct evidence, such as soil offsets and/or cracks indicating a fault-reactivation, was found.

Fig. 19. Aerial photograph of the area above the damaged segment of Uonuma tunnel

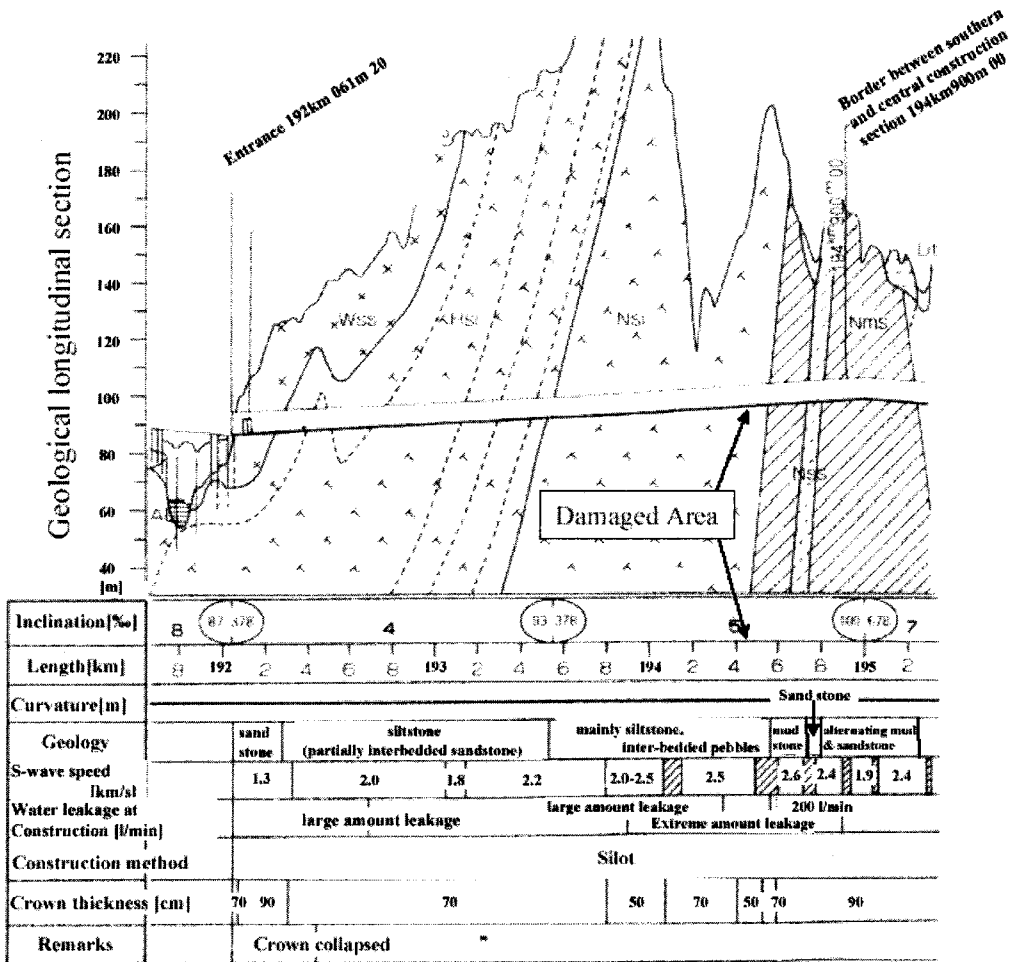
Given the geological complexity of this zone, the tunnel was carefully constructed with its both sides first excavated large enough to permit the insertion of steel supports, which served later as foundations for cutting upper half of the tunnel. The tunnel was constructed through a squeezing rock zone, which extends 120 m to north of the segment damaged in this earthquake (See the abrupt change in geological formation in Fig. 20). At the damaged location, the tunnel is about 60-100 meter deep as interpreted from Fig. 20. Fig. 20 indicates an extreme amount of leakage (200 liter/min) during the construction time. The leakage may be related to the river flowing above the tunnel.

Fig. 20. Geological profile along the southern construction section of Uonuma tunnel (Japan Railway Construction Corporation [5])
