DAMAGE TO EARTH STRUCTURES CAUSED BY THE 2004 NIIGATA-KEN CHUETSU EARTHQUAKE

Junichi KOSEKI¹, Yukika TSUTSUMI², Takashi KIYOTA³,
Susumu NAKAJIMA³ and Sajjad MAQBOOL³

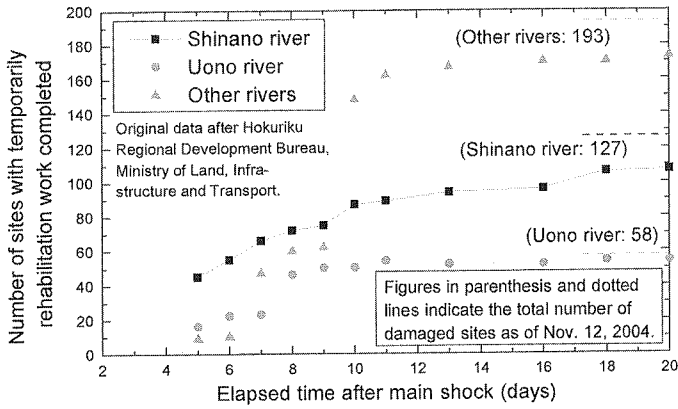
Figure 17. Progress of temporarily rehabilitation work on damaged river facilities including dikes

Based on the data reported by MLIT (2004a), progress of temporarily rehabilitation work on damage to river facilities including dikes is summarized in Figure 17 in terms of the number of sites. In ten days after the main shock, temporarily rehabilitation work was completed at about 70, 85 and 75 % of the damaged facilities along the Shinano river, the Uono river, and the other smaller rivers, respectively. In nineteen days after the main shock, it was completed at all the damaged dikes along the Shinano and Uono rivers (MLIT, 2004a). On the other hand, much longer time was required for rehabilitating severely damaged dikes in the other smaller rivers and natural dams that were created by earthquake-induced landslides in mountainous areas. For example, Figure 18 shows rehabilitation work on a severely damaged dike along the Kariyata river at Gohyaku-kari, Nakanosima-machi (site 11 in Figure 1), where cut-off sheet piles had been driven on the river side before executing the partial reconstruction work of the dike.
