DAMAGE INVESTIGATIONS of PUBLIC HALLS IN NAGAOKA CITY AFTER NIIGATA-CHUETSU EARTHQUAKE

ABSTRACT: This paper reports the results of damage survey to some public halls in Nagaoka city, the closest urban area to the epicenters of Niigata-Chuetsu earthquake. Because of the distance from the epicenter less structural damage to them was found. However the damage that these facilities were suffered, damage to suspended facilities especially to suspended ceilings, was so serious that they could not continue their functions after the earthquake.

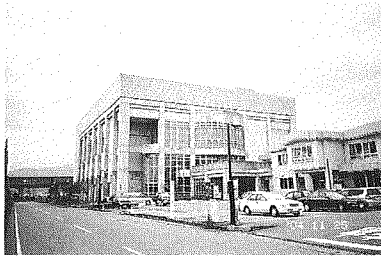
This public hall is located most south area in the city and close to the epicenter. However the damage to the structure was rather minor. Some minor cracks on seismic walls and crash of grout under beam base were found. Many ceiling panels have fallen off near the boundary age area, where the horizontal ceiling panels connected to inclined ceiling, of the arena. Some panels have also fallen in the middle part of the arena. Ceiling panels were made of glass wool. Slide, deformation and cut of connections between cross furrings or hooks between cross furring and main runners were observed. No brace member was seen in the hanger bolt systems.

(a) Exterior view

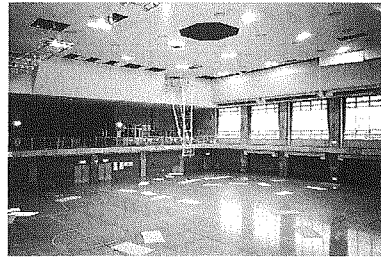
During the earthquake several people were using the arena and, fortunately, nobody was injured. Because of this damage the arena could not continue its function. In spite of all the request from neighbors the arena could not serve as the refugee space.

(b) Interior view

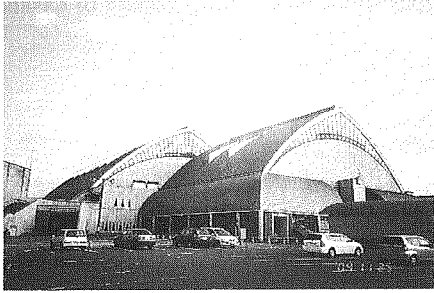
Structural skeletons are non-conventional system combining space truss and arch principle. No structural damage was found in the skeletons. Heavy suspended ceiling panels in the north side of the roof have fallen off in a wide scale. A large part of the north gallery seats were buried under the wreck of ceilings. A lot of hooks, which connect the furrings to the main runners, were deformed and removed with the furrings. During the earthquake the arena was in use and a student was badly injured by the fallen ceilings. The arena has been closed since soon after the earthquake.

(a) Exterior View

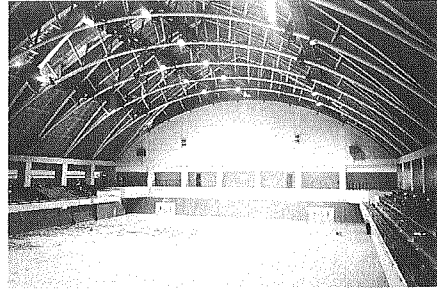
(b) Interior view

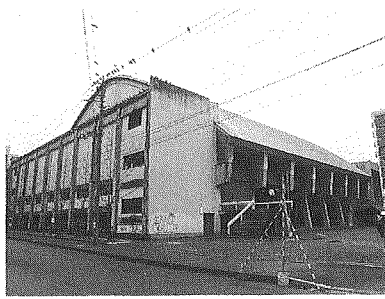
Some cracks were found on the RC seismic walls. No structural damage was found in the roof structures. The ceilings with plasterboards were designed in an arch shape with wavy pattern. The ceiling panels have fallen off in a wide scale, especially at the top of the both gable ends, probably because of collision with the end walls. Again many cross furrings and deformed hooks were also found on the floor. Fortunately nobody was using the arena during the earthquake.

(a) Exterior View

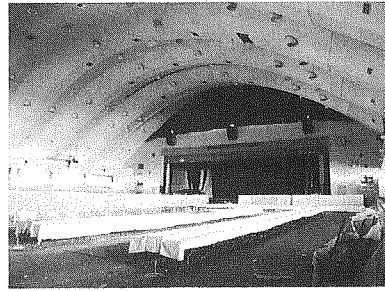
(b) Interior view

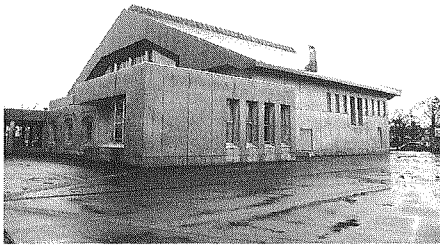
This public hall is located in north area of the city comparatively far from the epicenter. Minor cracks were found on the RC seismic walls. No damage to the roof structure nor roof bearings were found. For architectural finishing, ceiling panels of plasterboard were removed at the edge area of the arena, where inclination of the ceiling changes. The removals are also comparatively small. The arena could open as the relay point of the commodities for refugee.

(a) Exterior View

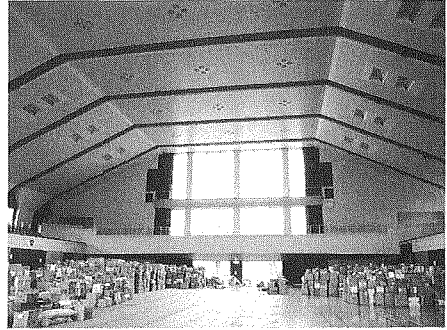
(b) Interior view

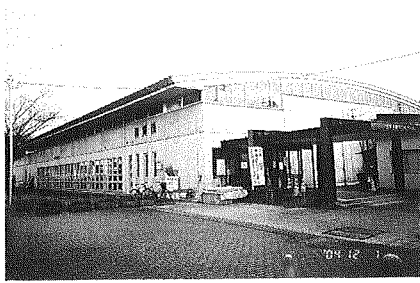
Location of this swimming is closer area to the epicenter. No structural damage was found in the structures of the swimming pool while some major cracks could be observed in the structures of smaller annex rooms attached to the buildings. In the swimming pool arena, a large part of the ceiling panels have fallen off. Larger removal could be found at edge area where suspended ceilings might have collided against walls. Panels around opening for air-conditionings were also removed. Metal work for openings have also fallen off. The ceiling panels were made of rather highly hygroscopic material, which seemed not appropriate for swimming pools. Although many pupils were in the pool during the earthquake, nobody was injured, fortunately.

(a) Exterior View

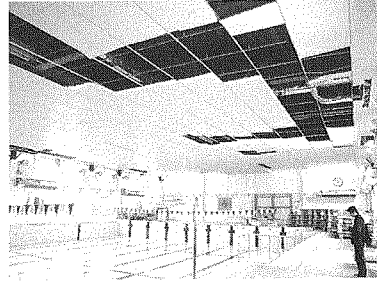
(b) Interior view
