Damage to Building Structures due to 2005 October 8 Pakistan Earthquake

Yoshiaki NAKANO¹, Takao NISHIKAWA², Yoshihiro TSUCHIYA³,
Yasushi SANADA⁴, and Hiromi SAMESHIMA⁵

Key Words: Pakistan Earthquake, Building damage, Seismic capacity, Quality of materials, Reinforcement details

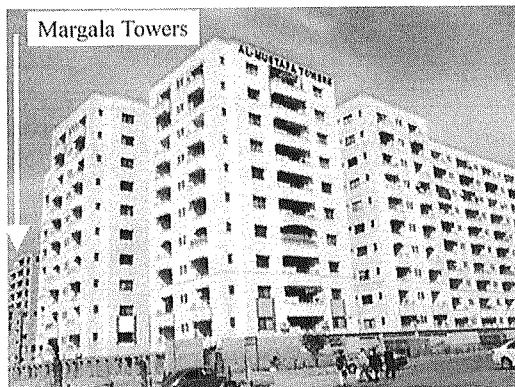
The towers were located neighboring Margala Towers (**Photo 2-1**). Some visible cracks were observed in URM (solid cement block) walls but no structural damage was apparently found in RC columns and shear walls. They were under repairing at the time of the investigation (**Photo 2-2**). The spacing of lateral and vertical reinforcement of an RC wall investigated with a rebar detector was 20cm and 12cm, respectively. According to the structural engineer who designed the building, the diameter of the lateral and vertical reinforcement of the wall was 13mm and 10mm, respectively.

Schmidt hammer tests were made on an elevator core wall and the estimated strength was 28 N/mm² ($R = 47$).

Photo 2-1. General view of Al-Mustafa Towers

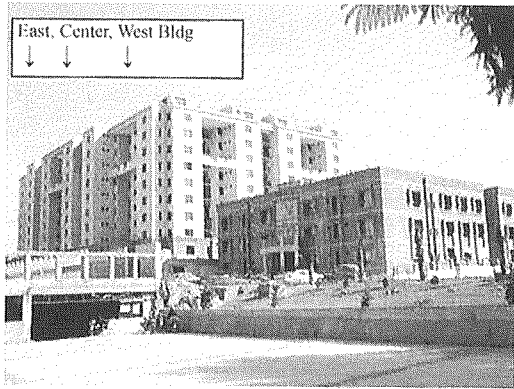
The apartment house consisted of 3 buildings (west, center, and east building) (**Photo 3-1**). Expansion joints were provided between each building. Major structural damage was found in beams.

Schmidt hammer tests were made on columns of the basement floor and the estimated strength was 33 N/mm² ($R = 54$).

Photo 3-1. General view of Park Towers

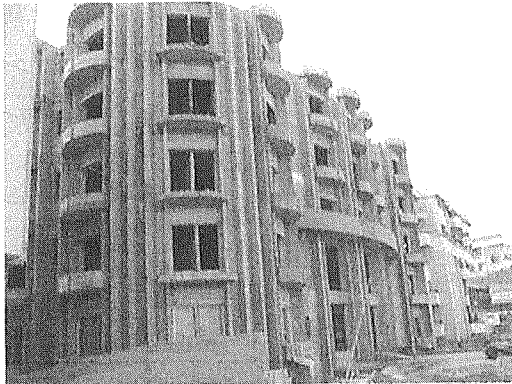
The building was under construction at the time of investigation (**Photo 4-1**). The typical column section was rectangular with 30cm width and 70cm depth. The hoops had 90-degree hooks (**Photo 4-2**). According to the structural engineer who designed the building, the width-to-depth ratio of typical RC columns in Islamabad was 1/2 to 1/3, and URM (hollow cement block) walls were 20cm thick for exterior walls and 15cm thick for interior walls. Some longitudinal rebars of beams were placed out of beam-column joint core concrete. Honeycombs were found in some concrete members. No structural damage was, however, apparently found in the building.

Schmidt hammer tests were made on a column in the 3rd story and the estimated strength was 26 N/mm² ($R = 40$).

Photo 4-1. General view of Al-Safa Heights

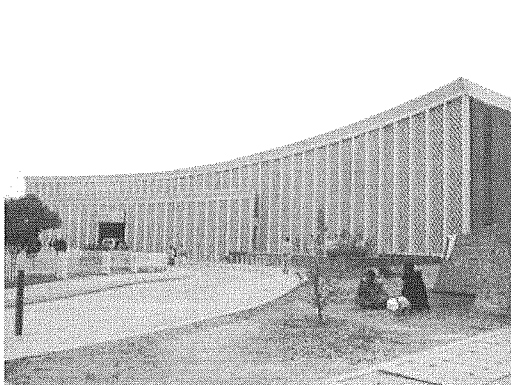
Photo 5-1 shows the general view of the building. The building had some minor cracks in URM walls. Cracks were also found in the interface between URM walls and boundary RC frame (beam and column) (**Photo 5-2**). Most of them were likely initiated before the event and widened due to shaking.

Photo 5-1. General view of G/P Ward

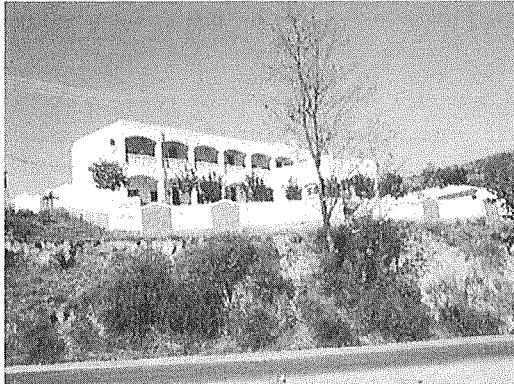
This building was situated on a hillside in Battal along the National Road N-35 running through the village (**Photo 6-1**). The building was designed and constructed in accordance with the Japanese building code since its construction was financially supported by the Japanese Government. It had flexural cracks at the top of a column with exposure of reinforcing bars (**Photos 6-2** and **6-3**). The shear reinforcement of 2-D10 (#3) was provided at a spacing of 10cm with 135-degree hooks (**Photo 6-4**). Although some cracks were found in the core concrete of the damaged part, no buckling of main bars was observed. The damage level of the column was identified to be level III in accordance with the Japanese Damage Level Evaluation Guidelines^{*1}. Minor flexural cracks were also found in almost all other columns in the corridor side ranging from damage level I to II.

Schmidt hammer tests were made on beams of the 1st story framing into the damaged column and the estimated strength was 21 N/mm^2 ($R = 40$).

Photo 6-1. General view of school

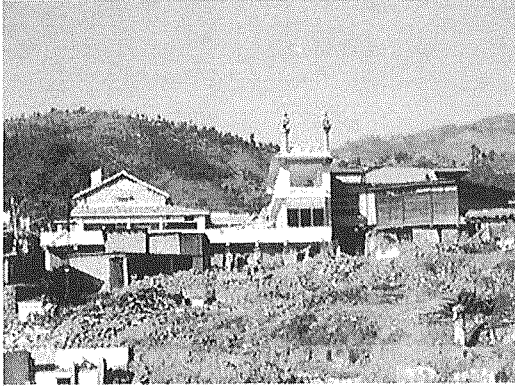
The Mosque (**Photo 8-1**) was located close to the Primary and High School for Girls described earlier. Some columns were seriously damaged resulting in partial collapse in the first story (**Photos 8-2 and 8-3**). Extensive shear cracks were found in URM walls (**Photo 8-4**).

Seismic capacity of the collapsed building was preliminarily calculated according to the Japanese Standard for Seismic Evaluation, neglecting the effects of URM walls to structural behavior. The structure was estimated to fail in flexure and its ultimate strength was 0.14 in terms of base shear coefficient.

Photo 8-1. General view of the mosque

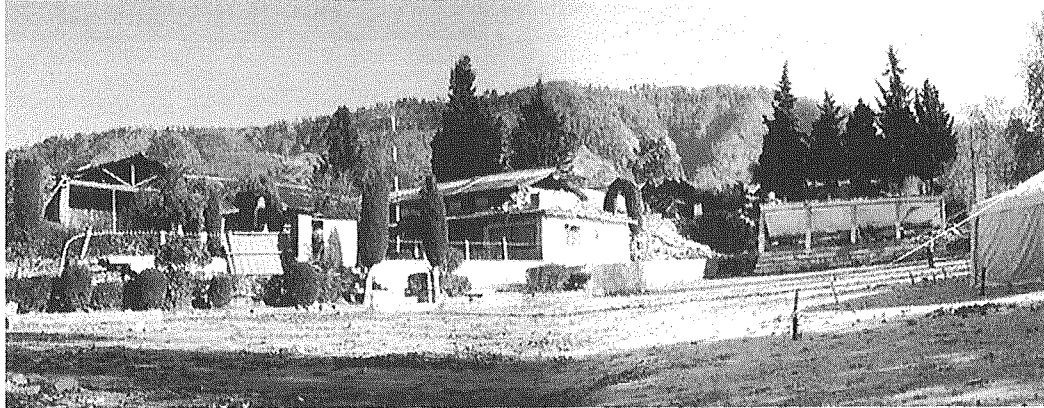
The school consisted of several URM buildings (**Photo 9-1**). Two of them were completely destroyed (**Photos 9-2 and 9-3**). The building collapse reportedly killed 35 and injured 150 out of 450 students.

Photo 9-1. General view of school
