DAMAGE TO ROADS CAUSED BY OCT. 8, 2005 NORTH PAKISTAN EARTHQUAKE

Obaid Hassan QURESHI ¹ and Junichi KOSEKI ²

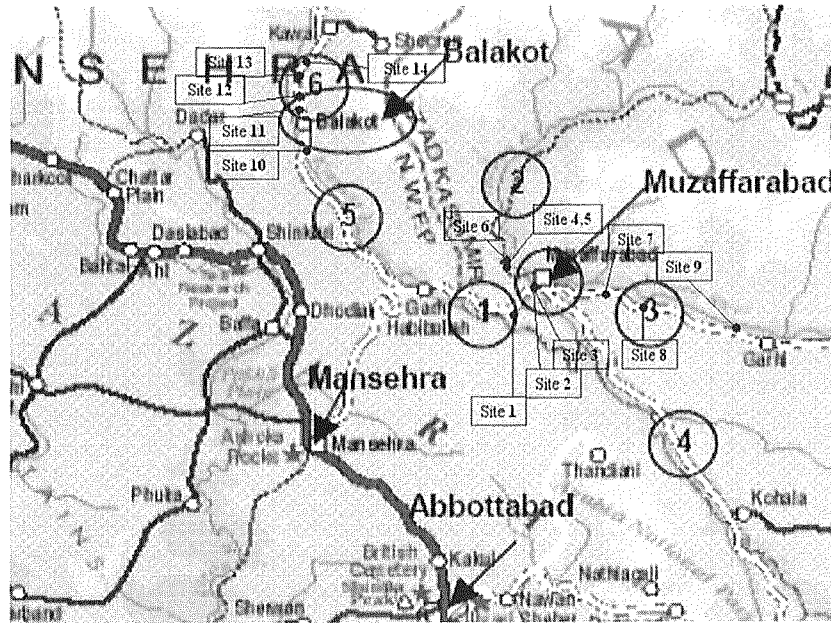
Fig. 2: Map showing the sites affected by slope instability on major roads

The road network throughout the earthquake zone suffered severe damage primarily due to landsliding. Slope failures were observed at various locations on roads in the affected areas. Some segments of the roads were open to the traffic during the time of visit whereas most of the length of some roads was not open as yet due to heavy landsliding e.g. Road No. 2, Road No. 6 and Road No. 7. Fig. 2 shows the sites on the main roads affected by the landslides. It is to be mentioned that these are only a few representative sites.

Landsliding and critical slope stability was a multi-scale problem that ranged from limited sloughing of surficial nature to a scale that encompassed entire mountain sides.

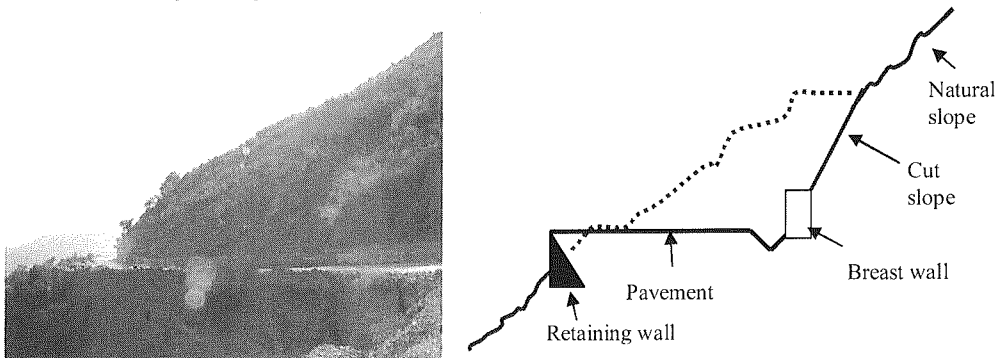
Fig. 3: Typical cross section of the roads in the affected area

Along the roads leading to Balakot and Muzaffarabad there was ample evidence of cleared landslides that blocked these roads. The roads in the affected area are constructed in cut. The typical section of the roads in the affected area is shown in Fig. 3. This geometry greatly helped in clearing most of the landslide sites for light traffic. The occurrence of these surficial landslides along the rather steep slopes is not unexpected. Most landslides appear to be in a meta-stable state and can be readily activated due to aftershocks or rain. Landslide hazard remains high throughout the affected areas.

Retaining structures used to support the ground experienced significant damage throughout the investigated area. In areas where breast walls (Fig. 3) are used, landslide debris overtopped these walls sometimes resulting in damage due to impact of large boulders. The retaining walls and breast walls in the surveyed area are mostly of gravity type and made up of stone masonry bonded by cement mortar.

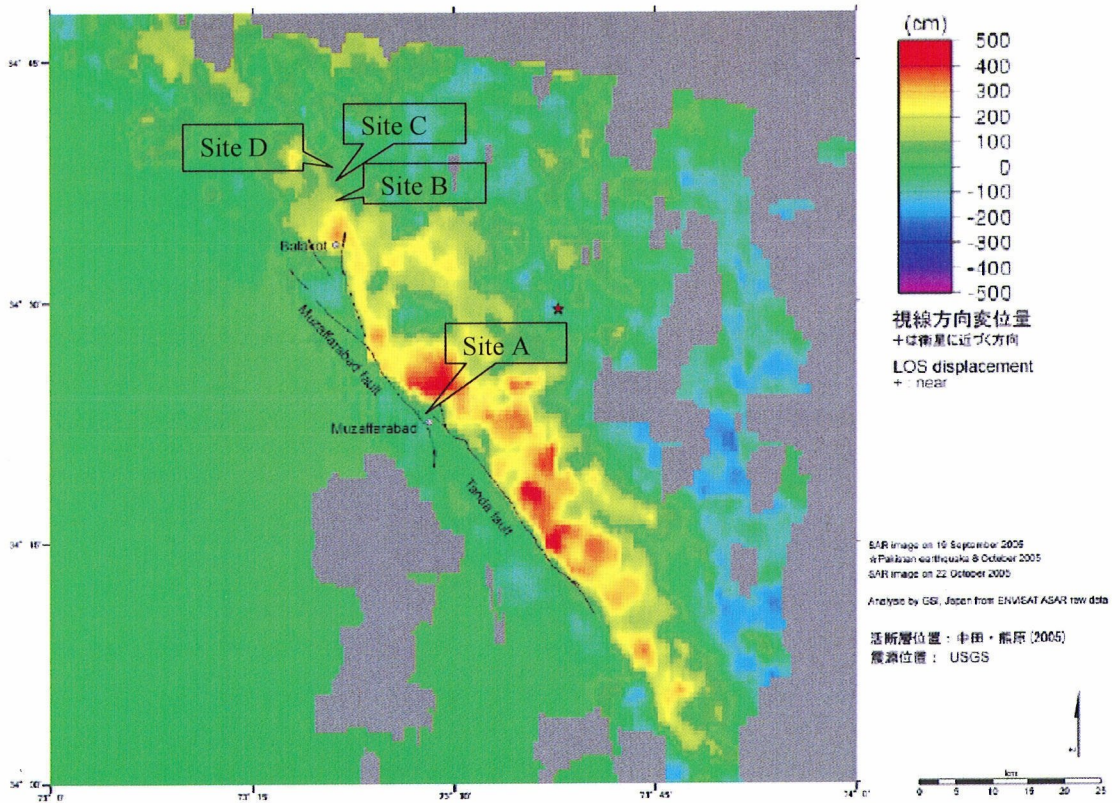
Fig. 36: Deformation map of the earthquake (after Tobita et al, 2005)

Tobita et al (2005) presented the deformation map of the area during this earthquake (Fig. 36). The sites shown in Figs. 32 through 35 are plotted on the deformation map here, which gives a hint that the ground ruptures at the above-mentioned sites can be the surface effects of underlying fault. But the detailed field investigation is necessary for reaching to a conclusion.
