# STRONG GROUND MOTIONS AND SOIL DEFORMATIONS IN THE MAY 27, 2006, MID-JAVA EARTHQUAKE\*

**ABSTRACT:** A devastating earthquake occurred in Mid-Java, Indonesia on May 27, 2006. Japan Society of Civil Engineers (JSCE hereafter) dispatched its first investigation/technical support team including ERS members to the severely damaged areas; south of Yogyakarta in Indonesia by this earthquake during the period from June 10 to 17, 2006 in a close cooperation with the Indonesian Institution of Engineers (PII) and the Ministry of Public Works, Indonesia. This report describes briefly findings obtained through the authors' reconnaissance, highlighting some geotechnical issues for better rehabilitations.

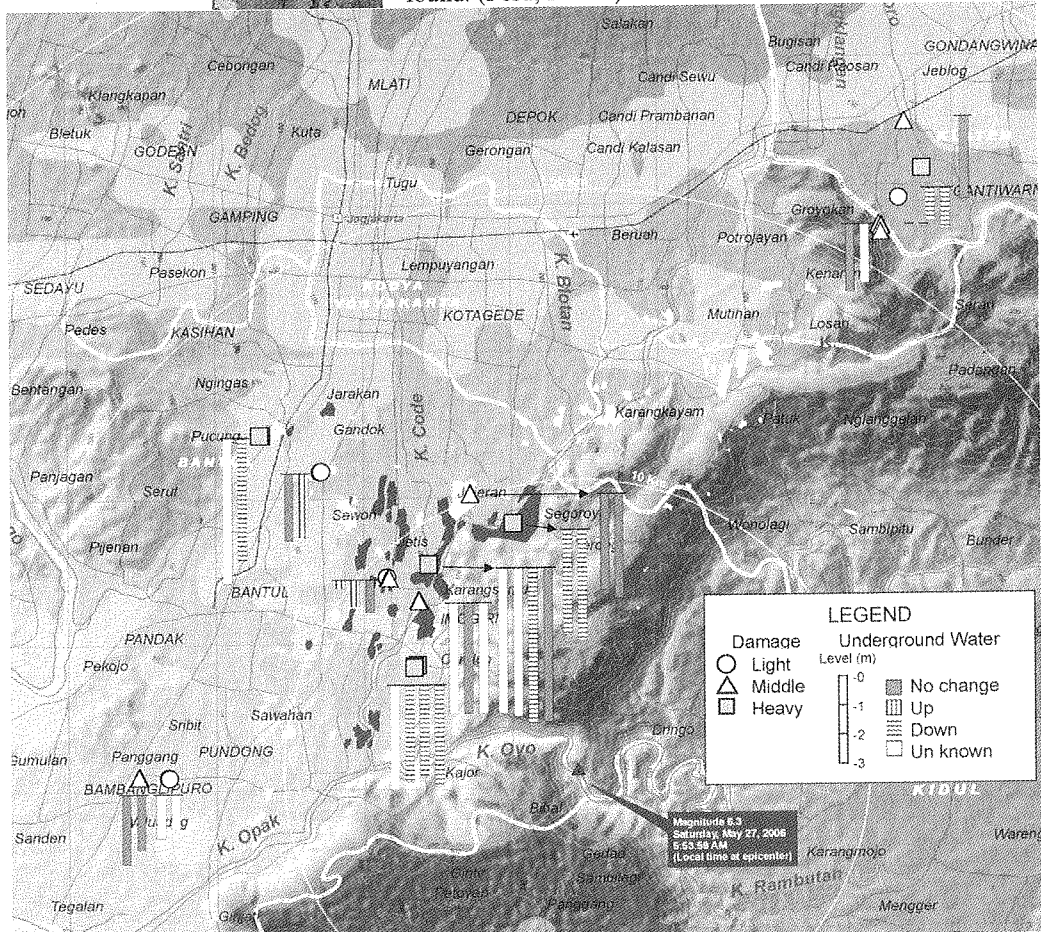
Fig. 2. Locations of investigated wells

- \* Lengths of bars show depths of water levels as of June 12-13, 2006.
- \* Changes of water levels are all from owners and/or eyewitnesses.
- \* The background map illustrates a preliminary damage assessment of the affected areas (UNOSAT website: <http://unosat.web.cern.ch>). Red, orange and yellow colored spots show respectively extensive, middle and limited devastation areas.

Even in the SW-NE trending narrow belt of the most serious devastation, the damage were distributed in clusters probably due to local ground conditions and soil deformations. However the team observed just few evidences showing that soils have been deformed visibly. The team members checked if underground water levels had changed due to the strong ground motions at a total of 40 wells randomly distributed in the damaged area (Fig. 2). Some eyewitnesses said that they saw muddy dark-colored water spouted out of their wells, and plastic pipes for pumping water out of these wells were found bent, broken and pushed up. They clearly indicate that soils beneath the wells have liquefied, however no clear sand volcanoes were found in their vicinities. Damage to houses
