GEOTECHNICAL SURVEY REPORT ON 2006 YOGYAKARTA (MID-JAVA) EARTHQUAKE

Ruta Ireng WICAKSONO¹, Junichi KOSEKI², and Takashi KIYOTA³

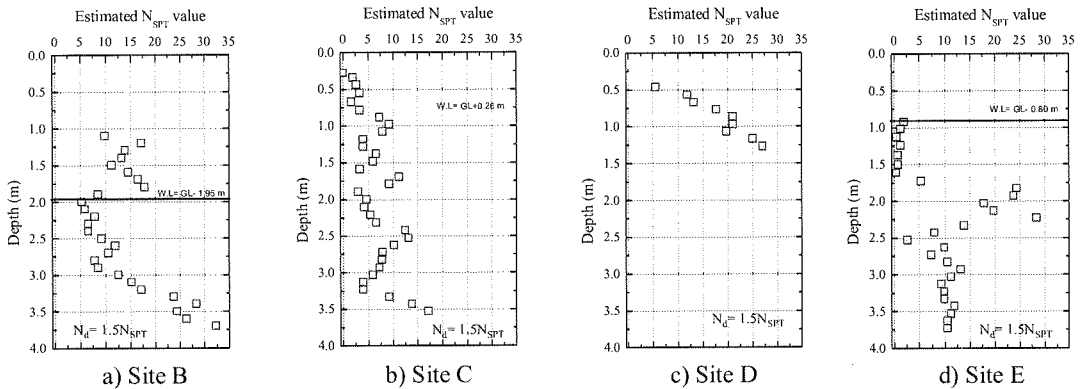
Figure 3. N_{SPT} values at Sites B, C, D, and E

At site C at Candirejo village, Tegal Tirto, Berbah in Sleman District, spouting out of groundwater at maximum about 1 m in height for about 24 hours after the earthquake was observed. Even at the time of the survey that was conducted in one month, water was still springing out (Photo 5). At this site as shown in Figure 3b, soft soil deposits with N_{SPT} values less than 10 having thickness of about 3 m were identified.

At Site D at Muhammadiyah University in the suburb of the Yogyakarta city, as shown in Photo 7, a revetment surrounding a pond failed. A dynamic cone penetration test was conducted on the embankment. As shown in Figure 3c, rather stiff soil deposit with N_{SPT} values more than 10 could be found at about 0.5 m depth.

At Site E at Mutihan in Klaten district, spouting of groundwater to a maximum height of about 1 m was observed after the earthquake (Photo 8). In this region, high collapse ratio of houses was observed. As shown in Figure 3d, soft soil deposit with N_{SPT} values less than 5 was observed until about 1.75 m depth, where the groundwater level was about 1 m from the surface. In addition, another soft soil deposit with N_{SPT} values of about 10 was observed at deeper than about 2.5 m from the ground surface.

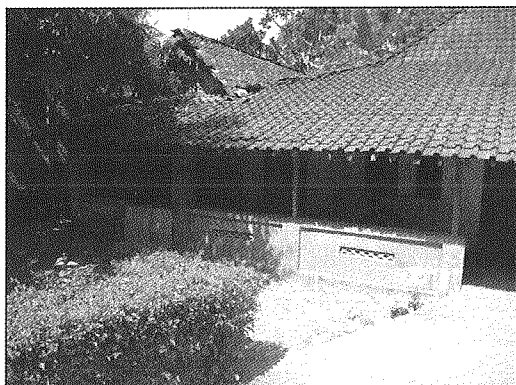
At Site G at Bayat and site H nearby Jombor Lake in Klaten district as shown in Photos 11 and 12 respectively, no extensive damage was observed. In addition, at Site H, plugging of well and spouting of groundwater were not reported throughout the village.

Photo 11. Houses condition at Site G

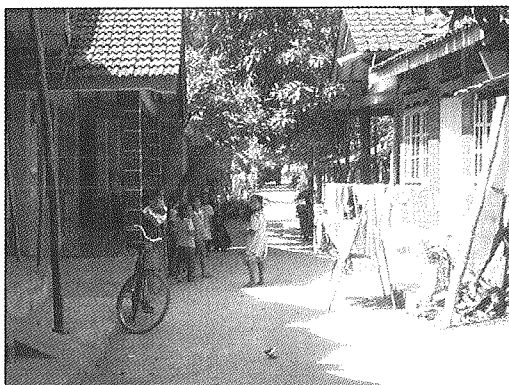
Photo 12. Houses condition at Site H

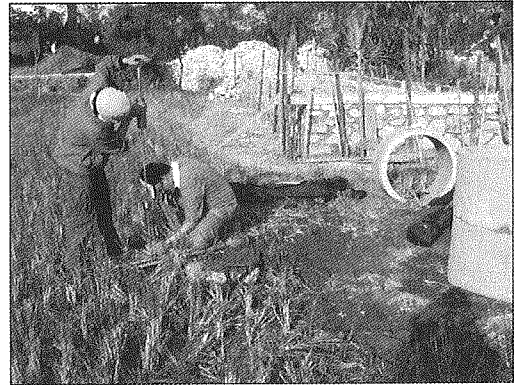
At Site I in Patalan, Bantul district, a primary school building and its surroundings were damaged as shown in Photo 13. At Site J that was about 1 km from Site I towards the north, a housing lot was under construction on a paddy field as shown in Photo 14. Results of dynamic penetration tests at Sites I and J are shown in Figures 4a and 4b, respectively. At both sites, the groundwater level was shallower than 1 m from the ground surface, below which soft soil deposits with N_{SPT} values less than 10 could be found for a thickness of about 2 to 3 m.

Photo 14. Housing lot on paddy field at Site J
