DAMAGE IN AREAS AFFECTED BY THE AUGUST 15, 2007 PISCO EARTHQUAKE, PERU*

Jörgen JOHANSSON¹, Paola MAYORCA²,
Edwin LEON³ and Tatiana TORRES³

Key Words: Pisco Earthquake, liquefaction, adobe, confined masonry

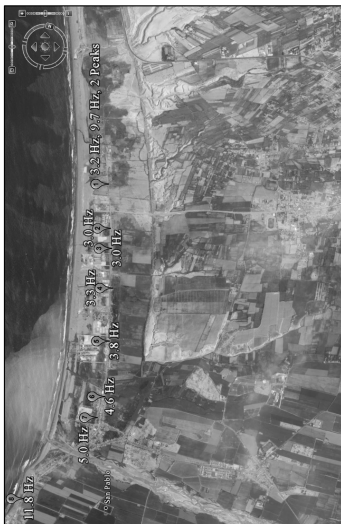
The most remarkable geotechnical aspect of the 2007 Pisco Earthquake was the damage caused by the liquefaction and accompanying lateral spreading, not only in Tambo de Mora (Chincha Baja), but also in the parts of Pisco closest to the ocean. Tambo de Mora is located on an alluvial deposit in the south and a marine deposit in the north (see Figure 3) and to the east of the marine deposit lies the Pleistocene Canete formation consisting of alternating layers of sand and silt stones [5]. Ground water

Figure 3. Google earth image of Tambo de Mora. The dots mark the limit between formations.

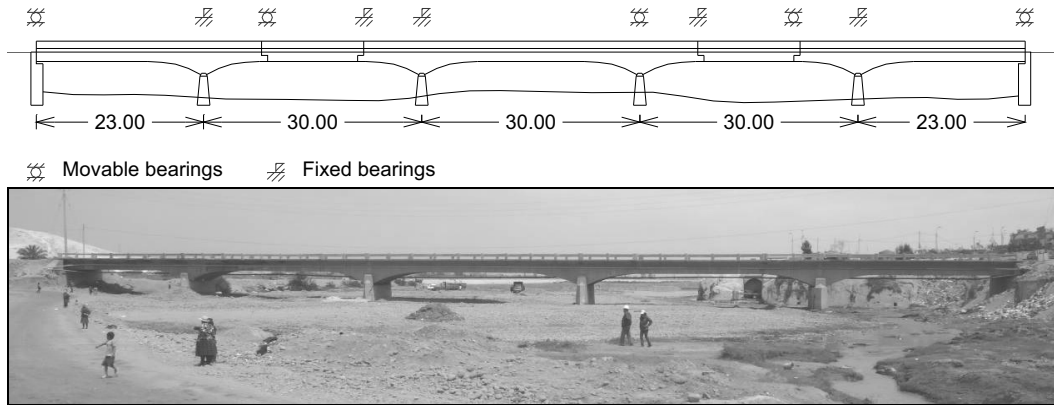
The 136-m long Huamani bridge was the largest structure of this type in the earthquake affected area. Two rather slender abutments (typical Base/Height = 0.3), and four intermediate pillars are supported on 5.4m-deep, and 7.3m-deep caissons, respectively. According to the bridge drawings, there is no connection between the abutments/pillars and the caissons. The bridge superstructure is supported on fixed and movable bearings as shown in Figure 22. The southern abutment tilted towards the north causing settlement and cracking of the embankment. Intermediate pillars also rotated. Although the north abutment was not as damaged as the southern, settlement of the backfill was observed there. The geological formation at the bridge north access belongs to the Miocene/early Pliocene age whereas alluvial deposits are found in the south.

Figure 22. Layout of the Huamani bridge (downstream direction)

The bridge superstructure permanently moved upstream about 8cm. At the movable bearings on the abutment, the steel fittings separated from the concrete structure. The stoppers, on the pillar's movable support, which were supposed to restrain the transverse movement, were not found. Probably they had been completely corroded away. The lateral movement of the bridge caused damage to the concrete wings of the pillars, especially that with the movable bearing. These wings had very little steel reinforcement (Figure 23 and 24).

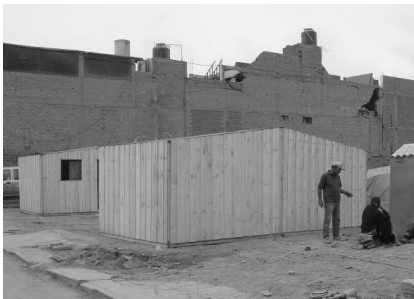
A few temporary houses were observed in downtown Pisco (Figure 25). To be eligible for this, the beneficiary should first clean his/her lot from debris. Many people, who could not benefit from these facilities, built their own temporary houses with the material they could recover from their collapse house roofs, mainly straw mats. At some visited locations housing requirements were mostly covered by tents. At schools, such as the San Luis Gonzaga High School in Ica, temporary classrooms were being installed while the team was surveying. Also, temporary health centers were installed in Pisco (Figure 26).

Figure 25. Wooden temporary house

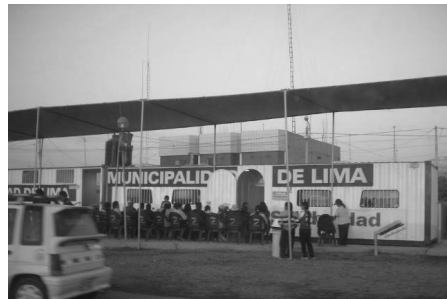
Figure 26. Temporary health center in Pisco (Ica) (courtesy of Ms. Shizuko Matsuzaki)
